**Institute of Water and Flood Management (IWFM),BUET**

**TERM PAPER ON ,  
FROM CRISIS TO RECOVERY: A  
STUDY OF EMBANKMENT BREACH  
MANAGEMENT IN POLDER 22.**

**Course : HE 6301 Community Based Engineering in Water Management**

# From Crisis to Recovery: A Study of Embankment Breach Management in Polder 22

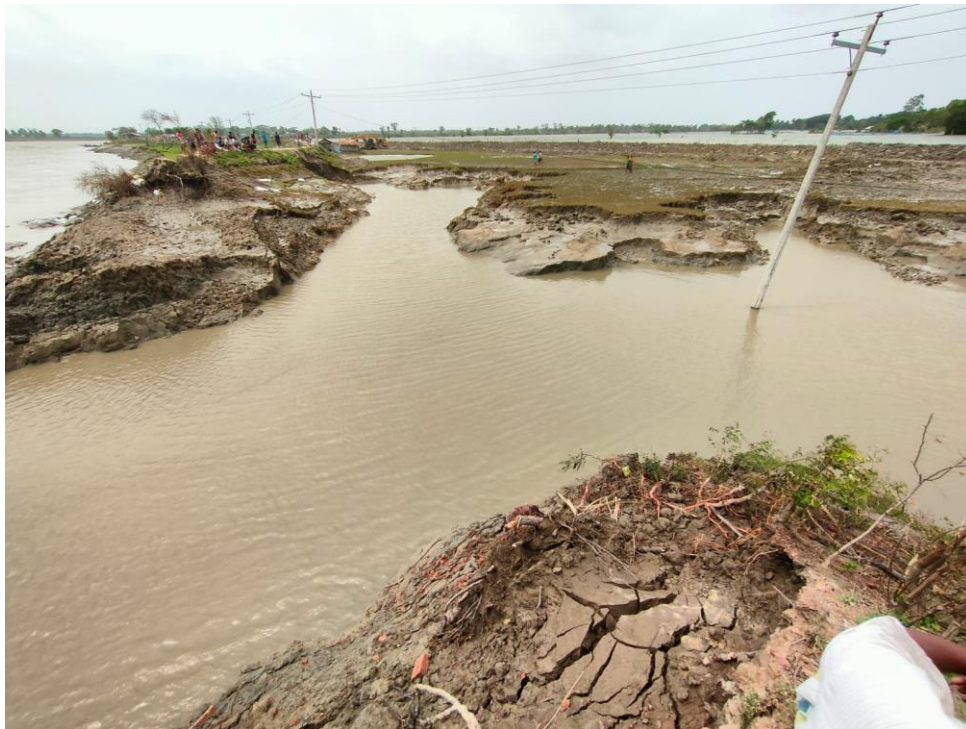
Figure 02 : Breached Embankment during Tidal Surge

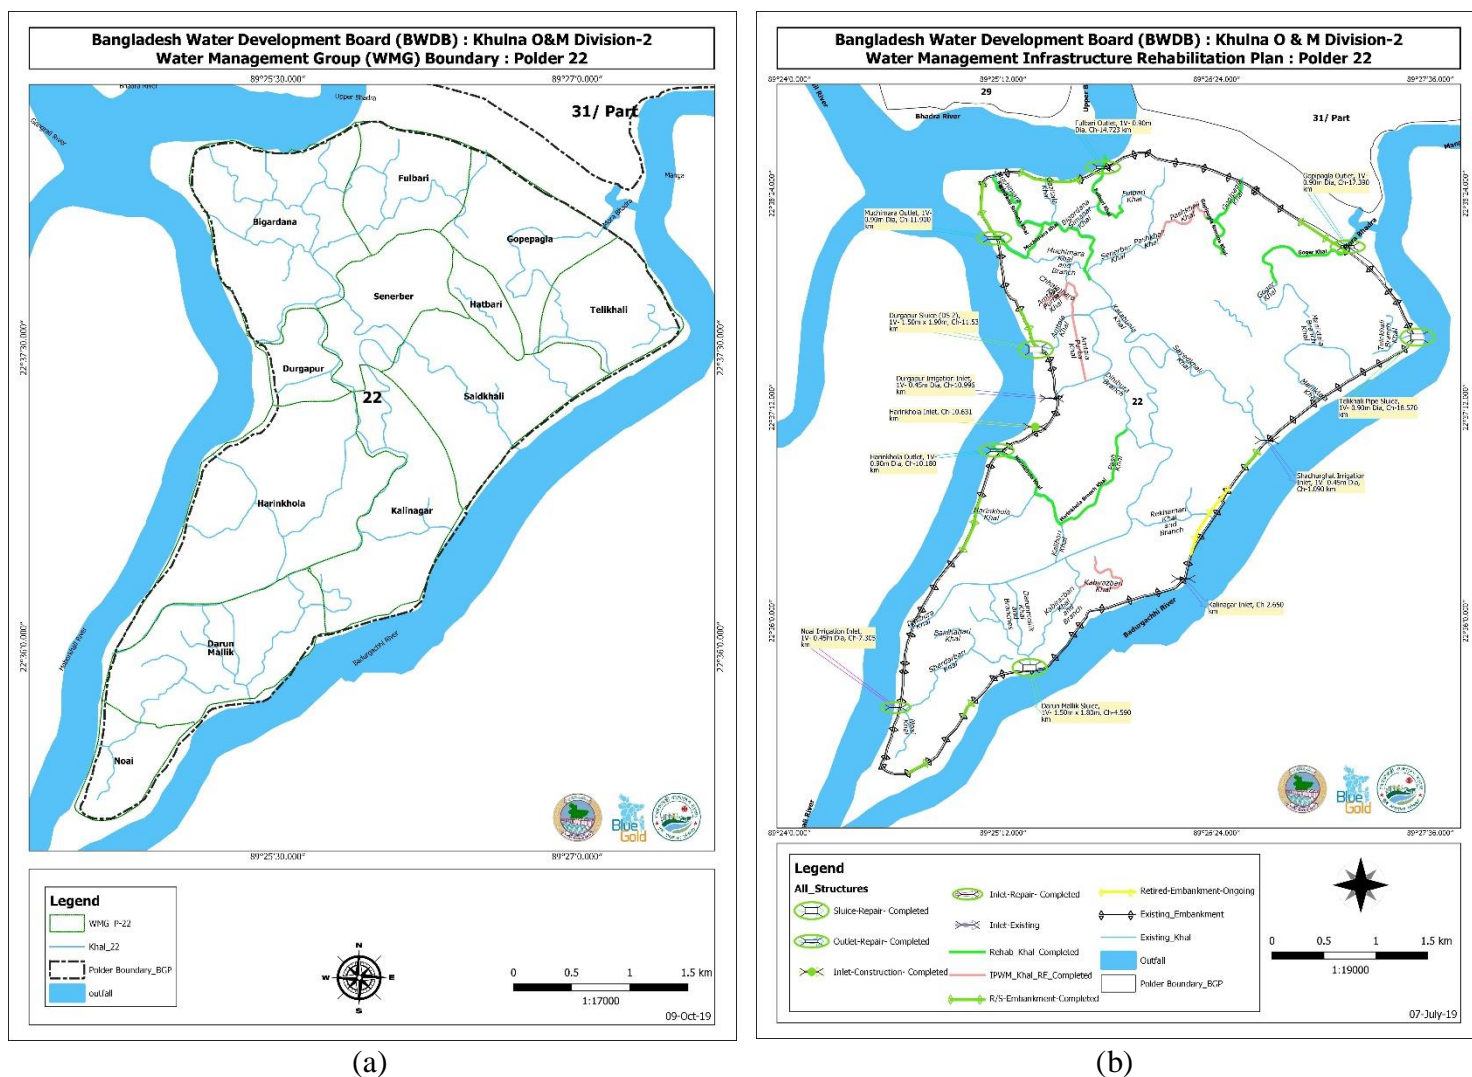
Figure 03 : Map of Polder 22 (a) Water Management Group Boundary;(b) Water Management Infrastructure Rehabilitation Plan [5]

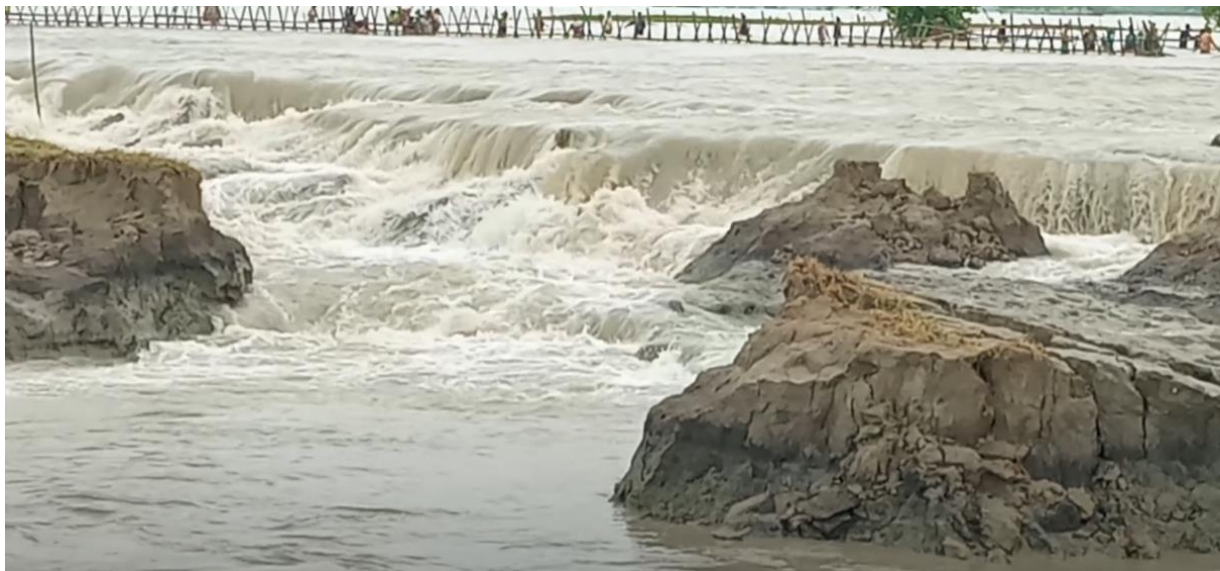
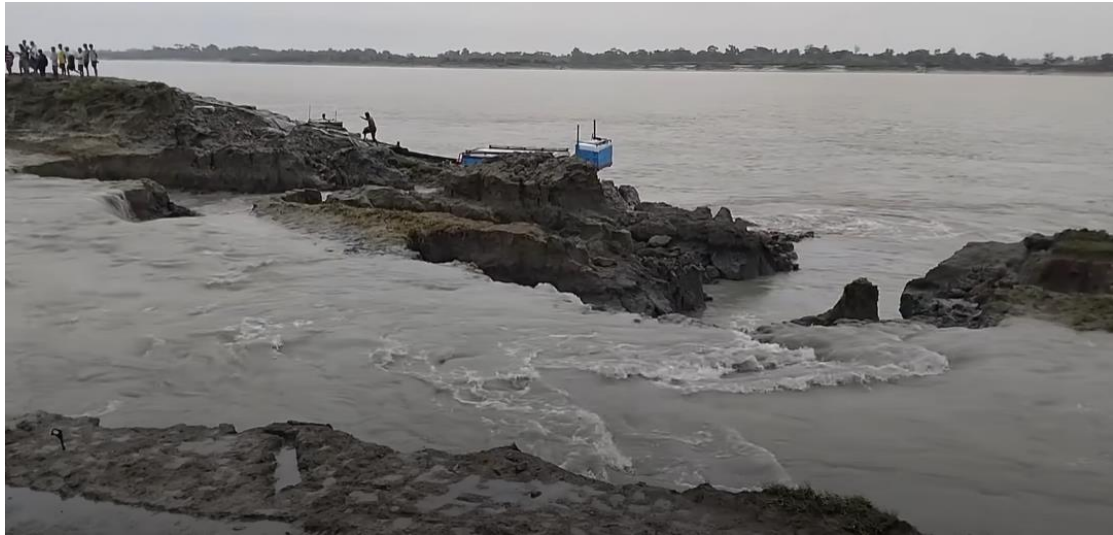
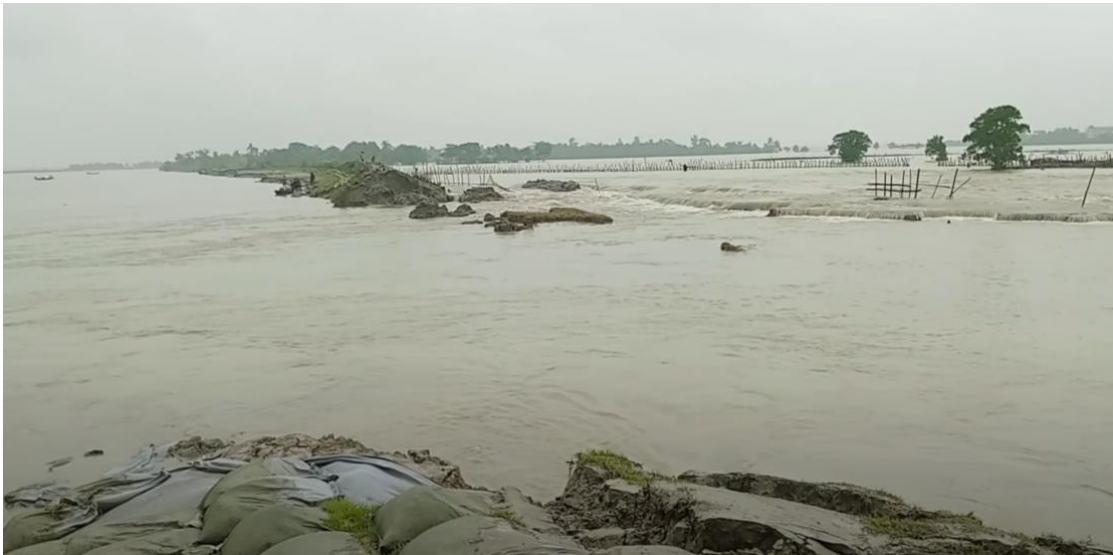
Figure 04 : Embankment Breaching at Polder 22

The embankment breach in Polder 22 has been a reoccurring event with the most recent incident taking place during Cyclone Remal in May 2024 and August 2024 Flood. The cyclone brought severe winds and large tidal waves which overwhelmed the already vulnerable embankments. The breach resulted in extensive flooding which caused widespread damage to homes, farmlands and local infrastructure. Flooding not only destroyed crops but also caused saltwater intrusion which is affecting soil quality and severely reducing agricultural productivity. This breach impacted the livelihoods of nearly 2,000 households resulting in food insecurity and financial losses.

**Weak Embankment Structures:** The embankments in Polder 22 are prone to erosion since they were built using earthen materials and insufficient reinforcement. Over the time, the embankments have weakened, making them vulnerable to breaches during high tides and cyclones. The absence of consistent maintenance simply made things worse and left the

embankments prone to collapse. The recent breach during Cyclone Remal demonstrated the vulnerability of these structures as the embankments failed to resist the force of the tidal surges.

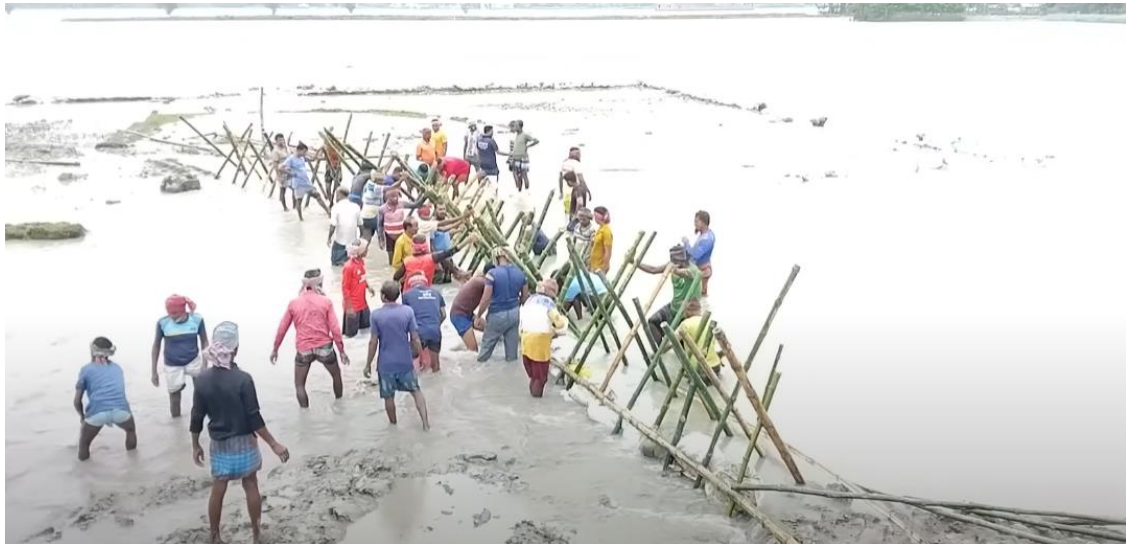
(a) Community efforts to immediate response in Breach Closing

When the embankment breach happened,the local community acted quickly to limit the damage.Residents used available materials such as sandbags, bamboo and wooden planks to create temporary barriers attempting to slow down water intrusion. Despite limited resources, community actions were crucial in stopping the breach from worsening before external assistance arrived.Traditional flood management skills passed down through generations proved valuable, as locals strengthened embankments using natural resources such as mud and

bamboo. However, due to the size of the break and the constant water pressure these efforts were just temporary solutions that needed government assistance. During this period, individuals expressed their disappointments regarding the lack of assistance from the Bangladesh Water Development Board (BWDB) from the very beginning. Although the government agency assigned an excavator to address the situation, it was unable to access the breach area and thus proved to be ineffective.

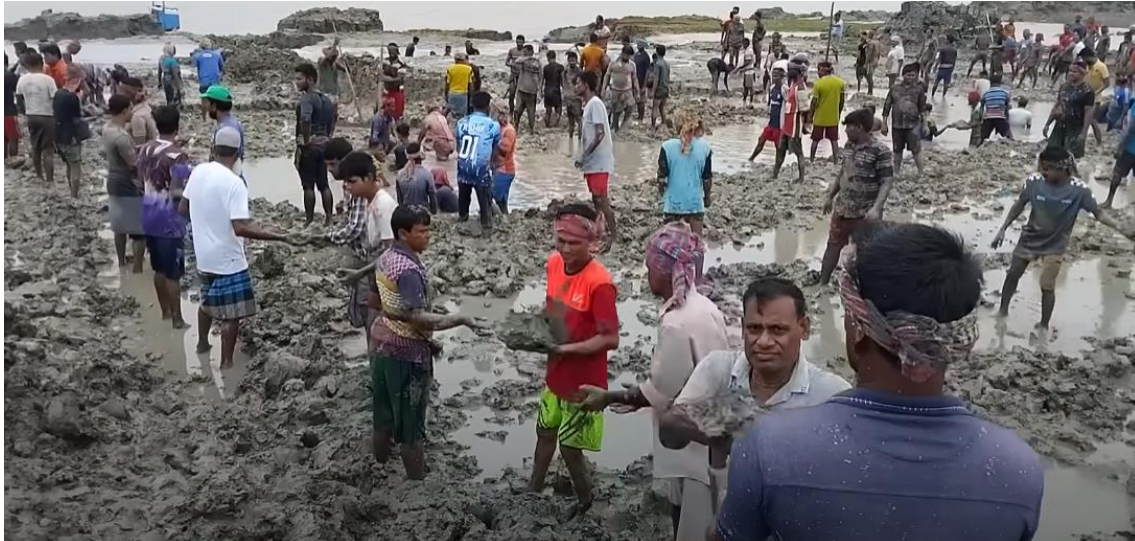
(b) Community Participation in Breach Embankment closing

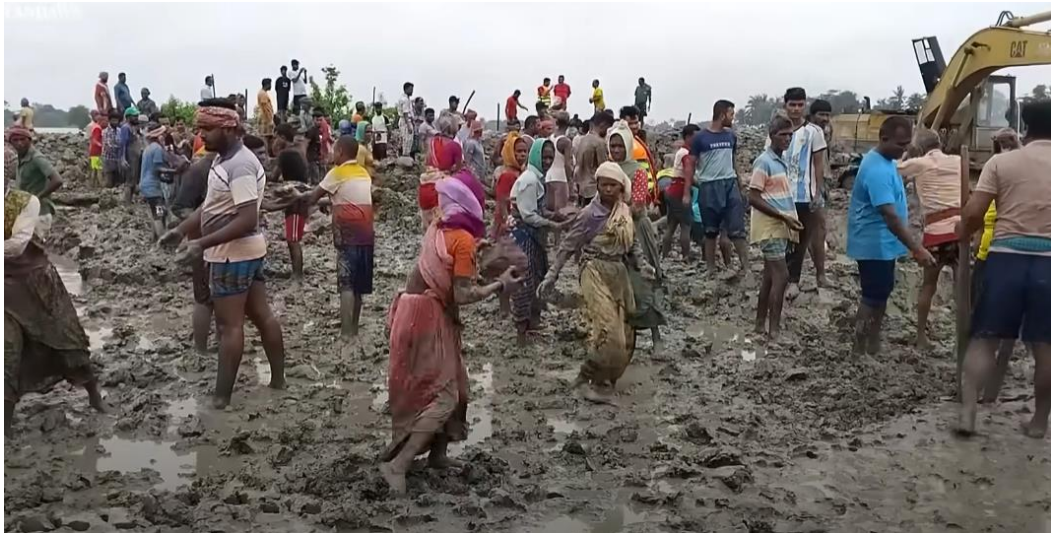
(c)Participation of Women in Embankment repair work

Figure 05: Community's immediate response including women's participation

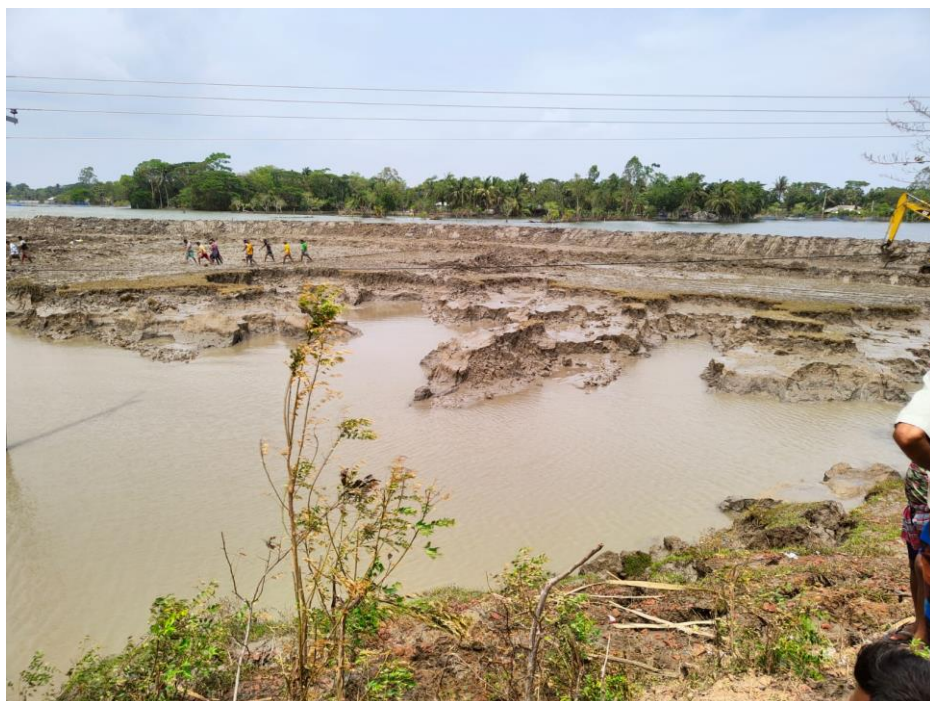
Figure 06: Construction of Ringdike to protect the Embankment

The Bangladesh Water Development Board (BWDB) attempted to address the breach in Polder 22 using the Ring Dike Technique. This method is a well-known engineering approach used in emergency situations to stabilize embankments and prevent further erosion during breaches. The technique involves constructing a circular embankment (ring dike) around the breached area to isolate it from direct tidal forces allowing for reinforcement work to be carried out in a controlled environment.

STEP	DESCRIPTION
01	Identify the Breach: The first step involves identifying the exact location and extent of the breach. Engineers mark the affected area to determine the size of the ring dike required.
02	Construct the Ring Dike: A temporary embankment (ring dike) is constructed around the breach using materials such as sandbags, clay, and geotextiles. The ring dike acts as a barrier, isolating the breached area from the surrounding water.
03	Pump Out Excess Water: Once the ring dike is in place, excess water trapped inside the enclosed area is pumped out.
04	Reinforce the Embankment: After the area is stabilized, the breached embankment is reinforced using additional sandbags and vegetation-based techniques to prevent future erosion.

Although the Ring Dike Technique provided a temporary buffer, it was not a long-term solution. Persistent tidal pressure and limited resources slowed down the full closure process.
