Test Motor 1

Experiment Report

Test Fires 1–8

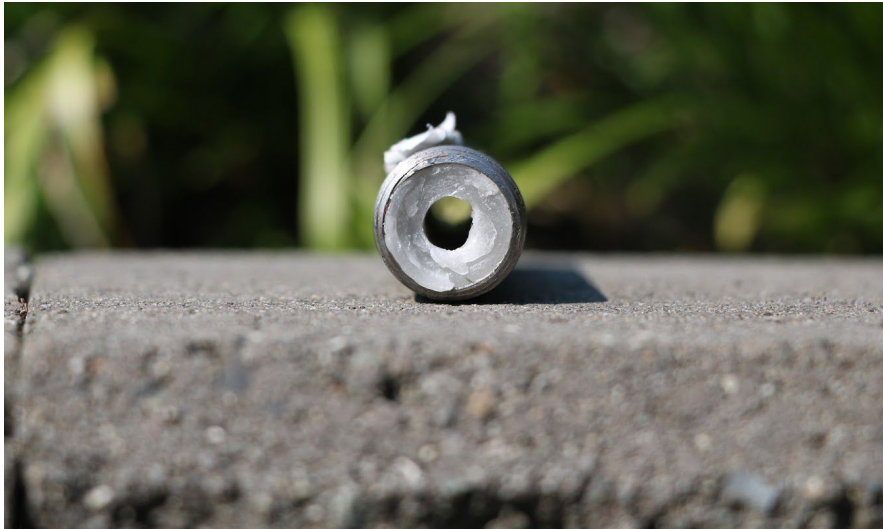
Figure 1: paraffin wax inside $\frac{3}{4}$ inner diameter steel tube

- 1 Acrylic tube ($\frac{1}{2}$ inch diameter)
- 1 Computer running Logger Pro software
- 1 Vernier Labquest®
- 1 gaseous oxygen tank
- 1 gas pressure regulator
- $\frac{3}{4}$ diameter inch steel pipe
- Paraffin wax (as much as possible while letting enough oxygen through for combustion) See figure 1.
- Test stand (for size see figure 2)
 - 1 Sliding rail
 - 3 steel Tightening straps (1x 1 inch, 2x $\frac{3}{4}$ inch)
 - 1 small block of wood
 - 2 large blocks of wood (for bottom and and front)
 - 2 sheets of wood (2 on each side)
 - Sand (to enough to fill the gap between the 2 sheets of wood on each side)
 - Vernier dual range (10N; 50N) force sensor
 - Screws and steel corner brackets
