# Measuring the progress of a recovery process after an earthquake: The case of L'Aquila, Italy

After the earthquake in 2009, L'Aquila (Italy) began a recovery process characterized by a delay in the reconstruction of the city center. Between 2010 and 2014 a **recovery index was formulated based on spatial indicators**, such as building condition and building use, to measure the progress of the recovery process in L'Aquila. Eight years after the earthquake, the work presented in this paper was used to update the recovery index, not only by measuring the progress of the recovery in L'Aquila but also by validating the usefulness of the proposed recovery index. To achieve this objective, the current research considered the same set of spatial indicators that were used to determine the progress of the recovery in L'Aquila by 2010, 2012, and 2014 in the revaluation of the expert criteria. It was found that in 2016 the number of reconstructed buildings and buildings under ongoing construction had significantly increased and the number of buildings with residential and commercial use had increased along the main roads. While progress was observed in the overall building condition, there

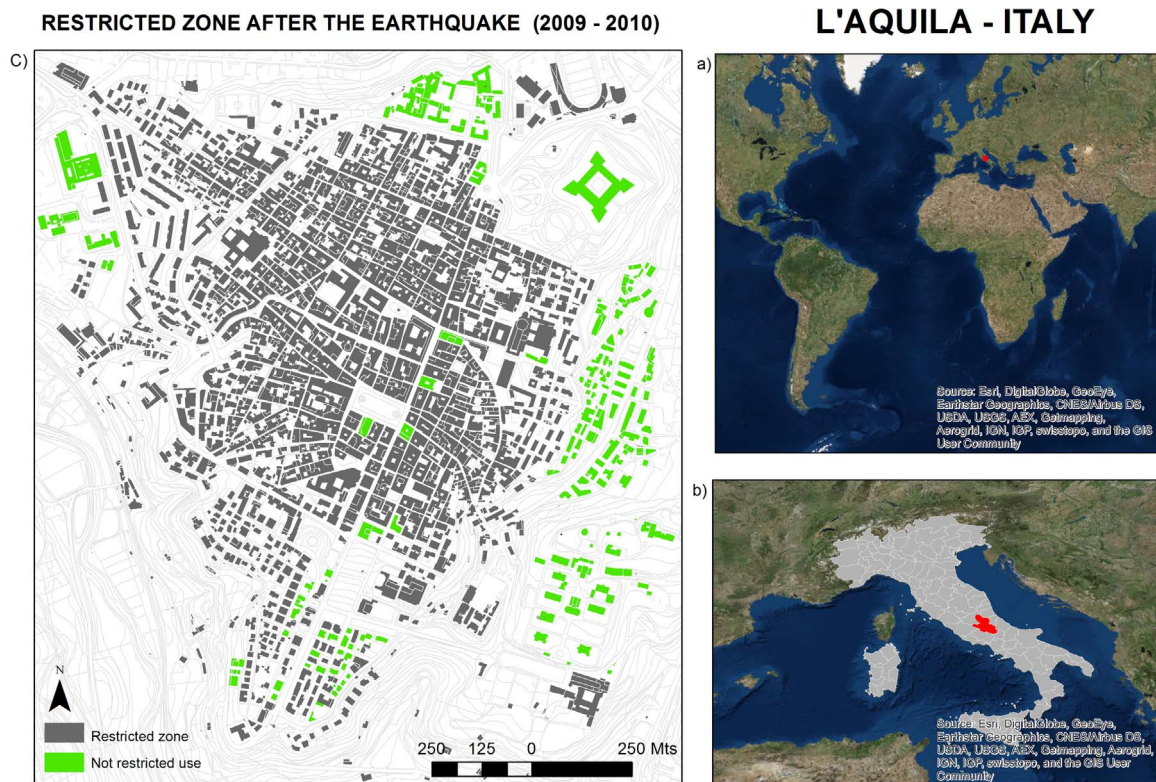
Fig. 1. a and b Location of the case study area: L'Aquila, Italy; c Restricted zone in L'Aquila after the earthquake on 6 April 2009.

On the 6th of April 2009, an earthquake with a magnitude of 6.3  $M_W$  and a hypocentral depth of 10 km struck the Italian city of L'Aquila (population 72,800). The epicenter was Poggio del Roio, 3.4 km to the southwest of the L'Aquila city center. L'Aquila is the capital of the namesake province and the administrative capital of the Abruzzo region in central Italy. Its location is shown in Fig. 1a and b.

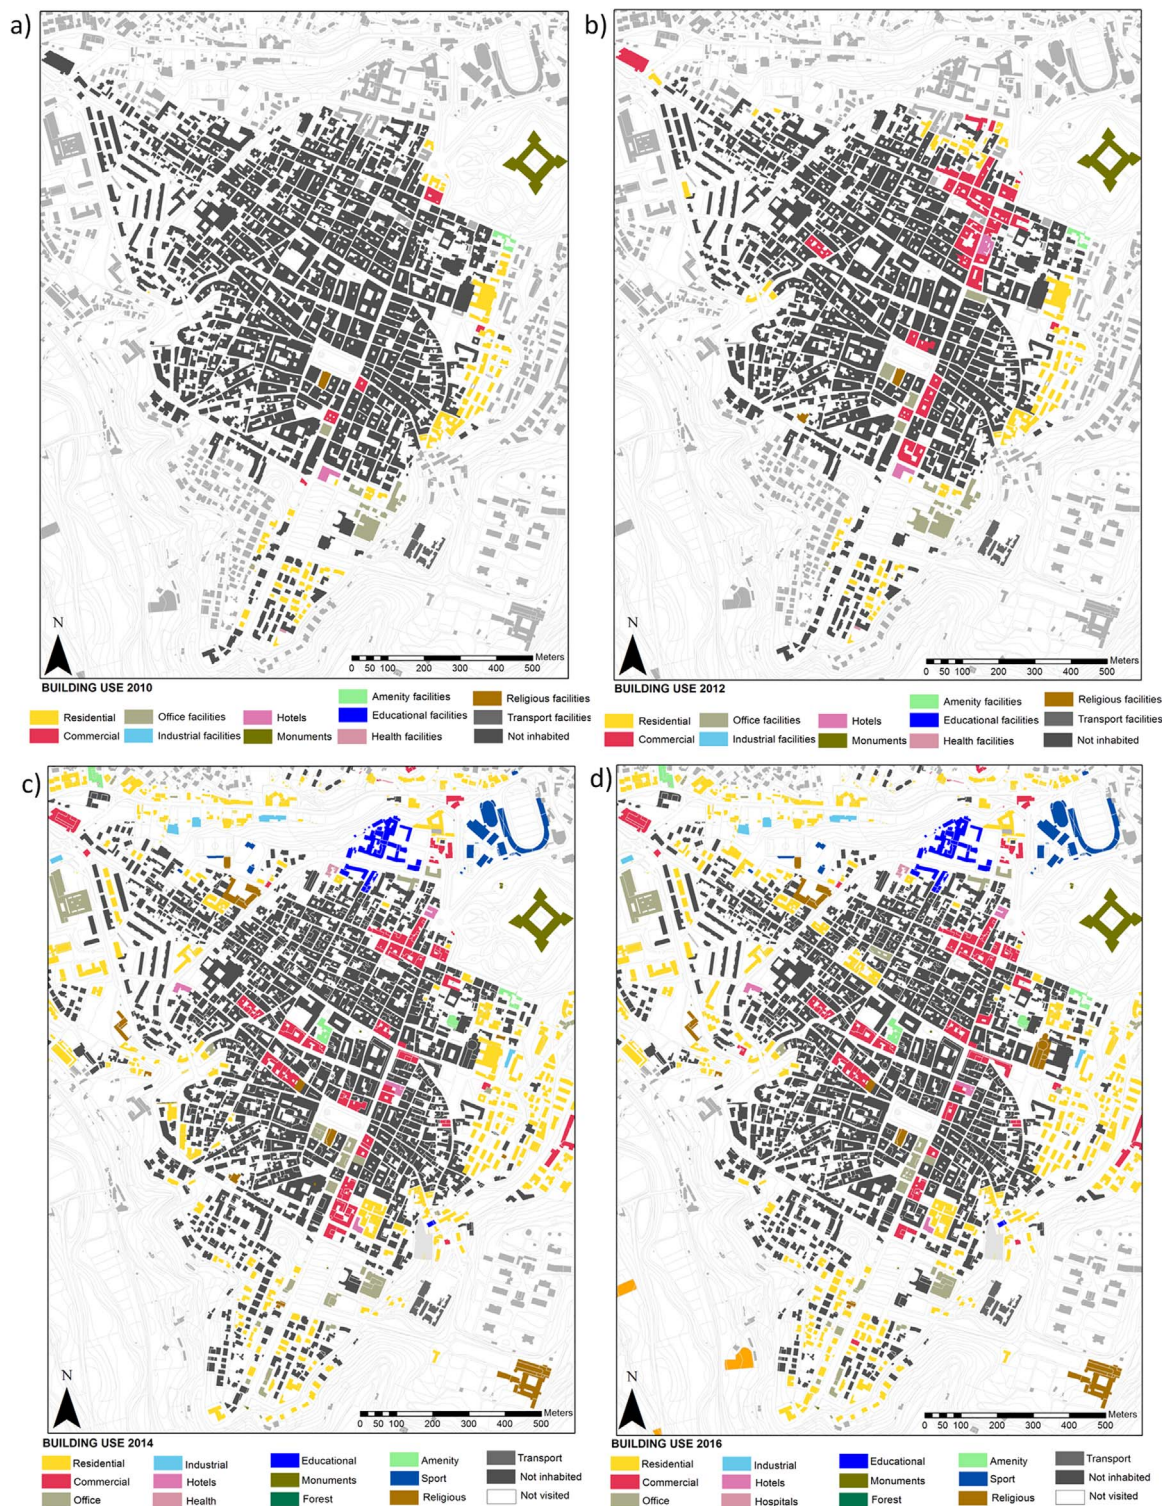
Fig. 6. Building condition in L'Aquila after the earthquake in a) 2010, b) 2012, c) 2014 and d) 2016.

The sampling area of the historic center of L'Aquila included 753 buildings. It was found that the percentage of buildings that were classified as *partially enabled* has decreased by over 4% (29) to 1% (11) between 2010 and 2016. The percentage of buildings *reconstructed* increased from just 5% (41) in 2010 to over 20% (150) in 2016. The percentage of buildings with *reconstruction projected* (announced on a billboard) rose from 2% (13) in 2012 to 4% (29%) in 2014 but slightly fell to 3% (24) in 2016. The percentage of *propped* buildings (still requiring structural support) increased significantly from just 4% (31) in 2010 to over 29% (220) in 2012. However, the percentage of *propped* buildings dropped by over 22% (165) in 2014 and to 16% (121) in 2016. The percentage of *inhabited* buildings reached a record of 15% (110) in 2012, from 13% (99) in 2010; but afterwards, the percentage of *inhabited* buildings continued to decrease from 9% (65) in 2014 to 8% (62) in 2016. The percentage of buildings with *restricted use* (uninhabited) steadily decreased from 82% (621) in 2010 to 44% (332) in 2012, to 9% (67) in 2014 and to 7% (52) in 2016, which is another sign of progress in the recovery process. The percentage of buildings *demolished* reached 3% (24) in 2014, from just over 1% (8) in 2012, but this number decreased again to 2% (18) in 2016. The percentage of *damaged* buildings in the sampling area in the city center of L'Aquila remained high at 23% (174) in 2014 [14] and decreased slightly to 20% (152) in 2016. These results are plotted in Table 4 and Figs. 5 and 6.

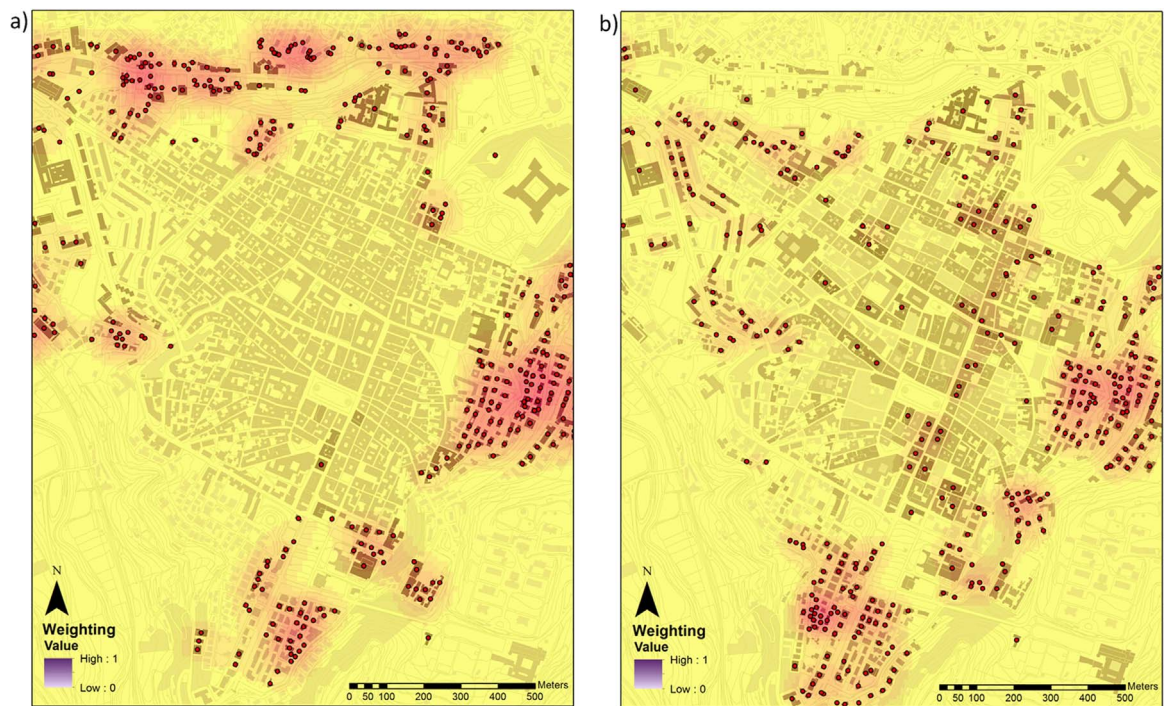
Fig. 9. Hotspots of recovery in L'Aquila in a) 2010 and b) 2016.

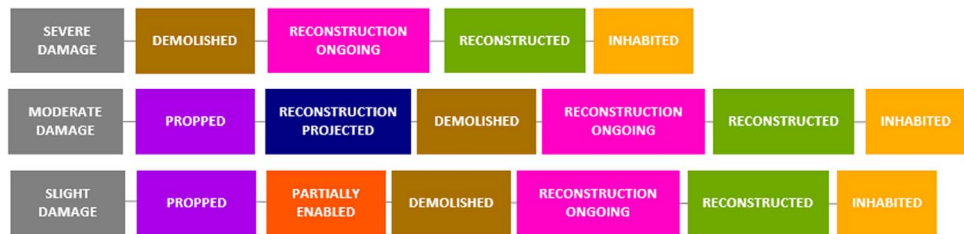
Fig. 10. Transitions in building condition in L'Aquila between 2009 and 2016.

found inhabited in the past fieldwork visits and are now in restoration. Transitions in building condition in L'Aquila between 2009 and 2016 are depicted in Fig. 10 and they are similar to the limit state event tree to assess building-level recovery developed by [9].

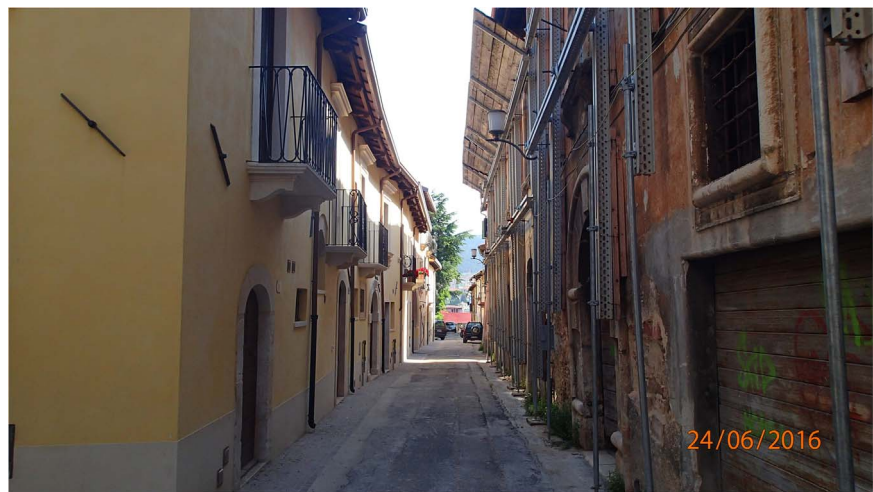
Fig. 11. Contrasts in the recovery process of the city center in L'Aquila.

Furthermore, there are many facilities, such as schools and offices, which need to be rebuilt to contribute to a functional living environment in the HC of L'Aquila. Before the earthquake, this HC was also the location of offices and private shared accommodation for students. This means that some householders were not physically living in those houses. The contrast between building conditions along the streets in the recovery process of L'Aquila can be observed in Fig. 11.
