Deterioration patterns of building cladding components for maintenance management

I. M. Shohet , M. Puterman & E. Gilboa

To cite this article: I. M. Shohet , M. Puterman & E. Gilboa (2002) Deterioration patterns of building cladding components for maintenance management, *Construction Management & Economics*, 20:4, 305-314, DOI: [10.1080/01446190210125563](https://doi.org/10.1080/01446190210125563)

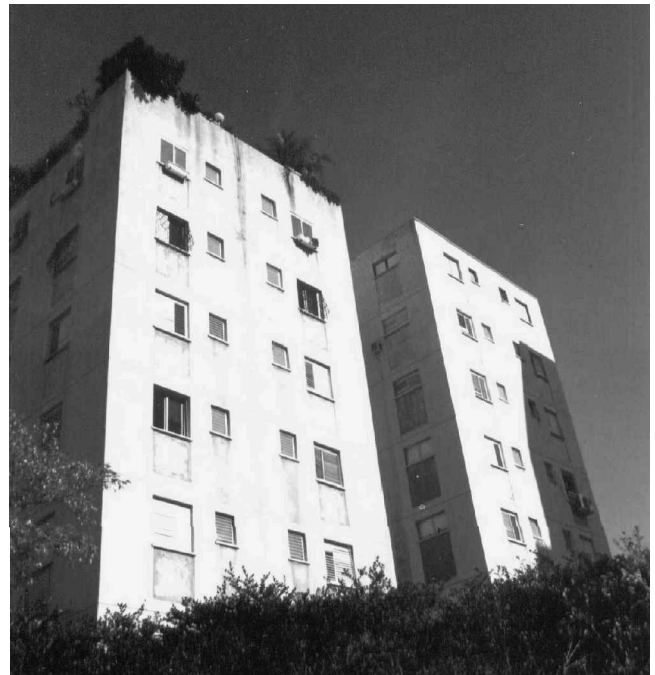
View of the 20 years old building – coated with rehabilitated eight years cementitious stucco in sea-shore environment

The structure under examination is a six-storey building with cementitious stucco. The building is 20 years old, and the exterior cladding was renovated nine years before the survey. Two degradation mechanisms were found. There was decay of the stucco due to its poor quality (porous rendering in a marine environment), with a component performance level of 50. This performance rate reflects cracks 0.5 mm wide and peel-off of cladding to the extent of 5% of the entire cladding area. Also there was deterioration of stucco due to lack of a drip-edge, with a component performance level of 60, reflecting development of micro-organisms and change of colour near the top edges of the cladding surface.

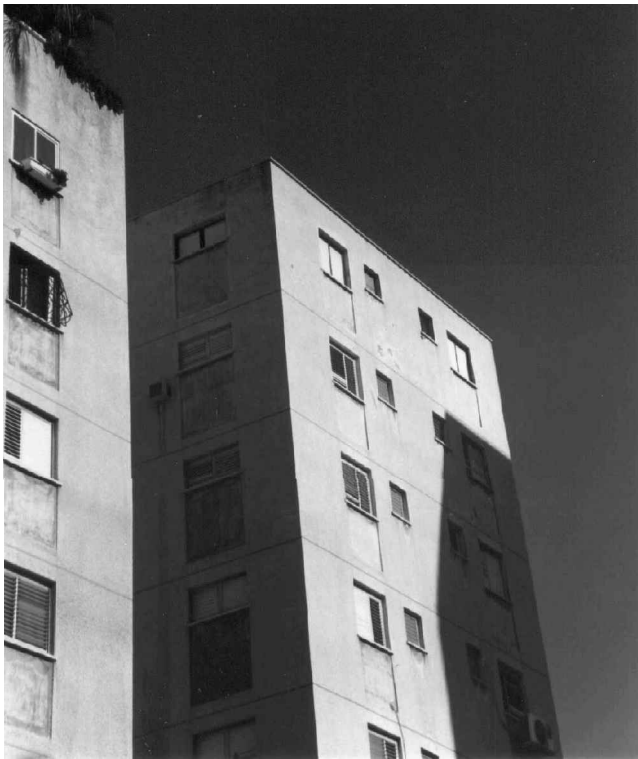
View of the failure in cementitious stucco of the 9 years old cladding
