REAL-TIME DETECTION OF CRACKS AND MOISTURE DEFECTS IN BUILDINGS: A Two-Part Report on Supervised and Unsupervised Methods

Study Group: 187th European Study Group with Industry (ESGI 187), 14–18 July 2025, University of Bristol, UK

Industrial Partner: Surveyr Company

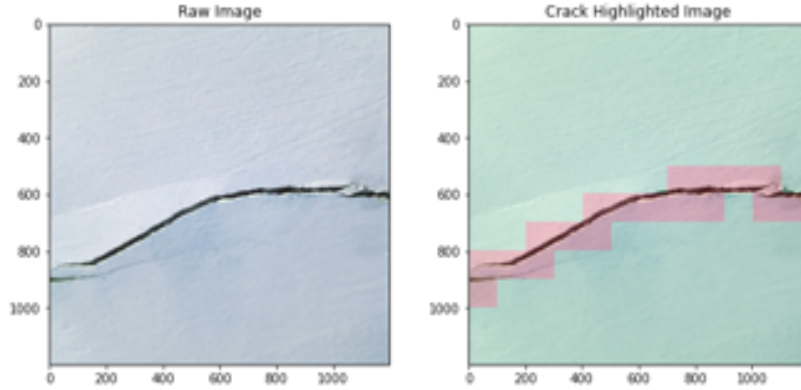
The results of crack classification and segmentation were based on a data set of 40,000 data points. The effectiveness of the segmentation is demonstrated in Figure 5, which shows the system’s ability to accurately localize and delineate crack boundaries in larger structural images. The raw image processing pipeline successfully identified the crack path along the concrete surface, with the highlighted segmentation mask (shown in pink overlay) accurately tracking the crack path from initiation to termination.

Figure 5. Crack segmentation results.

The segmentation algorithm effectively processed the geometry of curved cracks while preserving spatial accuracy, demonstrating the system’s capability to provide detailed geometric information necessary for structural assessment. Its confident region extraction approach ensures that only areas with a high probability of crack presence are highlighted, thereby reducing the number of false positives on complex surfaces. The ResNet-50 model

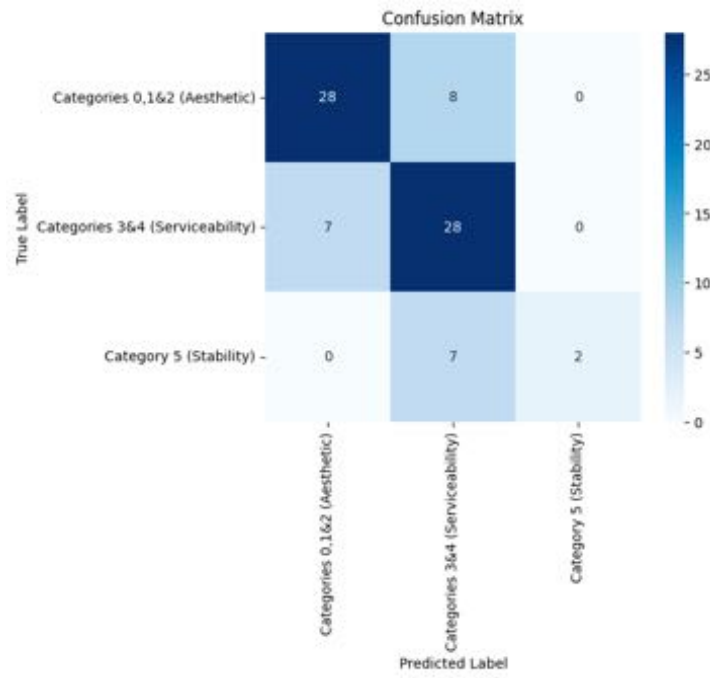
Figure 6. Confusion matrix for ResNet-50.

Category 5 (stability-related cracks) represented the most challenging classification scenario: only 2 out of 9 samples were correctly identified, while 7 samples were misclassified as serviceability-related cracks. A parallel comparison of annotated images (left) and model predictions (right), presented in Figure 7, demonstrates the practical effectiveness of the ResNet-50 classifier across different crack scenarios and construction materials. The test dataset covered a variety of surface types, including brickwork, concrete, stone, and painted surfaces, reflecting realistic building inspection conditions.

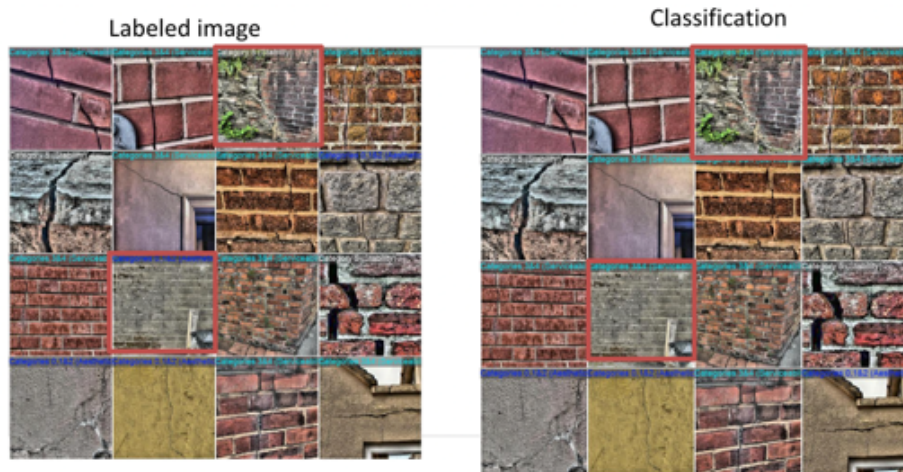
Figure 7. Side-by-side comparison of labeled images (left) and model predictions (right).

The classification color boundaries (shown in cyan, red, and blue frames) indicate the model's confidence in assigning categories, with a clear separation between classifications of aesthetics, serviceability, and stability. In some cases, borderline situations were

observed, where visual similarities between adjacent severity categories posed challenges both for human annotators and for the automated system—particularly in distinguishing between moderate cracks affecting serviceability and severe defects threatening structural stability.

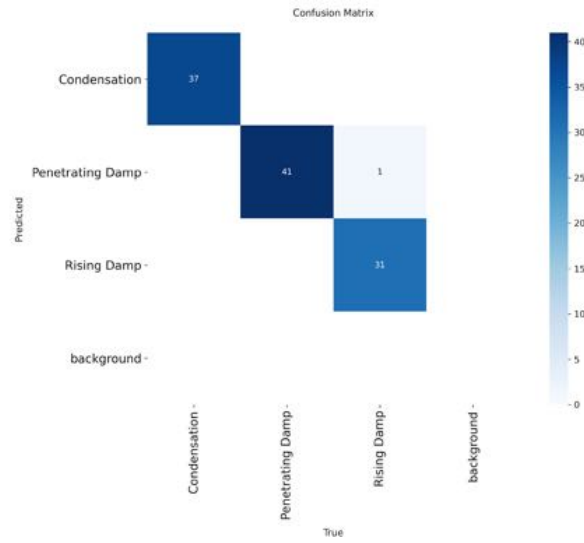
The confusion matrix for humidity classification (Figure 13) demonstrates the exceptional ability to distinguish between the three categories of moisture damage defined by BRE Digest 245. For condensation, perfect classification accuracy was achieved: 37 out of 37 samples were correctly identified, with no misclassifications. This result highlights the model's capability to recognize characteristic changes in surface moisture, thermal effects, and damage associated with evaporation. Penetrating dampness showed nearly perfect performance, with 41 correct classifications out of 42 samples (97.6% accuracy), and only one instance misclassified as rising damp, indicating minimal confusion between water ingress mechanisms.

Figure 13. Confusion matrix for moisture classification.

Rising damp demonstrated perfect classification: all 31 samples were correctly identified, demonstrating the ability of the model to recognize the characteristic salt damage patterns characteristic of capillary moisture movement. The absence of background misclassification and the clear dominance of diagonals in the confusion matrix indicate robust feature learning and effective recognition of different moisture damage mechanisms.

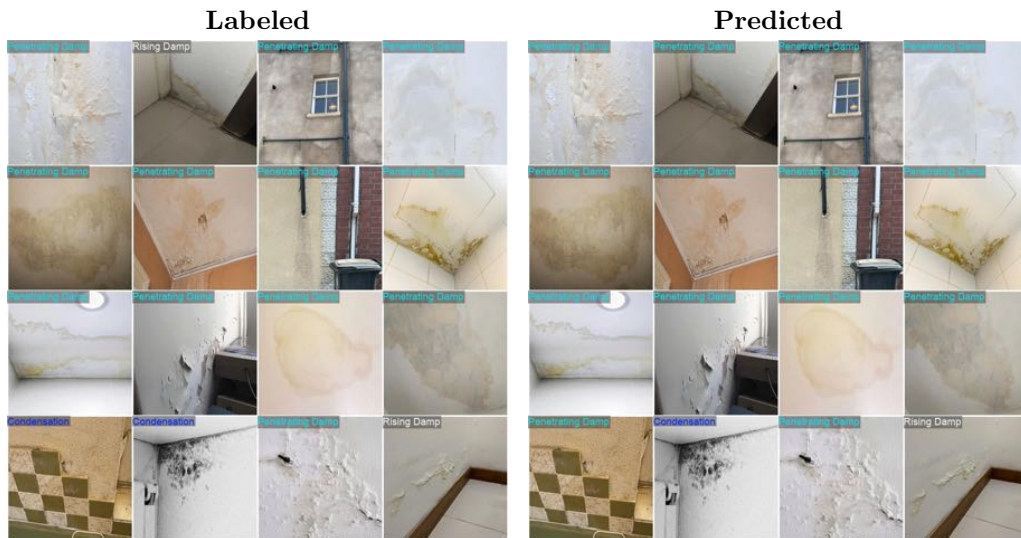
Side-by-side comparison of the ground truth results and the model identification results demonstrate the comprehensive ability of the moisture detection system to detect and classify different types of moisture damage in different building environments. Figure 14 shows the detection results, which show excellent performance in recognizing condensation formations on windows and cold surfaces, accurately identifying the characteristic water droplet formations and surface moisture films that distinguish condensation from other types of moisture. The Penetrating Damp Detection System has proven to be highly effective in accurately identifying water stains, discoloration and signs of damage associated with external water penetration through walls, roofs and building envelope defects. The model has demonstrated particular effectiveness in detecting high damp character-

istics, accurately identifying horizontal damp boundaries, salt efflorescence patterns and material degradation associated with capillary movement of moisture upon contact with the ground.

Figure 14. Moisture detection visualization results.

Bounding boxes and classification labels provide precise localization of moisture-affected areas, allowing targeted planning of restoration work and assessment of the extent of damage. High performance enables accurate detection of various surface materials, lighting conditions and moisture levels, from early moisture penetration to advanced damage. The

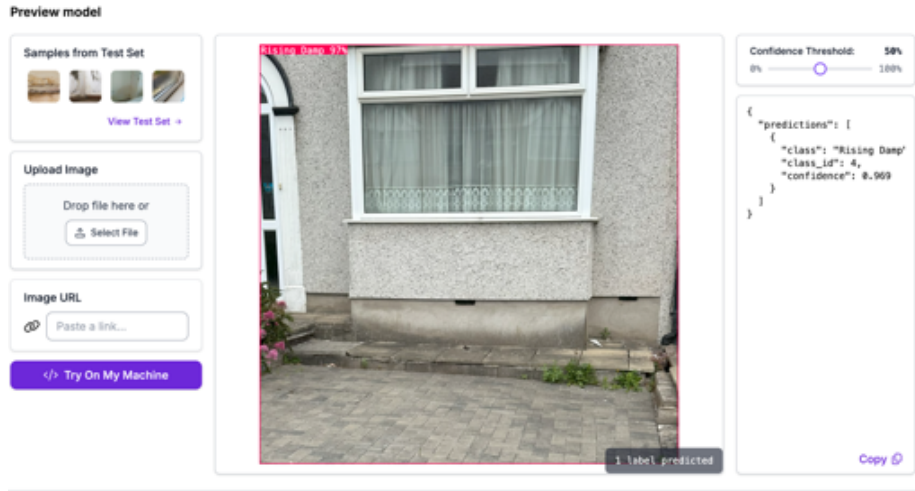
Figure 18. Roboflow model deployment platform.

model management functionality, including test case visualization, confidence threshold customization, and real-time inference capabilities. The humidity detection system example successfully detected increased humidity with 97% confidence, demonstrating the system's high performance in cloud deployment scenarios. The JSON output format provides structured data suitable for integration with existing building management systems, survey databases, and automated reporting workflows. Roboflow results can be seen in Figure 18.

URL-based processing, and API integration, demonstrates versatility for a variety of deployment scenarios, from individual assessments to large-scale building portfolio analysis. A confidence threshold adjuster allows users to customize the sensitivity based on application-specific requirements, balancing detection accuracy and false positive rates to meet validation protocols. End-to-end prediction results include class identification, confidence scores, and bounding box coordinates, providing comprehensive information for downstream analysis and documentation systems.
