Troubleshooting First Layer Print Failure

This SOP describes how to troubleshoot and adjust first layer print failures on FibreSeeker 3. Its purpose is to safely and effectively resolve first layer printing issues.

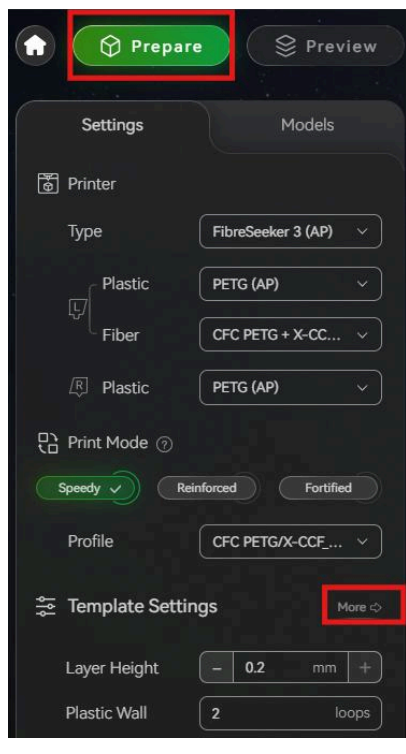
Step 1 Model Warping Step 1.1

No adhesive has been applied to the print bed.

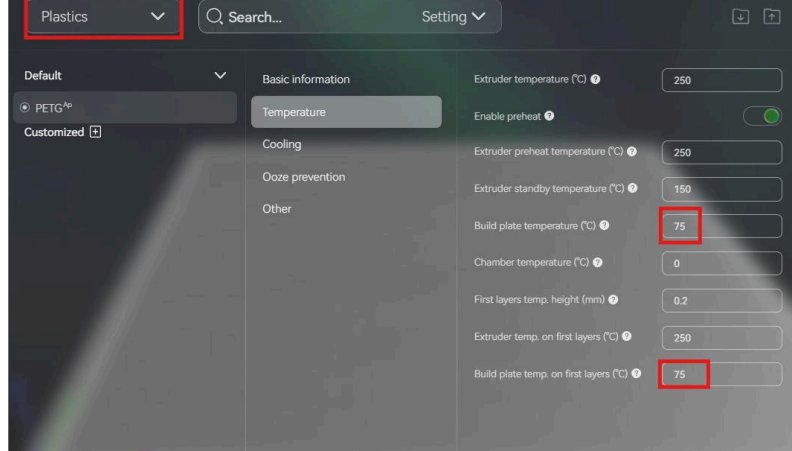
Step 1.2

Insufficient heatedbed temperature:

In the slicer, check if the temperature is too low and adjust it.
