BCA Vehicle Appraisal Report

BJ10 HSN, PEUGEOT 308 SW

Registration: BJ10 HSN	Colour: BLUE	Appraised: 20/10/2025
Transmission: Automatic	Odometer: 82,721 miles

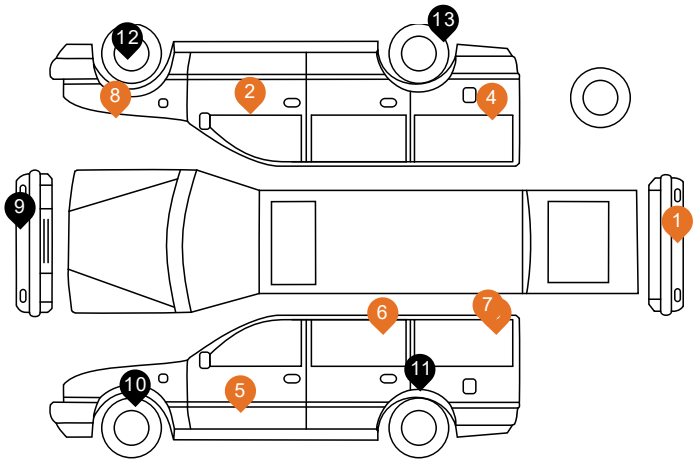
1. Bumper Rear; Cracked; Over 25mm
2. Door osf; Dented; Over 30mm
3. Qtr Panel nsr; Dented; Over 30mm
4. Qtr Panel osr; Dented; Over 30mm
5. Sill ns; Dented; With Paint Damage
6. Door nsr; Scratched; Over 25mm Thru Paint
7. Qtr Panel nsr; Scratched; Over 25mm Thru Paint
8. Wing osf; Scratched; Over 25mm Thru Paint
9. Bumper Front; Scratched; 25 to 100mm Thru Paint
10. Wheel Trim nsf; Scratched; Over 50mm
11. Wheel Trim nsr; Scratched; Over 50mm
12. Wheel Trim osf; Scratched; Over 50mm
13. Wheel Trim osr; Scratched; Over 50mm
