Vehicle Appraisal Report

BJ56 VHC, PEUGEOT 307

Registration: BJ56 VHC	Colour: GREY	Appraised: 26/10/2025
Transmission: Manual	Odometer: 89,306 miles

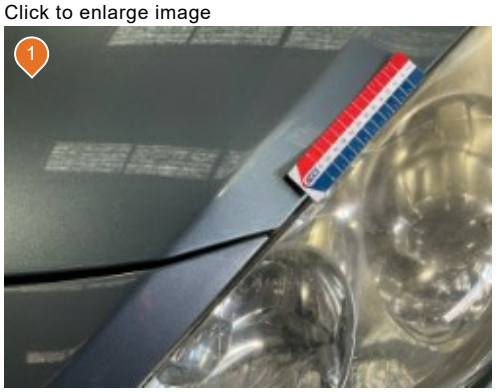
Exterior condition

1. Bonnet; Scratched; Over 25mm Thru Paint
2. Bumper Front; Scratched; Over 100mm Thru Paint
3. Qtr Panel nsr; Scratched; Rusted
4. C Post ns; Scratched; Over 25mm Thru Paint
5. C Post os; Scratched; Over 25mm Thru Paint
6. Bumper Front Moulding; Missing; Replace
7. Bumper Rear; Scratched; 25 to 100mm Thru Paint
8. Door Mirror Assy osf; Scratched (Painted); UpTo 25mm Thru Paint
9. Wheel nsf; Scratched; Up To 50mm
10. Wheel nsr; Scratched; Over 50mm
11. Wheel osf; Scratched; Over 50mm
12. Wheel osr; Scratched; Over 50mm

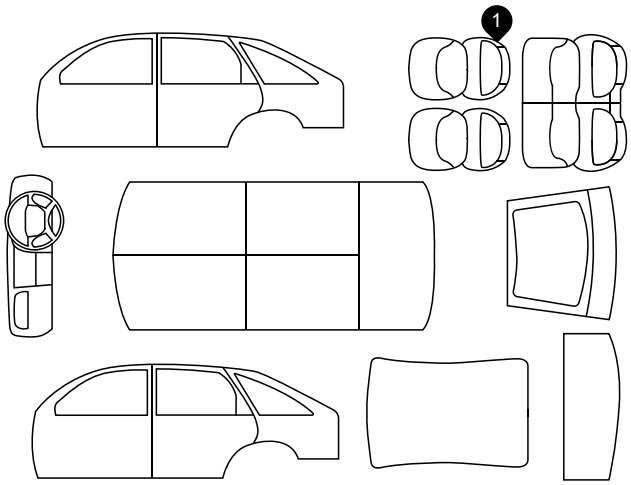
Interior condition

1 Seat Back Cover osf; Scuffed; Over 25mm
