BCA Vehicle Appraisal Report

CP08 HFO, HONDA JAZZ

Registration: CP08 HFO	Colour: SILVER	Appraised: 24/10/2025
Transmission: Manual	Odometer: 80,197 miles

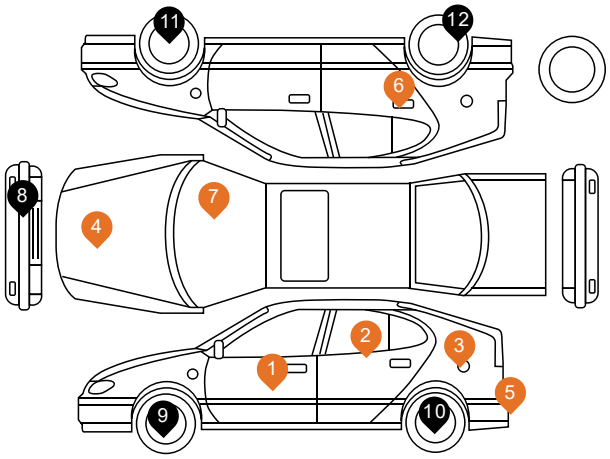
1. Door nsf; Dented; Over 30mm
2. Door nsr; Poor Previous Repair; Rippled UpTo 30%
3. Qtr Panel nsr; Dented; Over 30mm
4. Bonnet; Chipped; Multiple Chips
5. Bumper Rear; Scratched; Over 100mm Thru Paint
6. Door osr; Poor Previous Repair; Poor Colour
7. Screen Front; Chipped; Over 10mm
8. Bumper Front; Chipped; Multiple Chips
9. Wheel nsf; Scratched; Up To 50mm
10. Wheel nsr; Scratched; Over 50mm
11. Wheel osf; Scratched; Over 50mm
12. Wheel osr; Scratched; Over 50mm

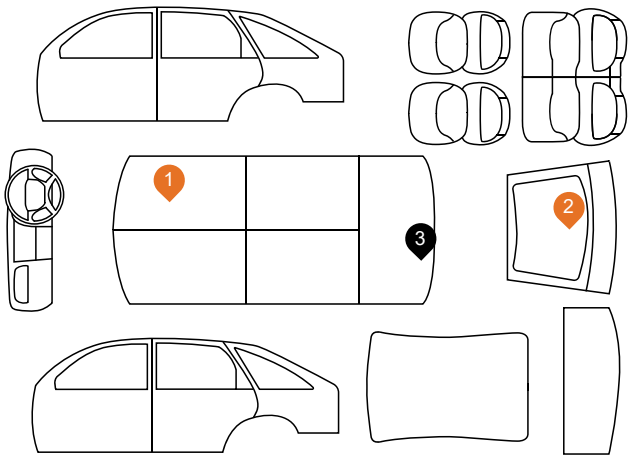
1	Carpets Front; Torn; Over 10mm
2	Tailgate Pad; Broken; Replace
3	Rear Panel Trim Int; Scuffed; UpTo 25mm
4	Seat Base Cover nsf; Soiled; Light
