BCA Vehicle Appraisal Report

DU55 BYJ, HYUNDAI GETZ

Registration: DU55 BYJ	Colour: RED	Appraised: 25/10/2025
Transmission: Automatic	Odometer: 61,374 miles

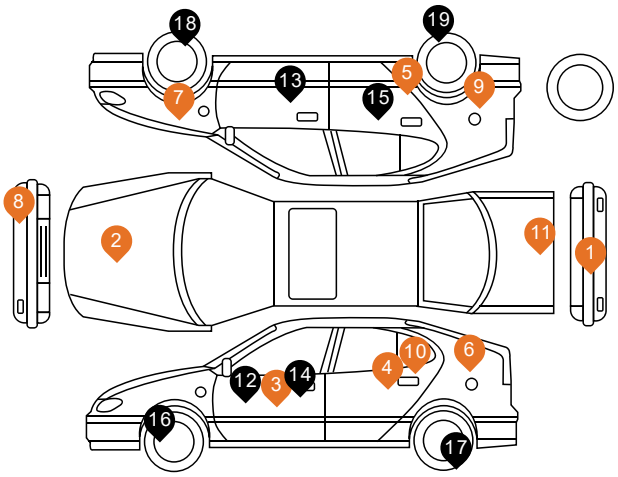
1. Bumper Rear; Cracked; Over 25mm
2. Bonnet; Dented; Over 30mm
3. Door nsf; Dented; Over 30mm
4. Door nsr; Dented; Over 30mm
5. Door osr; Dented; Over 30mm
6. Qtr Panel nsr; Dented; With Paint Damage
7. Wing osf; Dented; Over 30mm
8. Bumper Front; Poor Previous Repair; Paint Flake
9. Qtr Panel osr; Rusted; Over 5mm
10. C Post ns; Scratched; Over 25mm Thru Paint
11. Moulding Tailgate; Scratched (Painted); Over 25mm Thru Paint
12. Door Mirror Assy nsf; Scratched (Painted); Over 25mm Thru Paint
13. Door Mirror Assy osf; Scratched (Painted); Over 25mm Thru Paint
14. Handle Outer nsf; Scratched (Painted); Over 25mm Thru Paint
15. Handle Outer osr; Scratched (Painted); Over 25mm Thru Paint
16. Wheel nsf; Scratched; Over 50mm
17. Wheel nsr; Scratched; Over 50mm

18 Wheel osf; Scratched; Over 50mm

19 Wheel osr; Scratched; Over 50mm
