Vehicle Appraisal Report

FV06 AFZ, AUDI A3 SPORTBACK

Registration: FV06 AFZ	Colour: BLUE	Appraised: 24/10/2025
Transmission: Auto Clutch	Odometer: 163,718 miles

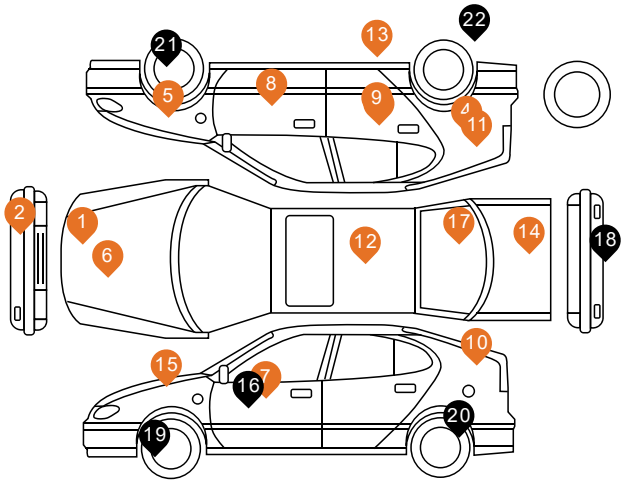
1. Bonnet; Dented; Over 30mm
2. Bumper Front; Dented; With Paint Damage
3. Door osr; Dented; Over 30mm
4. Qtr Panel osr; Dented; Over 30mm
5. Wing osf; Dented; Over 30mm
6. Bonnet; Chipped; Multiple Chips
7. Door nsf; Rusted; Over 5mm
8. Door osf; Rusted; Over 5mm
9. Door osr; Rusted; Over 5mm
10. Qtr Panel nsr; Rusted; Over 5mm
11. Qtr Panel osr; Rusted; Over 5mm
12. Roof; Scratched; Over 25mm Thru Paint
13. Sill os; Rusted; Over 5mm
14. Tailgate; Scratched; Over 25mm Thru Paint
15. Wing nsf; Rusted; Over 5mm
16. Door Mirror Assy nsf; Broken; Replace
17. Wiper Rear; Missing; Replace
18. Bumper Rear; Scratched; 25 to 100mm Thru Paint

19 Wheel nsf; Scratched; Over 50mm

20 Wheel nsr; Corroded; Light

21 Wheel osf; Scratched; Over 50mm

22 Wheel osr; Scratched; Over 50mm
