BCA Vehicle Appraisal Report

GL57 HVV, MINI COOPER

Registration: GL57 HVV	Colour: SILVER	Appraised: 20/10/2025
Transmission: Manual	Odometer: 69,188 miles

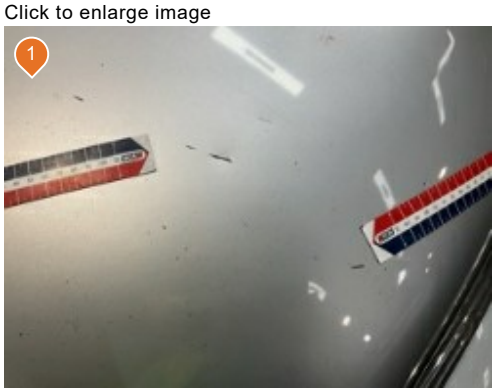
Exterior condition

1. Bonnet; Scratched; Over 25mm Thru Paint
2. Bumper Front; Scratched; Over 100mm Thru Paint
3. Door nsf; Scratched; Over 25mm Thru Paint
4. Qtr Panel osr; Scratched; Over 25mm Thru Paint
5. B Post os; Scratched; Over 25mm Thru Paint
6. Wheel nsf; Scratched; Over 50mm
7. Wheel nsr; Scratched; Over 50mm
8. Wheel osf; Scratched; Up To 50mm
9. Wheel osr; Scratched; Up To 50mm

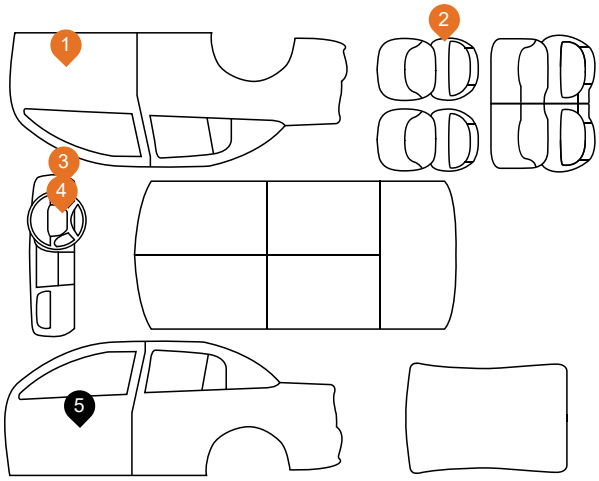
Interior condition

1. Door Pad osf; Torn; Over 10mm
2. Seat Back Cover osf; Torn; Over 3mm
3. Fascia Trim; Damaged; Replace
4. Switches And Controls; Broken; Replace
5. Door Pad nsf; Scuffed; UpTo 25mm
