BCA Vehicle Appraisal Report

GN13 VWE, VAUXHALL MERIVA

Registration: GN13 VWE	Colour: WHITE	Appraised: 22/10/2025
Transmission: Manual	Odometer: 119,585 miles

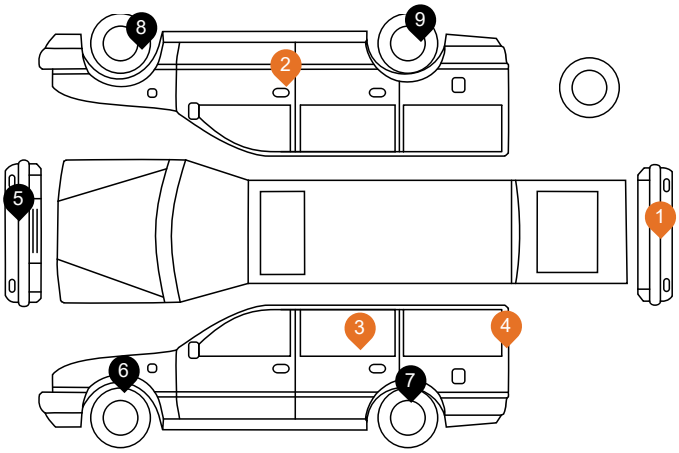
1. Bumper Rear; Dented; With Paint Damage
2. Door osf; Dented; Over 30mm
3. Door nsr; Poor Previous Repair; Poor Paint
4. Qtr Panel nsr; Scratched; Over 25mm Thru Paint
5. Bumper Front; Chipped; Multiple Chips
6. Wheel nsf; Scratched; Over 50mm
7. Wheel nsr; Scratched; Over 50mm
8. Wheel osf; Scratched; Over 50mm
9. Wheel osr; Scratched; Over 50mm
10. General Interior; Buyer Advisory; Report Only
