BCA Vehicle Appraisal Report

HN15 BYS, RENAULT CAPTUR

Registration: HN15 BYS	Colour: BLACK	Appraised: 26/10/2025
Transmission: Manual	Odometer: 179,256 miles

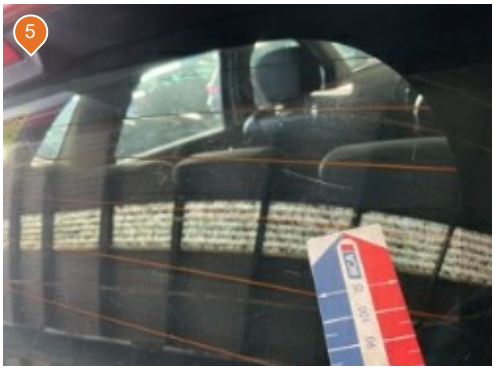
Exterior condition

1. Door nsr; Dented; Over 30% Of Panel
2. Roof; Dented; Over 30mm
3. Bonnet; Chipped; Multiple Chips
4. Bumper Rear; Scratched; Over 100mm Thru Paint
5. Tailgate Glass; Scratched; Over 30mm
6. Bumper Front; Insecure; Action Required
7. Door Moulding nsr; Missing; Replace
8. Moulding Tailgate; Broken; Replace
9. Qtr Panel Arch Extension ns; Missing; Replace
10. Aerial; Missing; Replace
11. Bumper Front; Chipped; Multiple Chips
12. Bumper Rear Moulding; Scuffed (Unpainted); Over 100mm
13. Wheel nsf; Corroded; Light
14. Wheel nsr; Corroded; Light
15. Wheel osf; Corroded; Light
16. Wheel osr; Corroded; Light

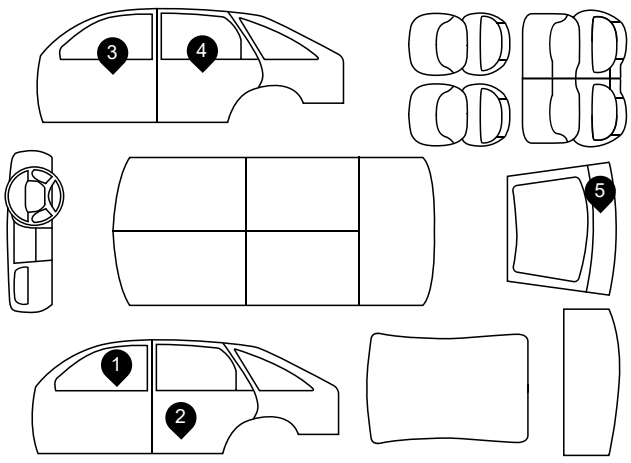
Interior condition

1. Door Pad nsf; Scuffed; Over 25mm
2. Door Pad nsr; Scuffed; Over 25mm
3. Door Pad osf; Scuffed; Over 25mm
4. Door Pad osr; Scuffed; Over 25mm
5. Tailgate Pad; Scuffed; Over 25mm
