BCA Vehicle Appraisal Report

HN59 AAO, MAZDA 3

Registration: HN59 AAO	Colour: GREY	Appraised: 26/10/2025
Transmission: Manual	Odometer: 157,076 miles

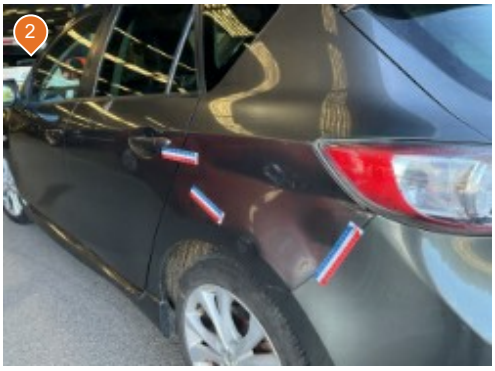
1. Door osr; Dented; Over 30mm
2. Qtr Panel nsr; Dented; With Paint Damage
3. Tailgate; Dented; Over 30mm
4. Wing osf; Dented; Over 30mm
5. Bonnet; Chipped; Multiple Chips
6. Bumper Front; Scratched; Over 100mm Thru Paint
7. Qtr Panel osr; Rusted; Over 5mm
8. Roof; Rusted; Over 5mm
9. Screen Front; Chipped; UpTo 10mm
10. Bumper Rear; Scratched; 25 to 100mm Thru Paint
11. Wheel nsf; Scratched; Over 50mm
12. Wheel nsr; Scratched; Up To 50mm
13. Wheel osf; Scratched; Over 50mm
14. Wheel osr; Scratched; Over 50mm

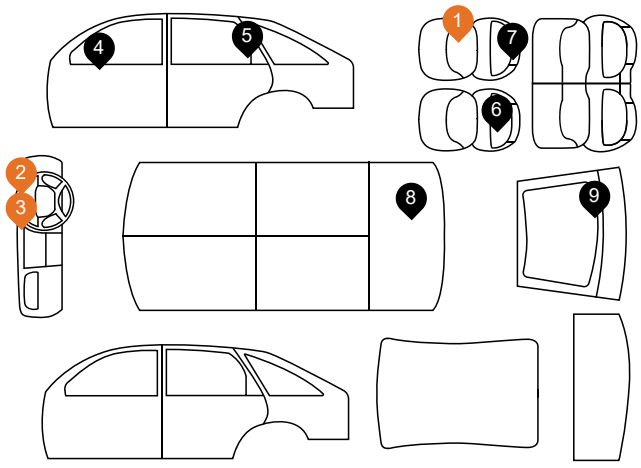
1. Seat Base Cover osf; Torn; Over 3mm
2. Switches And Controls; Broken; Replace
3. Switches And Controls; Broken; Replace
4. Door Pad osf; Scuffed; Over 25mm
5. Door Pad osr; Scuffed; Over 25mm
6. Seat Back Cover nsf; Scuffed; UpTo 25mm
7. Seat Back Cover osf; Scuffed; Over 25mm
8. Shelfload Cover Rear; Missing; Replace
9. Tailgate Pad; Scuffed; Over 25mm
