# BCA Vehicle Appraisal Report

## KFZ 8351, HYUNDAI I20

| Registration: KFZ 8351 | Colour: GREY | Appraised: 24/10/2025 |

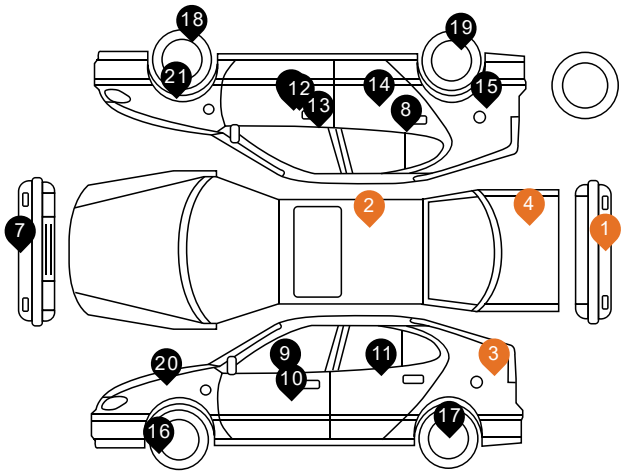
1. Bumper Rear; Cracked; Over 25mm
2. Roof; Dented; Over 30mm
3. Qtr Panel nsr; Rusted; Over 5mm
4. Tailgate; Rusted; Over 5mm
5. B Post os; Scratched; UpTo 25mm Thru Paint
6. B Post os; Dented; Between 10mm + 30mm
7. Bumper Front; Scratched; 25 to 100mm Thru Paint
8. C Post os; Scratched; UpTo 25mm Thru Paint
9. Door Mirror Assy nsf; Scratched (Painted); UpTo 25mm Thru Paint
10. Door nsf; Dented; Between 10mm + 30mm
11. Door nsr; Scratched; UpTo 25mm Thru Paint
12. Door osf; Dented; Between 10mm + 30mm
13. Door osf; Chipped; Edge Chip
14. Door osr; Scratched; UpTo 25mm Thru Paint
15. Qtr Panel osr; Dented; Between 10mm + 30mm
16. Wheel nsf; Scratched; Over 50mm
17. Wheel nsr; Scratched; Over 50mm

18 Wheel osf; Scratched; Over 50mm

19 Wheel osr; Scratched; Over 50mm

20 Wing nsf; Scratched; UpTo 25mm Thru Paint

21 Wing osf; Scratched; UpTo 25mm Thru Paint
