BCA Vehicle Appraisal Report

KM63 PUO, VAUXHALL ASTRA TOURER

Registration: KM63 PUO	Colour: BLUE	Appraised: 23/10/2025
Transmission: Automatic	Odometer: 141,584 miles

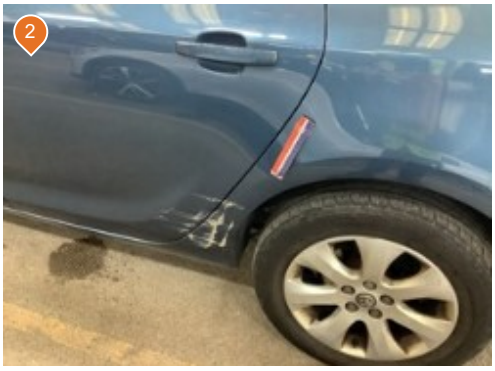
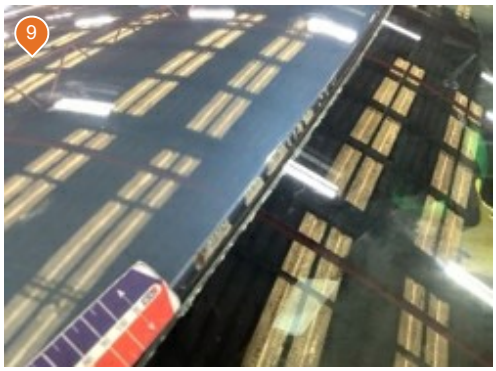
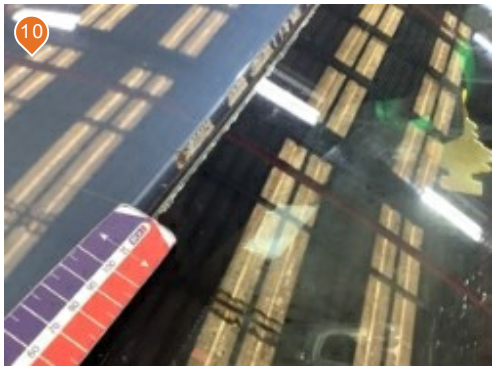
1. Door nsr; Dented; With Paint Damage
2. Qtr Panel nsr; Dented; With Paint Damage
3. Tailgate; Dented; Over 30mm
4. Bonnet; Chipped; Multiple Chips
5. Bumper Front; Poor Previous Repair; Poor Colour
6. Bumper Rear; Poor Previous Repair; Poor Colour
7. Door osf; Poor Previous Repair; Poor Paint
8. Door osr; Chipped; Multiple Chips
9. Roof; Poor Previous Repair; Paint Flake
10. Screen Front; Cracked; Replace
11. Wing nsf; Chipped; Multiple Chips
12. Wing osf; Chipped; Multiple Chips
13. Aperture Seal osf; Broken; Replace
14. Bumper Front Grill; Broken; Replace
15. Wheel nsf; Scratched; Over 50mm
16. Wheel nsr; Scratched; Over 50mm
17. Wheel osf; Scratched; Over 50mm
18. Wheel osr; Scratched; Over 50mm

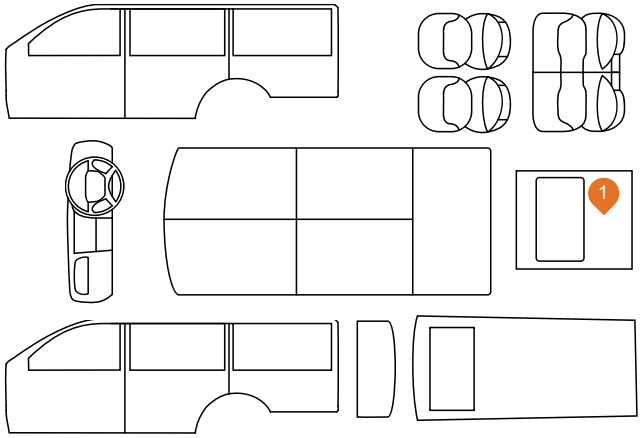
1 Tailgate Pad; Scuffed; Over 25mm
