BCA Vehicle Appraisal Report

KU60 JXJ, BMW 118I

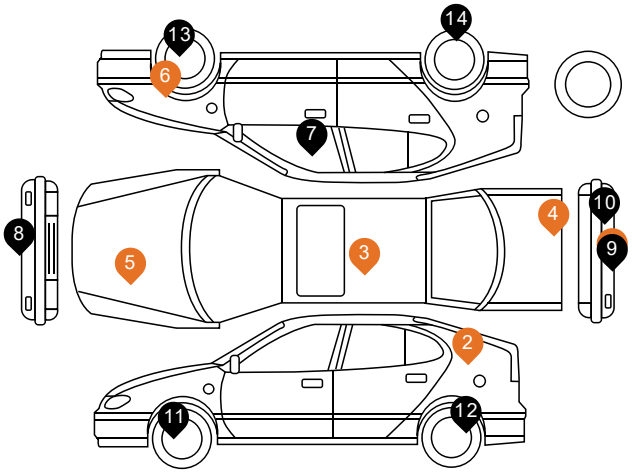
Grade 5
