Vehicle Appraisal Report

LD02 RZH, SUZUKI GRAND VITARA

Registration: LD02 RZH	Colour: SILVER	Appraised: 17/10/2025
Transmission: Automatic	Odometer: 107,786 miles

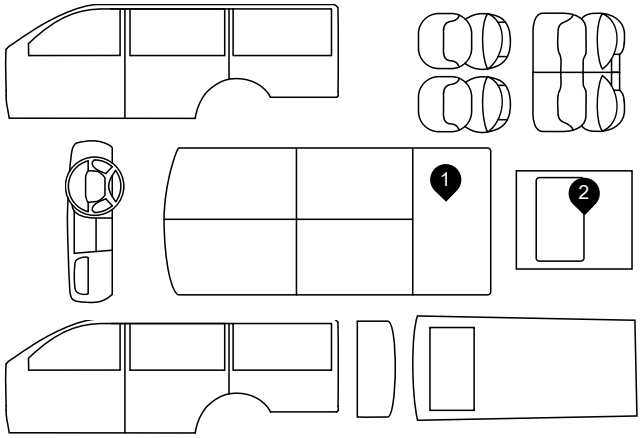
Exterior condition

1. Bumper Front; Poor Previous Repair; Paint Flake
2. C Post os; Scratched; Over 25mm Thru Paint
3. Bumper Rear; Scratched; 25 to 100mm Thru Paint
4. Wheel nsf; Corroded; Light
5. Wheel nsr; Corroded; Light
6. Wheel osf; Corroded; Light
7. Wheel osr; Corroded; Light
