BCA Vehicle Appraisal Report

LG10 YZW, HYUNDAI I20

Registration: LG10 YZW	Colour: RED	Appraised: 22/10/2025
Transmission: Manual	Odometer: 92,932 miles

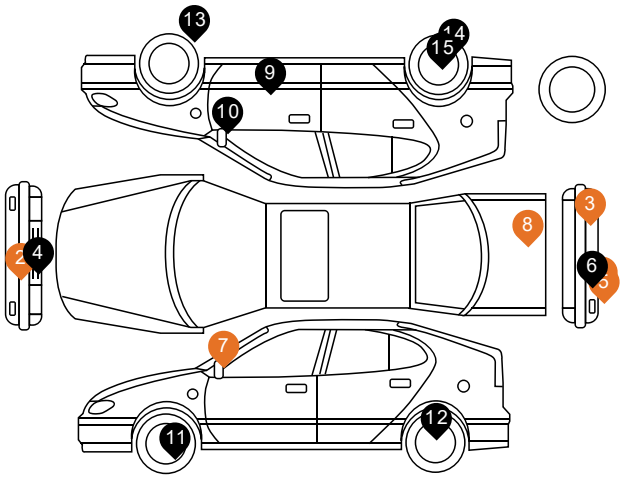
1. Bumper Rear; Dented; With Paint Damage
2. Bumper Front; Scratched; Over 100mm Thru Paint
3. Bumper Rear; Poor Previous Repair; Paint Flake
4. Headlamp ns; Broken; Replace
5. Lamp nsr; Broken; Replace
6. Lamp nsr; Broken; Replace
7. Door Mirror Assy nsf; Scratched (Painted); Over 25mm Thru Paint
8. Moulding Tailgate; Scratched (Painted); Over 25mm Thru Paint
9. Door Mirror Assy osf; Scratched (Painted); Over 25mm Thru Paint
10. Door Mirror Assy osf; Scratched (Painted); Over 25mm Thru Paint
11. Wheel nsf; Scratched; Over 50mm
12. Wheel nsr; Scratched; Over 50mm
13. Wheel osf; Scratched; Over 50mm
14. Wheel osr; Scratched; Over 50mm
15. Wheel Trim osr; Missing; Replace
16. General Exterior; Decals Fitted; Body Transfers

17 General Interior; Soiled; Light

18 General Interior; Buyer Advisory; Report Only

19 General Interior; Soiled; Light

20 General Interior; Buyer Advisory; Report Only

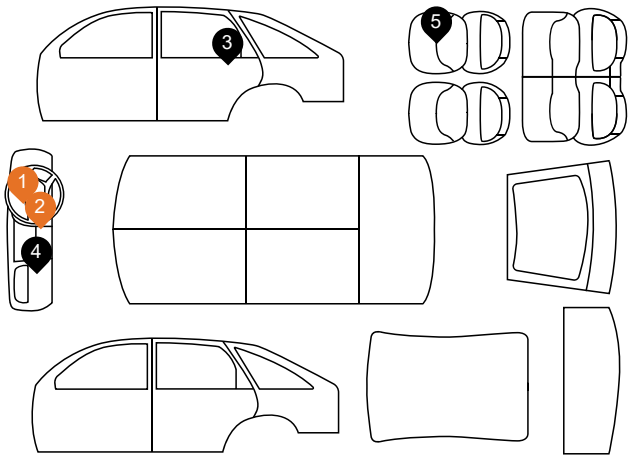
1 Fascia Panel; Scuffed; UpTo 25mm

2 Fascia Trim; Damaged; Replace

3 Door Pad osr; Scuffed; Over 25mm

4 Glove Box Lid; Scuffed; Over 25mm

5 Seat Base Cover osf; Scuffed; Over 25mm

6 Door Pad nsr; Soiled; Light

7 Door Pad osf; Soiled; Light
