BCA Vehicle Appraisal Report

LT57 HJZ, VAUXHALL ASTRA

Registration: LT57 HJZ	Colour: BLUE	Appraised: 22/10/2025
Transmission: Manual	Odometer: 93,819 miles

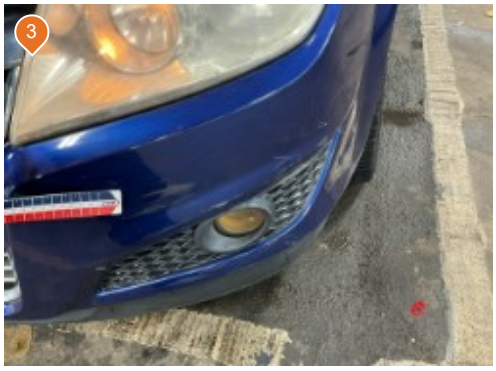
Exterior condition

1. Tailgate; Dented; Over 30mm
2. Wing nsf; Dented; Over 30mm
3. Bumper Front; Scratched; Over 100mm Thru Paint
4. Bumper Rear; Scratched; Over 100mm Thru Paint
5. Door nsf; Scratched; Over 25mm Thru Paint
6. Qtr Panel nsr; Scratched; Over 25mm Thru Paint
7. Wing nsf; Poor Previous Repair; Paint Flake
8. Bumper Rear; Scratched; 25 to 100mm Thru Paint
9. Moulding osf Wing; Scuffed (Unpainted); Over 100mm
10. Tailgate Aperture Seal; Broken; Replace
11. Wheel nsf; Scratched; Over 50mm
12. Wheel nsr; Scratched; Over 50mm
13. Wheel osf; Scratched; Over 50mm
14. Wheel osr; Scratched; Over 50mm
15. General Interior; Decals Fitted; Body Transfers
16. General Interior; Decals Fitted; Body Transfers

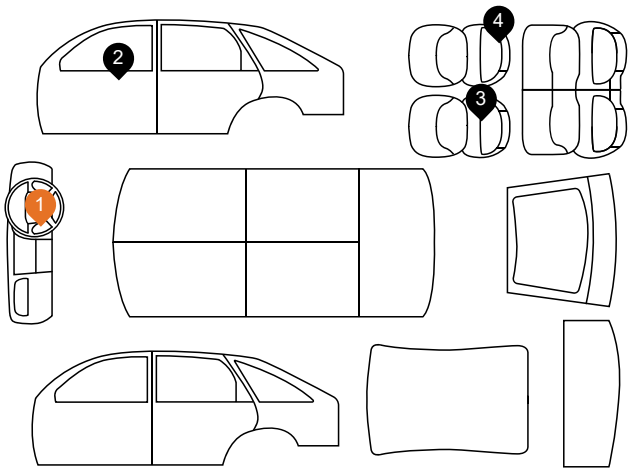
Interior condition

1. Fascia Trim; Damaged; Replace
2. Door Pad osf; Scuffed; Over 25mm
3. Seat Back Cover nsf; Scuffed; UpTo 25mm
4. Seat Back Cover osf; Scuffed; Over 25mm
