BCA Vehicle Appraisal Report

ML09 WJD, FORD C-MAX

Registration: ML09 WJD	Colour: BLUE	Appraised: 18/10/2025
Transmission: Automatic	Odometer: 96,964 miles

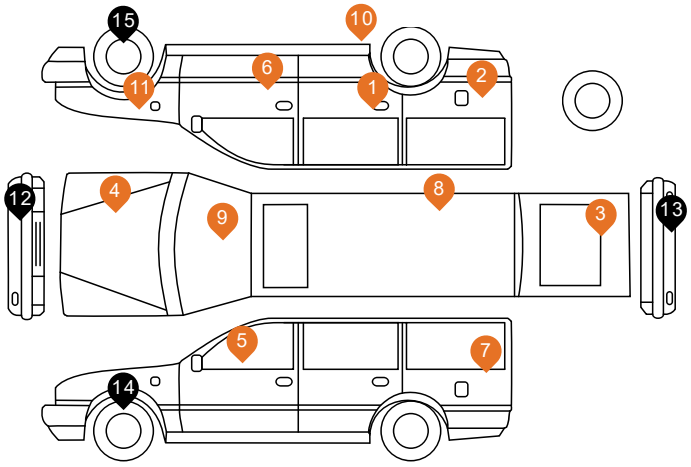
Exterior condition

1. Door osr; Poor Previous Repair; Rippled UpTo 30%
2. Qtr Panel osr; Dented; Over 30mm
3. Tailgate; Dented; Over 30mm
4. Bonnet; Poor Previous Repair; Poor Paint
5. Door nsf; Chipped; Over 5mm
6. Door osf; Poor Previous Repair; Poor Paint
7. Qtr Panel nsr; Scratched; Over 25mm Thru Paint
8. Roof; Poor Previous Repair; Paint Flake
9. Screen Front; Cracked; Replace
10. Sill os; Rusted; Over 5mm
11. Moulding osf Wing; Broken; Replace
12. Bumper Front; Scratched; 25 to 100mm Thru Paint
13. Bumper Rear; Scratched; 25 to 100mm Thru Paint
14. Wheel nsf; Scratched; Over 50mm
15. Wheel osf; Scratched; Over 50mm
16. General Interior; Buyer Advisory; Report Only

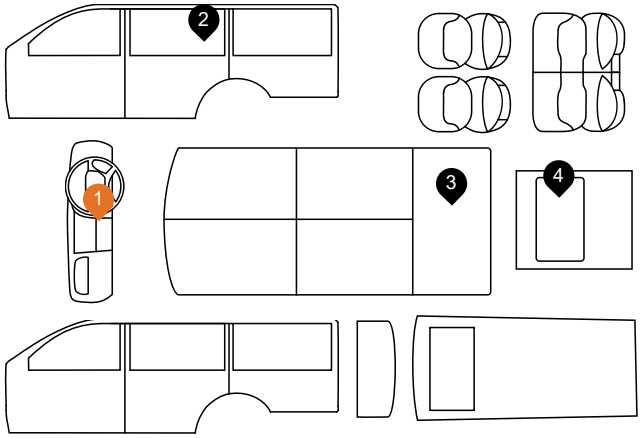
Interior condition

1 Fascia Trim; Damaged; Replace

2 Door Pad osr; Scuffed; UpTo 25mm

3 Shelfload Cover Rear; Missing; Replace

4 Tailgate Pad; Scuffed; UpTo 25mm

5 Seat Base Cover osr; Soiled; Light
