BCA Vehicle Appraisal Report

NU10 GPF, RENAULT MEGANE

Registration: NU10 GPF	Colour: SILVER	Appraised: 24/10/2025
Transmission: Manual	Odometer: 112,216 miles

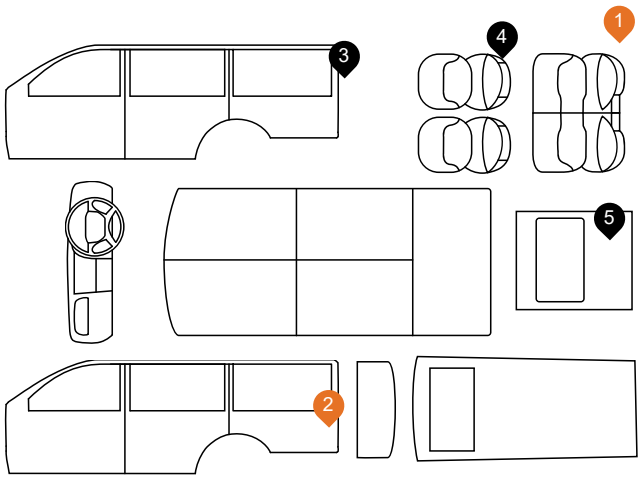
1. Sill os; Dented; Over 30mm
2. Bonnet; Poor Previous Repair; Paint Flake
3. Bumper Front; Poor Previous Repair; Paint Flake
4. Door nsf; Scratched; Over 25mm Thru Paint
5. Qtr Panel nsr; Scratched; Over 25mm Thru Paint
6. Bumper Rear; Scratched; 25 to 100mm Thru Paint
7. Door Moulding osf; Scratched (Painted); Over 25mm Thru Paint
8. Door Mirror Assy osf; Scratched (Painted); UpTo 25mm Thru Paint
9. Wheel nsf; Scratched; Over 50mm
10. Wheel nsr; Scratched; Over 50mm
11. Wheel osf; Scratched; Over 50mm
12. Wheel osr; Scratched; Over 50mm
