BCA Vehicle Appraisal Report

OY58 BAA, MERCEDES-BENZ CLC 220

Registration: OY58 BAA	Colour: SILVER	Appraised: 23/10/2025
Transmission: Auto/Manual Mode	Odometer: 130,456 miles

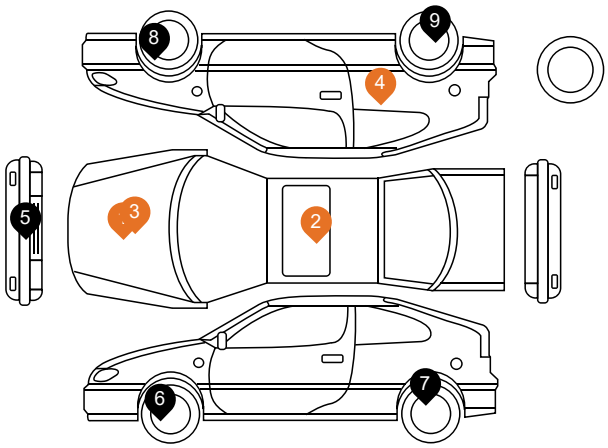
1. Bonnet; Dented; Over 30mm
2. Roof; Dented; Over 30mm
3. Bonnet; Rusted; Over 5mm
4. Qtr Panel osr; Scratched; Over 25mm Thru Paint
5. Bumper Front; Scratched; 25 to 100mm Thru Paint
6. Wheel nsf; Scratched; Over 50mm
7. Wheel nsr; Scratched; Over 50mm
8. Wheel osf; Scratched; Over 50mm
9. Wheel osr; Scratched; Over 50mm
