Vehicle Appraisal Report

PJ09 AEE, MINI COOPER

Registration: PJ09 AEE	Colour: RED	Appraised: 22/10/2025
Transmission: Manual	Odometer: 89,877 miles

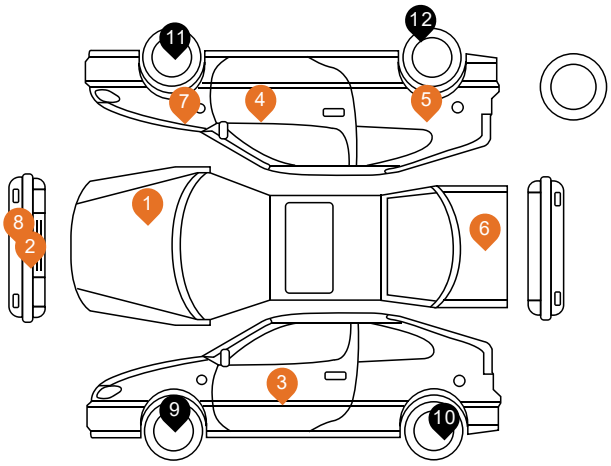
1. Bonnet; Poor Previous Repair; Paint Flake
2. Bumper Front; Poor Previous Repair; Paint Flake
3. Door nsf; Poor Previous Repair; Paint Flake
4. Door osf; Poor Previous Repair; Poor Paint
5. Qtr Panel osr; Poor Previous Repair; Paint Flake
6. Tailgate; Poor Previous Repair; Paint Flake
7. Wing osf; Poor Previous Repair; Poor Paint
8. Bumper Front Moulding; Broken; Replace
9. Wheel nsf; Scratched; Up To 50mm
10. Wheel nsr; Scratched; Up To 50mm
11. Wheel osf; Scratched; Over 50mm
12. Wheel osr; Scratched; Over 50mm
13. General Exterior; Buyer Advisory; Report Only
14. Tyre nsr; Damaged; Replace

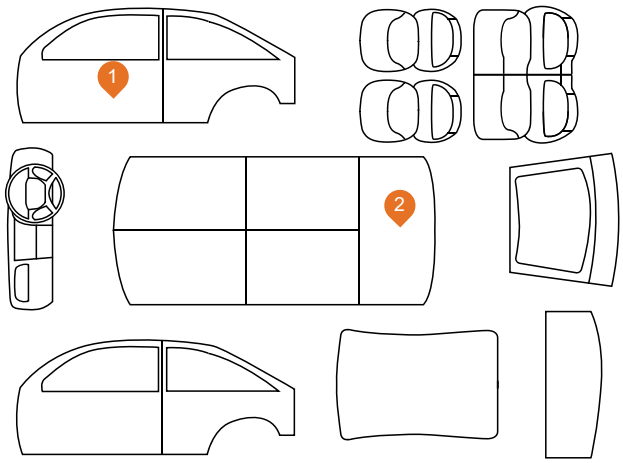
1 Door Pad osf; Torn; Over 10mm

2 Shelfload Cover Rear; Damaged; Replace
