BCA Vehicle Appraisal Report

RJ04 NKZ, BMW X3

Registration: RJ04 NKZ	Colour: RED	Appraised: 25/10/2025
Transmission: Automatic	Odometer: 103,488 miles

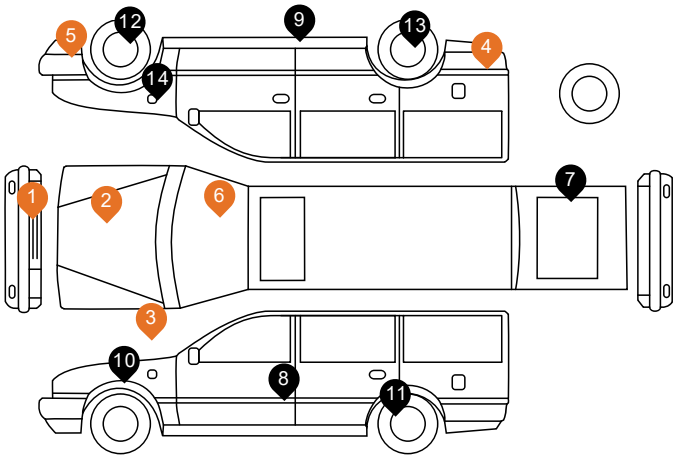
1. Bumper Front; Cracked; Over 25mm
2. Bonnet; Dented; With Paint Damage
3. Wing nsf; Dented; Over 30mm
4. Bumper Rear; Scratched; Over 100mm Thru Paint
5. Bumper Front; Insecure; Action Required
6. Screen Front; Chipped; UpTo 10mm
7. Badgedecal Rear; Broken; Replace
8. Sill Panel Trim ns; Scratched (Painted); Over 25mm Thru Paint
9. Sill Panel Trim os; Scratched (Painted); Over 25mm Thru Paint
10. Wheel nsf; Scratched; Over 50mm
11. Wheel nsr; Scratched; Over 50mm
12. Wheel osf; Scratched; Up To 50mm
13. Wheel Trim osr; Scratched; Up To 50mm
14. Wing Front Arch Extension os; Broken; Replace
