Vehicle Appraisal Report

ST09 AFJ, VOLVO C30

Registration: ST09 AFJ	Colour: BLUE	Appraised: 21/10/2025
Transmission: Manual	Odometer: -

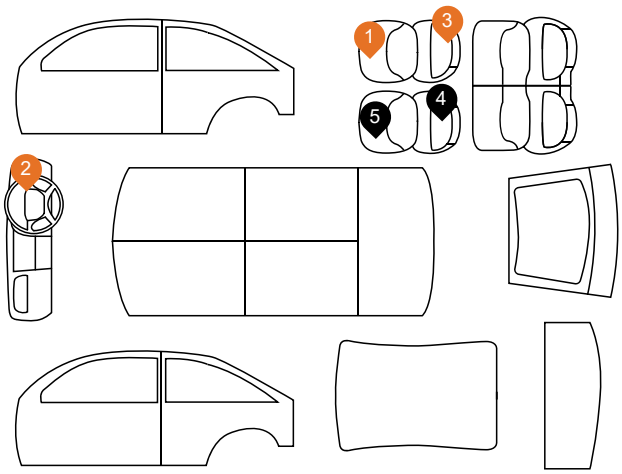
1. Bumper Rear; Dented; With Paint Damage
2. Bumper Front; Scratched; Over 100mm Thru Paint
3. Bumper Front; Scratched; 25 to 100mm Thru Paint
4. Door Mirror Assy osf; Scratched (Painted); Over 25mm Thru Paint
5. Grille Front; Scratched (Painted); Over 25mm Thru Paint
6. Moulding nsf Wing; Scratched (Painted); Over 25mm Thru Paint
7. Wheel nsf; Scratched; Over 50mm
8. Wheel nsr; Scratched; Over 50mm
9. Wheel osf; Scratched; Over 50mm
10. Wheel osr; Scratched; Over 50mm
