BCA Vehicle Appraisal Report

SV63 TLN, CITROEN C4 PICASSO

Registration: SV63 TLN	Colour: BLUE	Appraised: 24/10/2025
Transmission: Auto Clutch	Odometer: 262,478 miles

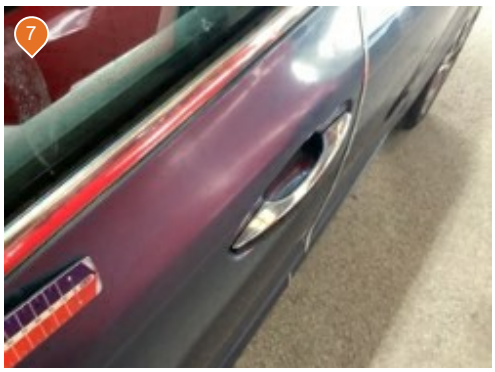
1. Door nsr; Dented; Over 30mm
2. Qtr Panel nsr; Dented; Over 30mm
3. Sill os; Dented; With Paint Damage
4. Bonnet; Chipped; Multiple Chips
5. Bumper Front; Poor Previous Repair; Poor Colour
6. Bumper Rear; Poor Previous Repair; Paint Flake
7. Door nsf; Poor Previous Repair; Paint Flake
8. Door osf; Rusted; Over 5mm
9. Sill ns; Rusted; Over 5mm
10. Sill os; Rusted; Over 5mm
11. Tailgate; Poor Previous Repair; Poor Paint
12. Wing nsf; Rusted; Over 5mm
13. Wing osf; Rusted; Over 5mm
14. B Post os; Dented; With Paint Damage
15. A Post ns; Rusted; Over 5mm
16. A Post os; Rusted; Over 5mm

17 Door Mirror Assy nsf; Scratched (Painted); Over 25mm Thru Paint

18 Wheel nsf; Corroded; Light

19 Wheel nsr; Corroded; Light

20 Wheel osf; Corroded; Light

21 Wheel osr; Corroded; Light

22 Wheel Trim nsf; Missing; Replace

23 Wheel Trim nsr; Missing; Replace

24 Wheel Trim osf; Missing; Replace

25 Wheel Trim osr; Missing; Replace

26 General Exterior; Buyer Advisory; Report Only

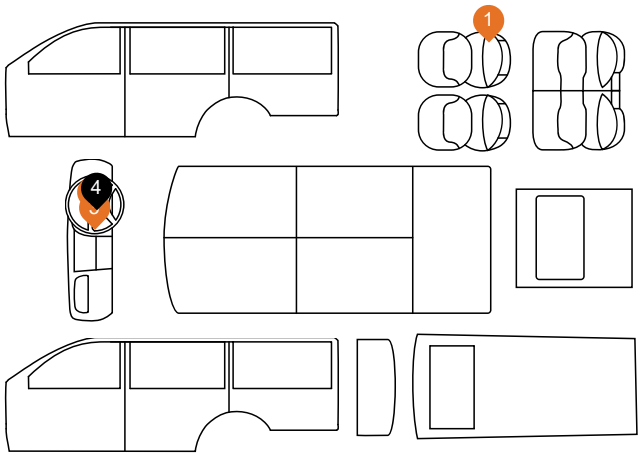
1. Seat Base Cover osf; Torn; Over 3mm
2. Air Vents osf; Damaged; Replace
3. Switches And Controls; Broken; Replace
4. Air Vents nsf; Damaged; Replace
