Vehicle Appraisal Report

WL57 EYU, HONDA CIVIC

Registration: WL57 EYU	Colour: SILVER	Appraised: 24/10/2025
Transmission: Manual	Odometer: 93,164 miles

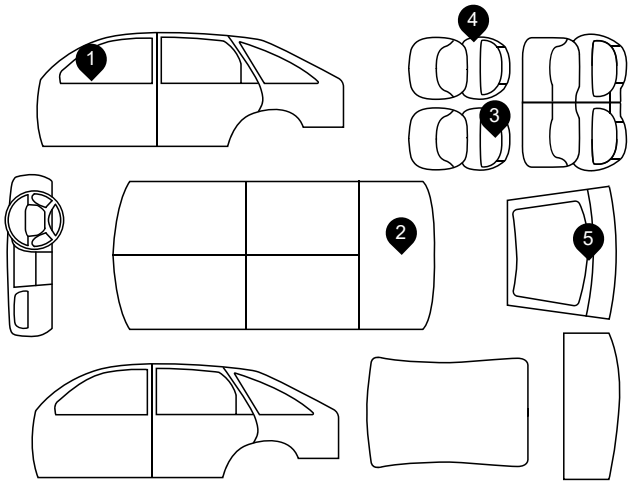
1. Bonnet; Dented; Over 30mm
2. Bumper Front; Dented; With Paint Damage
3. Door osf; Dented; Over 30mm
4. Qtr Panel nsr; Dented; With Paint Damage
5. Wing osf; Dented; Over 30mm
6. Bumper Rear; Scratched; Over 100mm Thru Paint
7. Qtr Panel osr; Rusted; Over 5mm
8. Door Mirror Assy nsf; Broken; Replace
9. Door Mirror Assy osf; Broken; Replace
10. Fogdriving Lamp nsf; Broken; Replace
11. Bumper Front Moulding; Broken; Replace
12. Front TowEye Cvr; Missing; Replace
13. Wheel nsf; Scratched; Over 50mm
14. Wheel nsr; Scratched; Over 50mm
15. Wheel osf; Scratched; Over 50mm
16. Wheel osr; Scratched; Up To 50mm
