BCA Vehicle Appraisal Report

YA08 GMV, RENAULT MEGANE

Registration: YA08 GMV	Colour: BLUE	Appraised: 23/10/2025
Transmission: Manual	Odometer: 90,805 miles

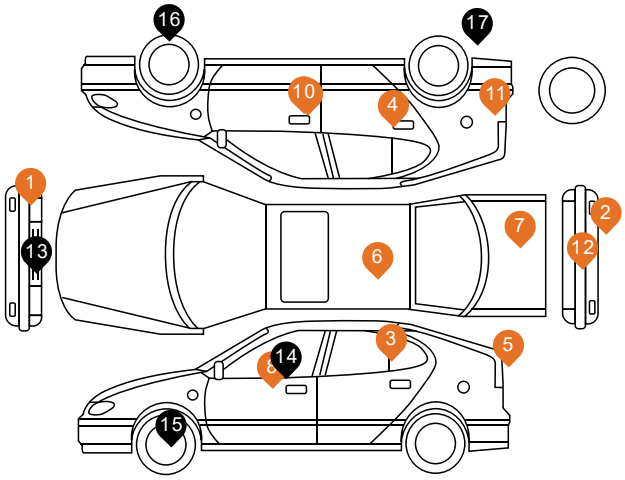
1. Bumper Front; Poor Previous Repair; Poor Paint
2. Bumper Rear; Poor Previous Repair; Poor Paint
3. Door nsr; Poor Previous Repair; Poor Paint
4. Door osr; Poor Previous Repair; Poor Paint
5. Qtr Panel nsr; Poor Previous Repair; Poor Paint
6. Roof; Poor Previous Repair; Paint Flake
7. Tailgate; Poor Previous Repair; Poor Paint
8. A Post ns; Poor Previous Repair; Poor Paint
9. A Post os; Poor Previous Repair; Poor Paint
10. B Post os; Scratched; Over 25mm Thru Paint
11. Fuel Flap; Poor Previous Repair; Poor Paint
12. Lamp osr; Broken; Replace
13. Bumper Front Moulding; Scratched (Painted); Over 25mm Thru Paint
14. Door Mirror Assy nsf; Scratched (Painted); Over 25mm Thru Paint
15. Wheel nsf; Scratched; Over 50mm
16. Wheel osf; Scratched; Over 50mm
17. Wheel osr; Scratched; Over 50mm

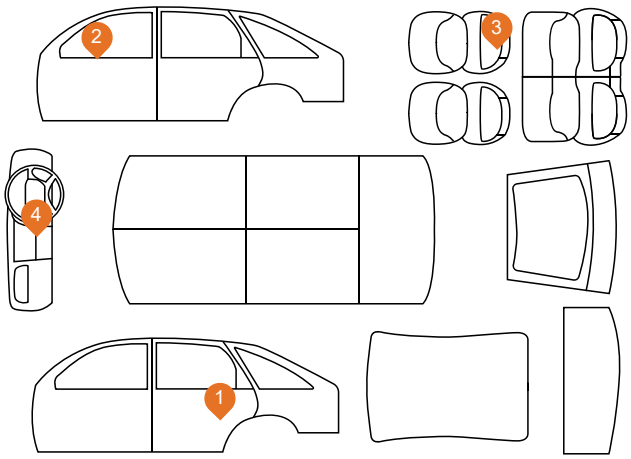
1. Door Pad nsr; Torn; Between 3mm + 10mm
2. Door Pad osf; Torn; Between 3mm + 10mm
3. Seat Back Cover osf; Torn; Over 3mm
4. Fascia Trim; Damaged; Replace
