BCA Vehicle Appraisal Report

YS08 ZRY, PEUGEOT 107

Registration: YS08 ZRY	Colour: SILVER	Appraised: 23/10/2025
Transmission: Auto Clutch	Odometer: 65,025 miles

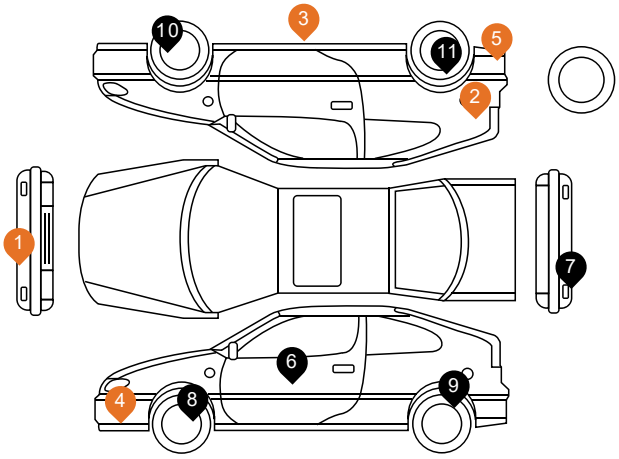
Grade 3
