Vehicle Appraisal Report

YT09 YGX, TOYOTA AVENSIS

Registration: YT09 YGX	Colour: SILVER	Appraised: 08/10/2025
Transmission: Manual	Odometer: 133,644 miles

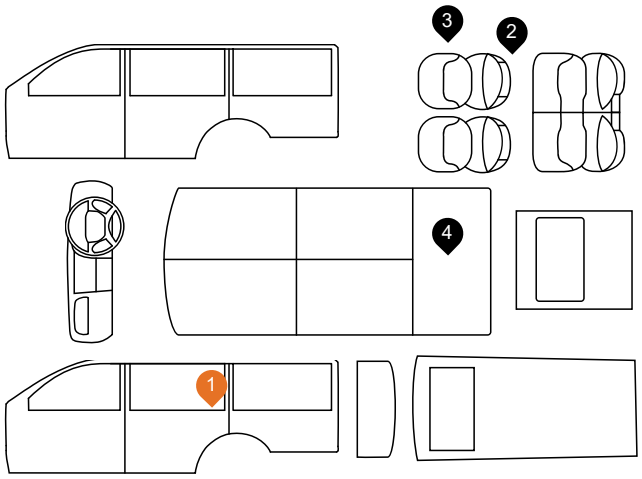
Exterior condition

1. Door nsf; Dented; Over 30mm
2. Door nsr; Dented; With Paint Damage
3. Door osr; Dented; Over 30mm
4. Qtr Panel nsr; Poor Previous Repair; Rippled UpTo 30%
5. Qtr Panel osr; Poor Previous Repair; Rippled UpTo 30%
6. Wing osf; Dented; Over 30mm
7. Bonnet; Chipped; Multiple Chips
8. Bumper Front; Scratched; Over 100mm Thru Paint
9. Bumper Front; Scratched; Over 100mm Thru Paint
10. Bumper Rear; Scratched; Over 100mm Thru Paint
11. Door nsr; Poor Previous Repair; Poor Paint
12. Door osf; Scratched; Over 25mm Thru Paint
13. Tailgate; Rusted; Over 5mm
14. C Post os; Scratched; Over 25mm Thru Paint
15. Lamp nsr; Broken; Replace
16. Wheel nsf; Scratched; Over 50mm
17. Wheel nsr; Scratched; Over 50mm
18. Wheel osf; Scratched; Over 50mm

19 Wheel osr; Scratched; Over 50mm

20 General Interior; Soiled; Light

21 Tyre osr; Punctured; Replace
