Vehicle Inspection Report

ASTON BARCLAY
Chelmsford

TW15TEA - MERCEDES-BENZ C 220 **NAMA** 2

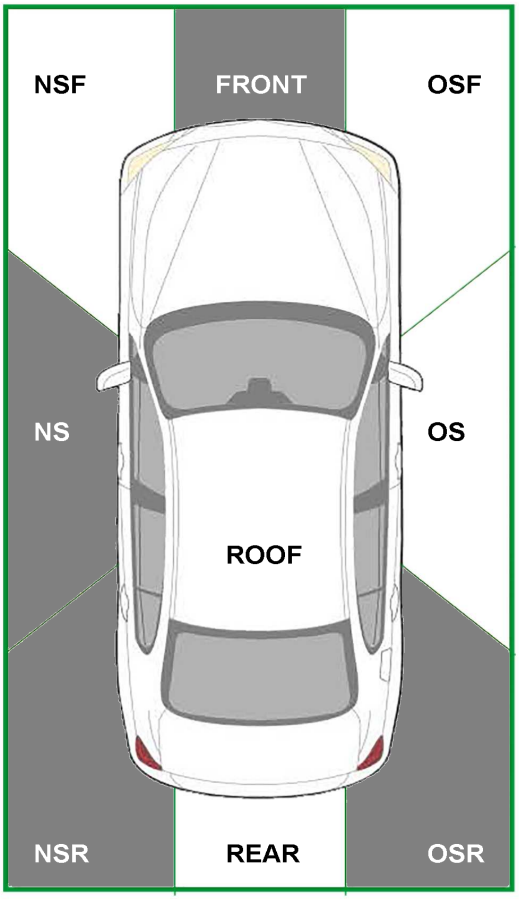
1	**Bonnet**	Poor Previous Repair Poor Paint	Refinish
2	**Wheel nsr**	Corroded Light	Smart Repair
	Wheel osr	Scratched Up To 50mm	Smart Repair
3	**Door nsf**	Scratched UpTo 25mm Thru Paint	Smart Repair
