# FIVE-YEAR REVIEW TAR CREEK SUPERFUND SITE OTTAWA COUNTY, OKLAHOMA

APRIL 2000

U. S. ENVIRONMENTAL PROTECTION AGENCY

REGION 6

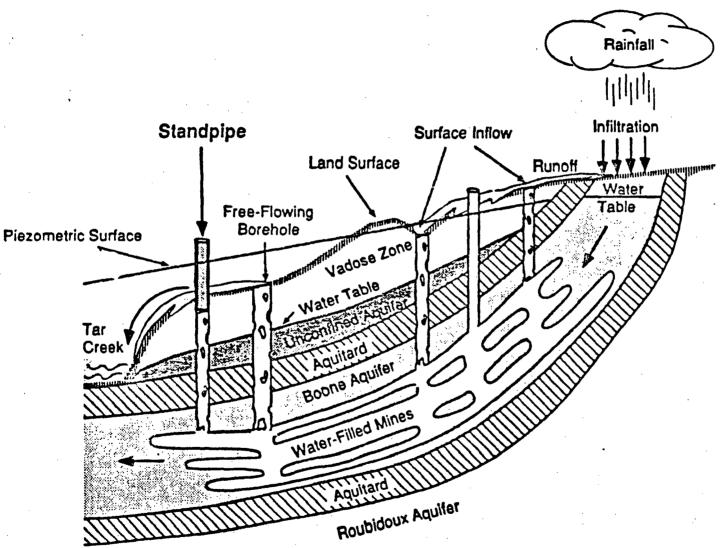
Figure 3. Acid Mine Discharge Process

The majority of the mine workings were flooded by 1979 due to ground water infiltration and surface water inflow. Since the potentiometric level (i.e., artesian level) exceeded the ground surface elevation in low lying areas along Tar Creek in the far southern portions of the Picher Field (near Commerce), acid mine water discharged to the surface through abandoned mine shaft openings and boreholes. This process is shown schematically in Figure 3.
