AI Car Damage Inspection Report

Report ID: d3387c1a-7ce | **Timestamp:** 2026-11-02 09:34:33 UTC

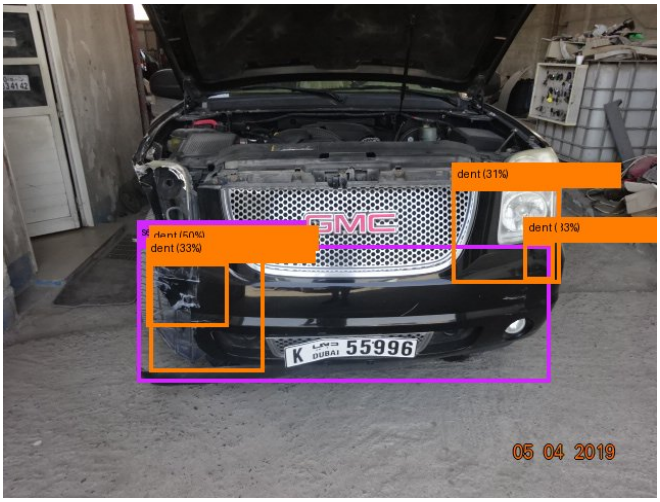
Inspection Verdict	DAMAGED	**Confidence Score**	98.5%
Estimated Severity	SEVERE	**Damaged Area Ratio**	20.72%
Needs Human Review	NO (Auto Pass)	**Pipeline Latency**	79.7 ms

#	Damage Class	Confidence	Bounding Box [x1, y1, x2, y2]
1	severe_replace	95.6%	[131.0, 234.7, 535.2, 367.8]
2	dent	50.3%	[143.2, 239.2, 255.4, 357.4]
3	dent	33.3%	[509.7, 231.2, 539.8, 268.2]
4	dent	32.7%	[140.3, 251.3, 220.4, 313.8]
5	dent	31.2%	[439.7, 178.9, 545.9, 271.2]
