Weatherford

Four Barriers Corrosion Evaluation

Company:	SAUDI ARAMCO
Well:	HRDH_1702_1
Field:	HARADH
Country:	SAUDI ARABIA
Log Date:	15-May-2026
Report Delivery Date:	22-May-2026

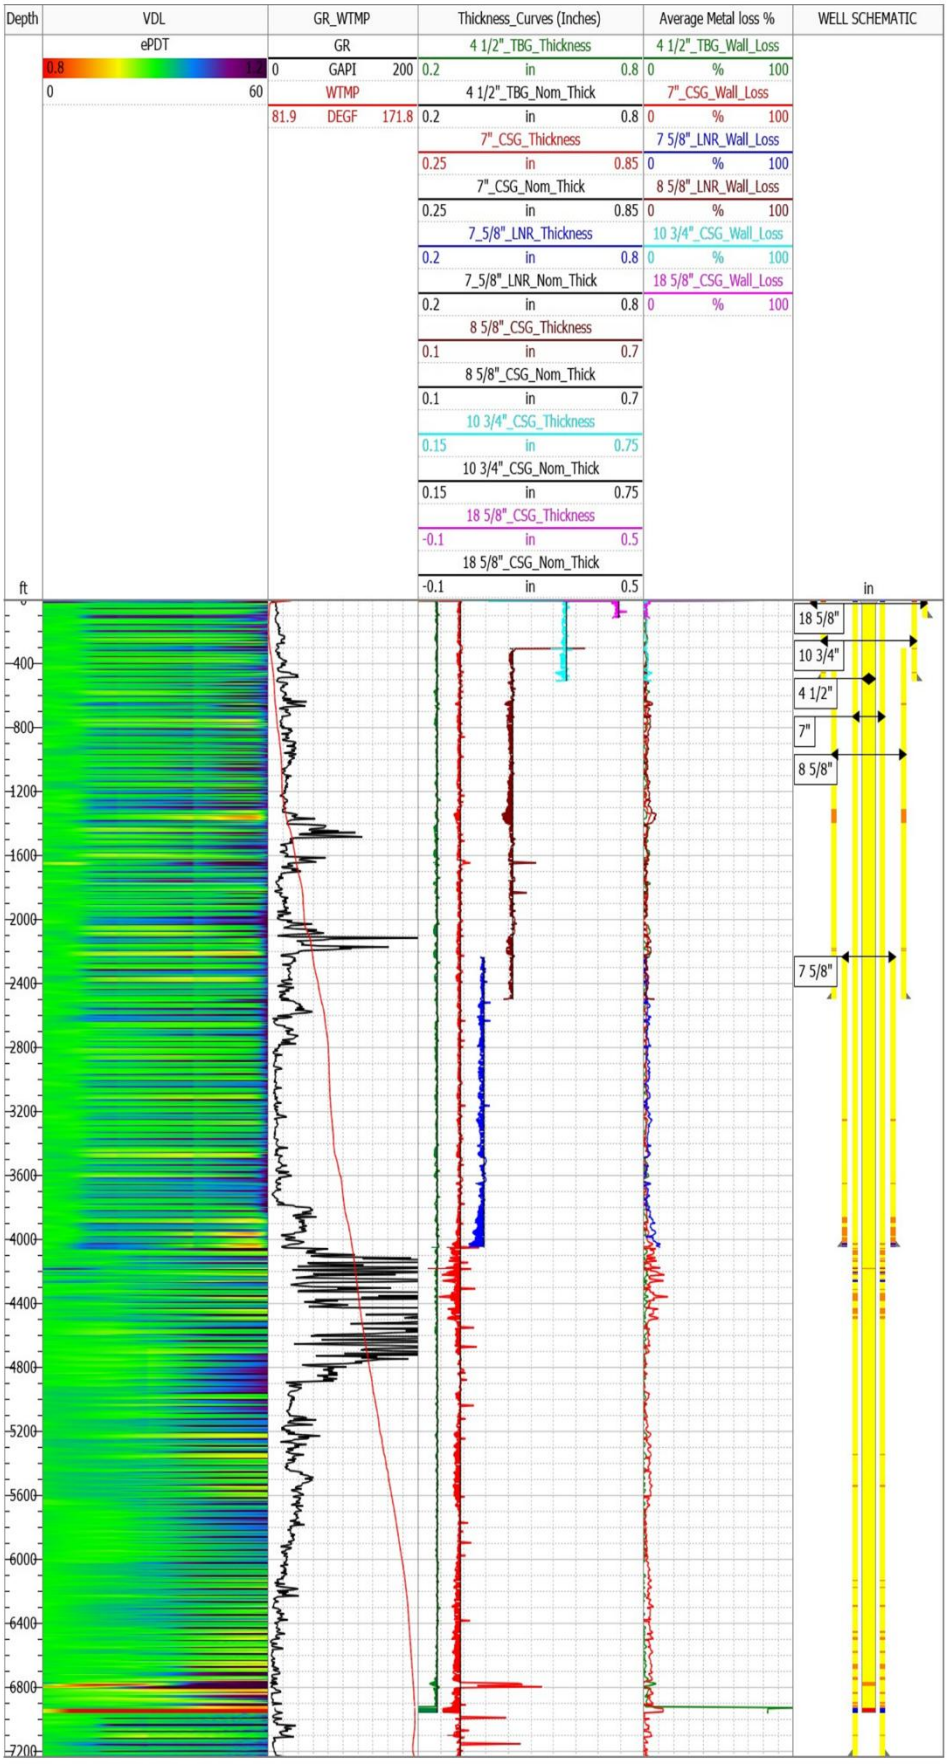
4. One Page Summary

Pipe OD (inch)	Max WL	Grade of Metal loss	Hotter Spot Depth (ft)
18 5/8" CSG	5.1%	B	18.3
10 3/4" CSG	6.2%	B	457.1
8 5/8" LNR	8.7%	B	1345.6
7 5/8" LNR	11.2%	C	4027.0
7" CSG	31.2%	D	4180.4
4 1/2" TBG	7.0%	B	4180.2

•Minor metal loss detected across the 18 5/8" casing string.
•Minor metal loss detected across the 10 3/4" casing string.
•Minor metal loss detected across the 8 5/8" liner string.
•Moderate metal loss detected across the 7 5/8" liner string.
•Intensive metal loss detected across the 7" casing string.
•Minor metal loss detected across the 4 1/2" tubing string.
•Temperature anomaly observed across the logging interval.

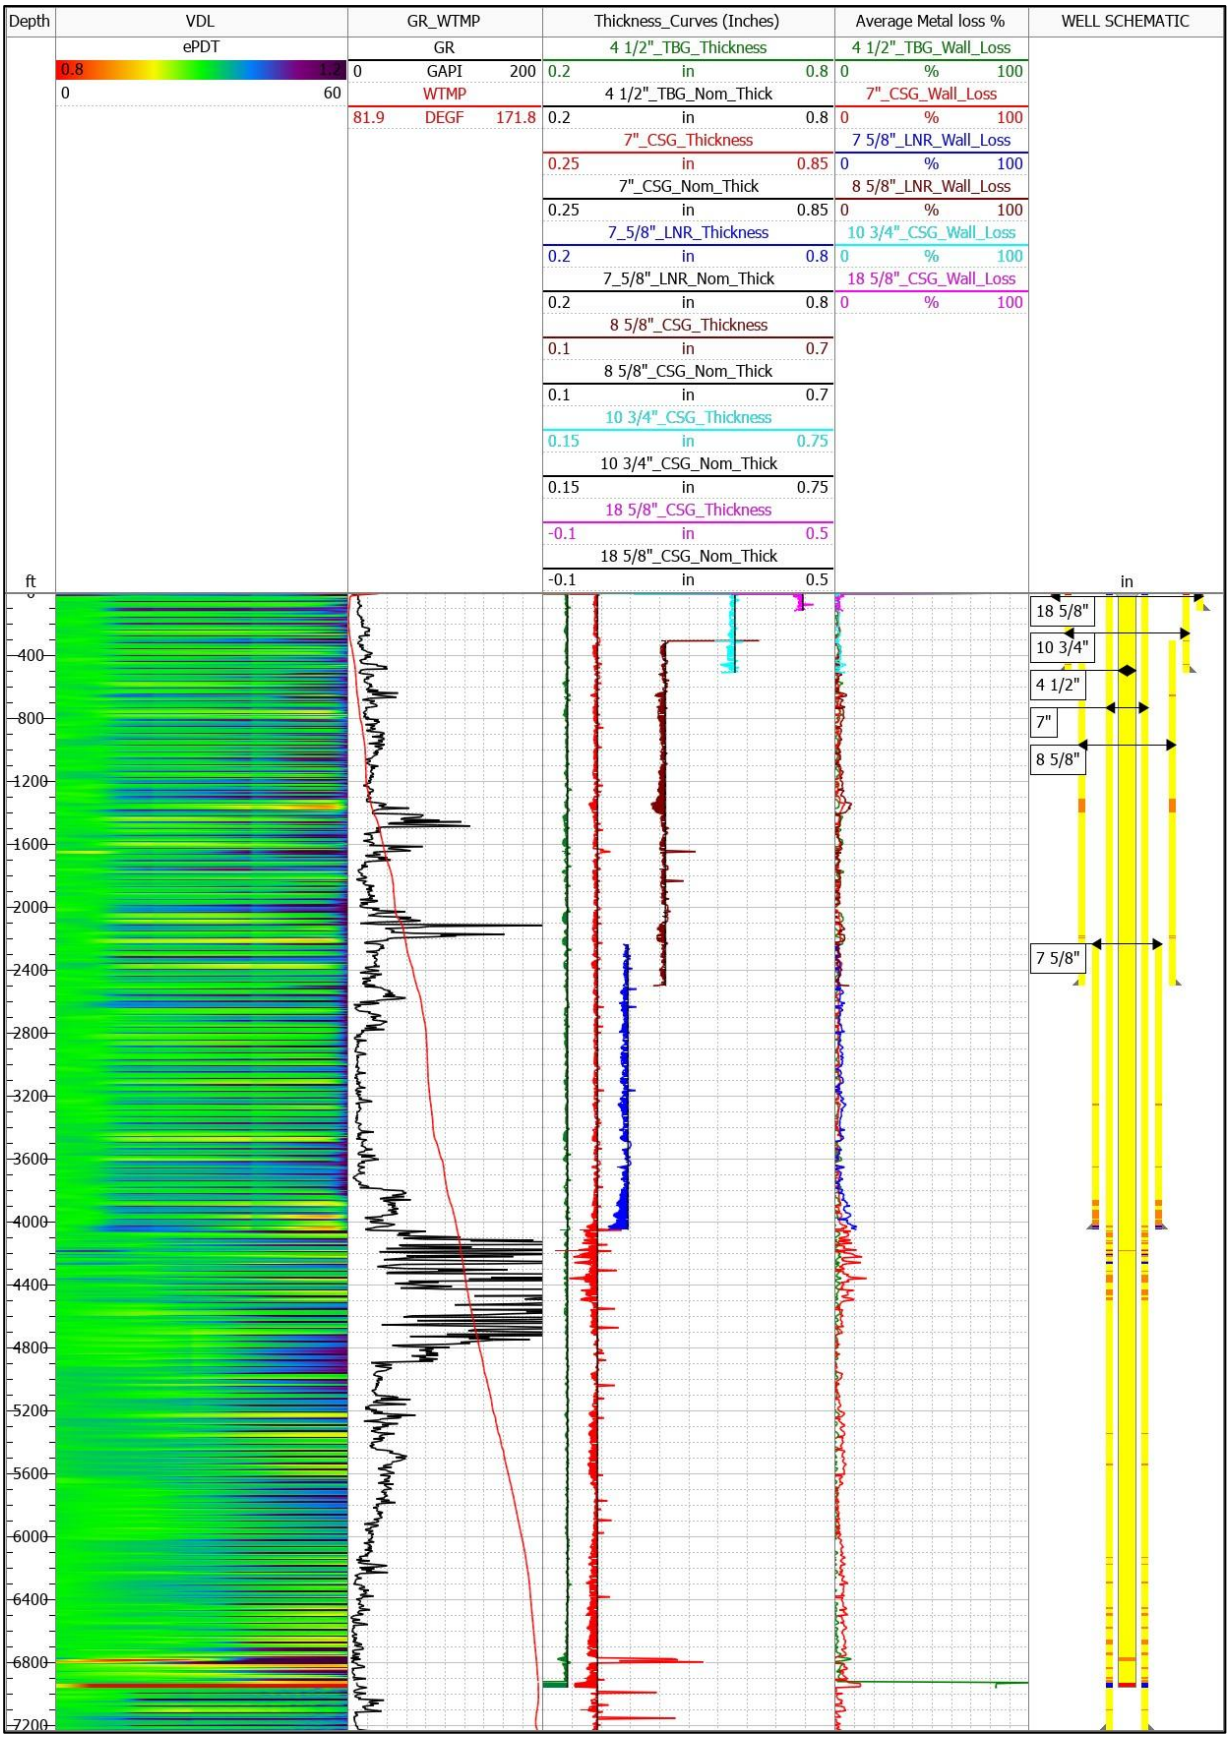
Figure 2 - Four Barriers Metal Loss Evaluation Results

- Minor metal loss detected across the **18 5/8” casing string.**
- Minor metal loss detected across the **10 3/4” casing string.**
- Minor metal loss detected across the **8 5/8” liner string.**
- Moderate metal loss detected across the **7 5/8” liner string.**
- Intensive metal loss detected across the **7” casing string.**
- Minor metal loss detected across the **4 1/2" tubing string.**
- Temperature anomaly observed across the logging interval.
- Excellent data quality & repeatability.

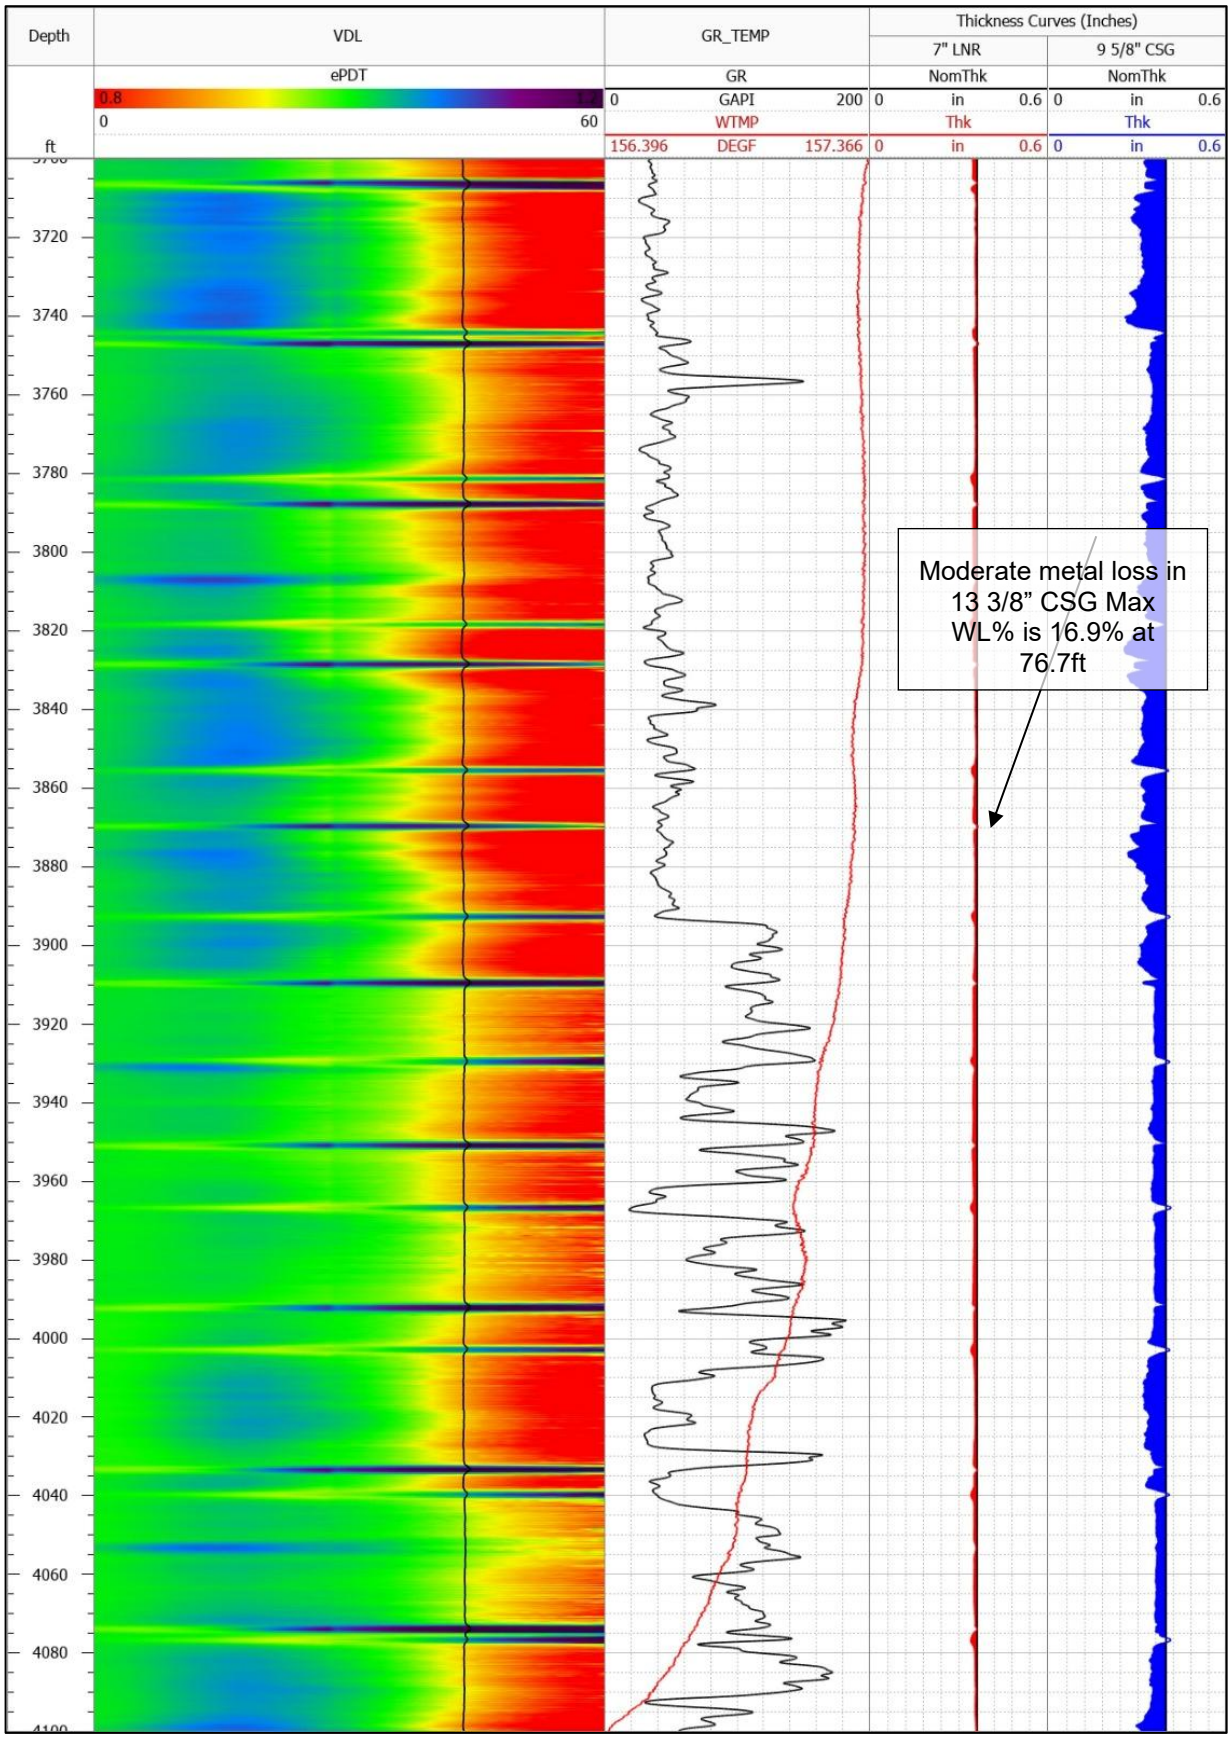
Figure 5 - Highest Metal Loss Channel Selection

#	Top Body (ft)	Bottom Body (ft)	Body Length (ft)	Nom Thk (in)	Min Thk (in)	Max Loss Depth (ft)	Max Loss (%)	Grade	Damage Profile (% wall loss)
104	3819.5	3855.0	35.5	0.395	0.253	3824.9	35.9	D	
101	3707.7	3743.9	36.1	0.395	0.255	3740.4	35.4	D	
105	3857.0	3892.3	35.3	0.395	0.266	3876.8	32.8	D	
97	3561.3	3594.8	33.5	0.395	0.292	3579.1	25.9	D	
111	4077.9	4113.2	35.3	0.395	0.293	4098.3	25.7	D	
103	3782.5	3817.5	35.0	0.395	0.297	3810.2	24.8	D	
106	3894.3	3928.7	34.4	0.395	0.299	3904.4	24.4	D	
112	4115.2	4150.2	35.0	0.395	0.303	4117.6	23.3	D	
99	3634.4	3669.3	35.0	0.395	0.303	3662.2	23.2	D	
102	3745.9	3780.5	34.7	0.395	0.308	3779.6	22.0	D	
109	4004.0	4039.0	35.0	0.395	0.317	4014.7	19.8	C	
100	3671.3	3705.7	34.4	0.395	0.320	3700.9	18.9	C	
108	3968.2	4002.0	33.8	0.395	0.335	4000.9	15.3	C	
107	3930.7	3966.2	35.5	0.395	0.336	3946.5	15.0	C	
113	4152.2	4187.4	35.3	0.395	0.344	4183.5	12.8	C	
96	3523.5	3559.3	35.8	0.395	0.346	3534.9	12.3	C

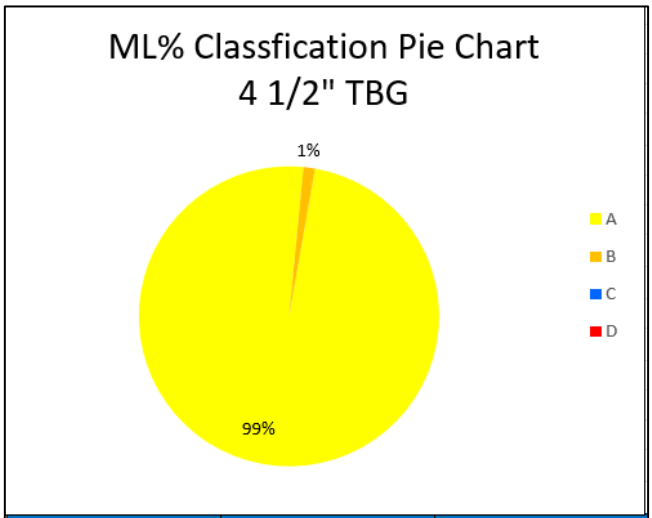
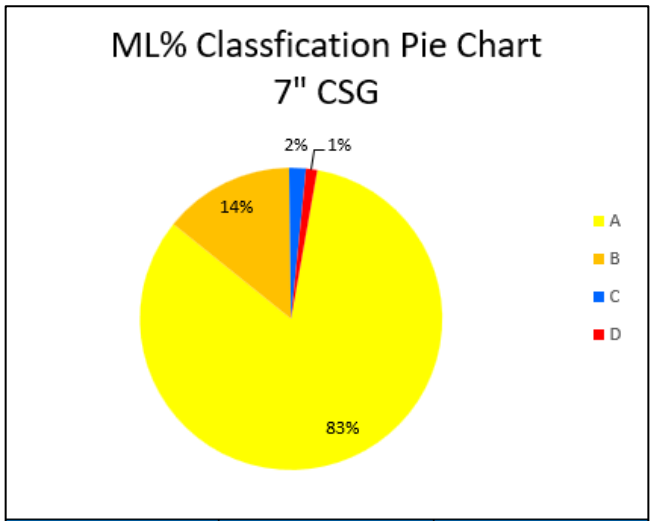
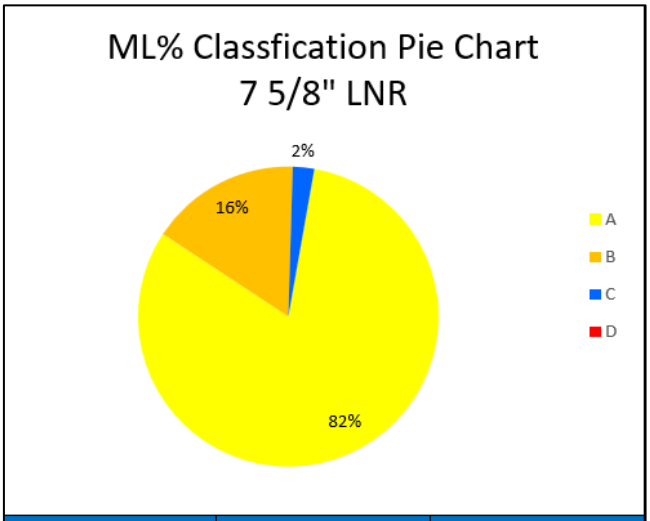
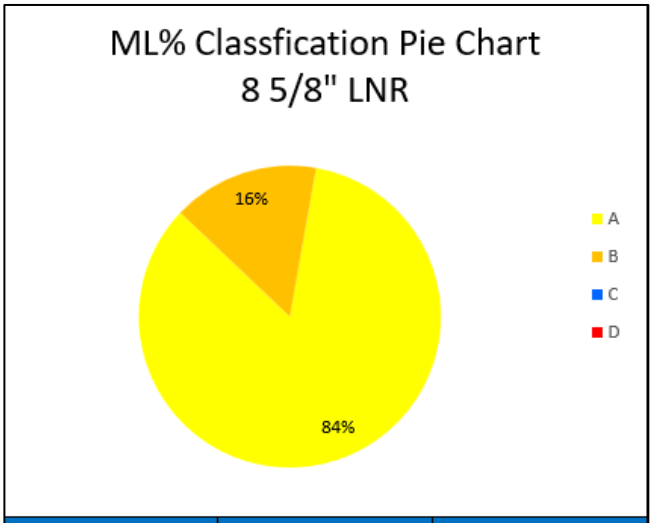
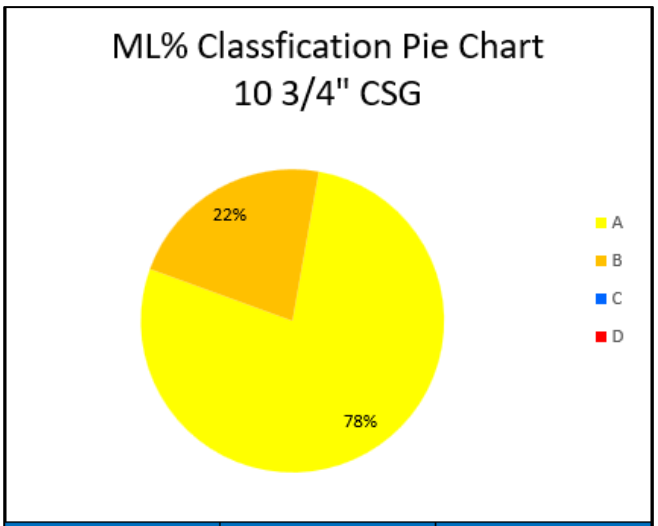
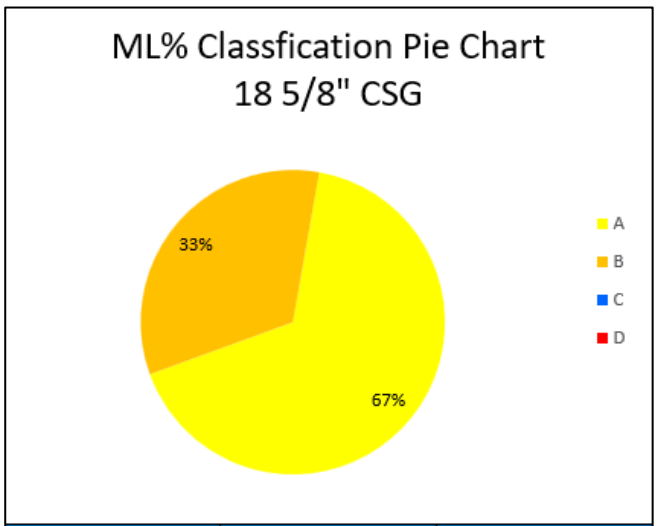
Figure 14 - Metal Loss Pie Chart Summary

Grade	Joints	% of Total
A	159	99%
B	2	1%
C	0	0%
D	0	0%
Total	161	100%

Grade	Joints	% of Total
A	139	83%
B	23	14%
C	3	2%
D	2	1%
Total	167	100%

Grade	Joints	% of Total
A	35	82%
B	7	16%
C	1	2%
D	0	0%
Total	43	100%

Grade	Joints	% of Total
A	43	84%
B	8	16%
C	0	0%
D	0	0%
Total	51	100%

Grade	Joints	% of Total
A	7	78%
B	2	22%
C	0	0%
D	0	0%
Total	9	100%

Grade	Joints	% of Total
A	2	67%
B	1	33%
C	0	0%
D	0	0%
Total	3	100%

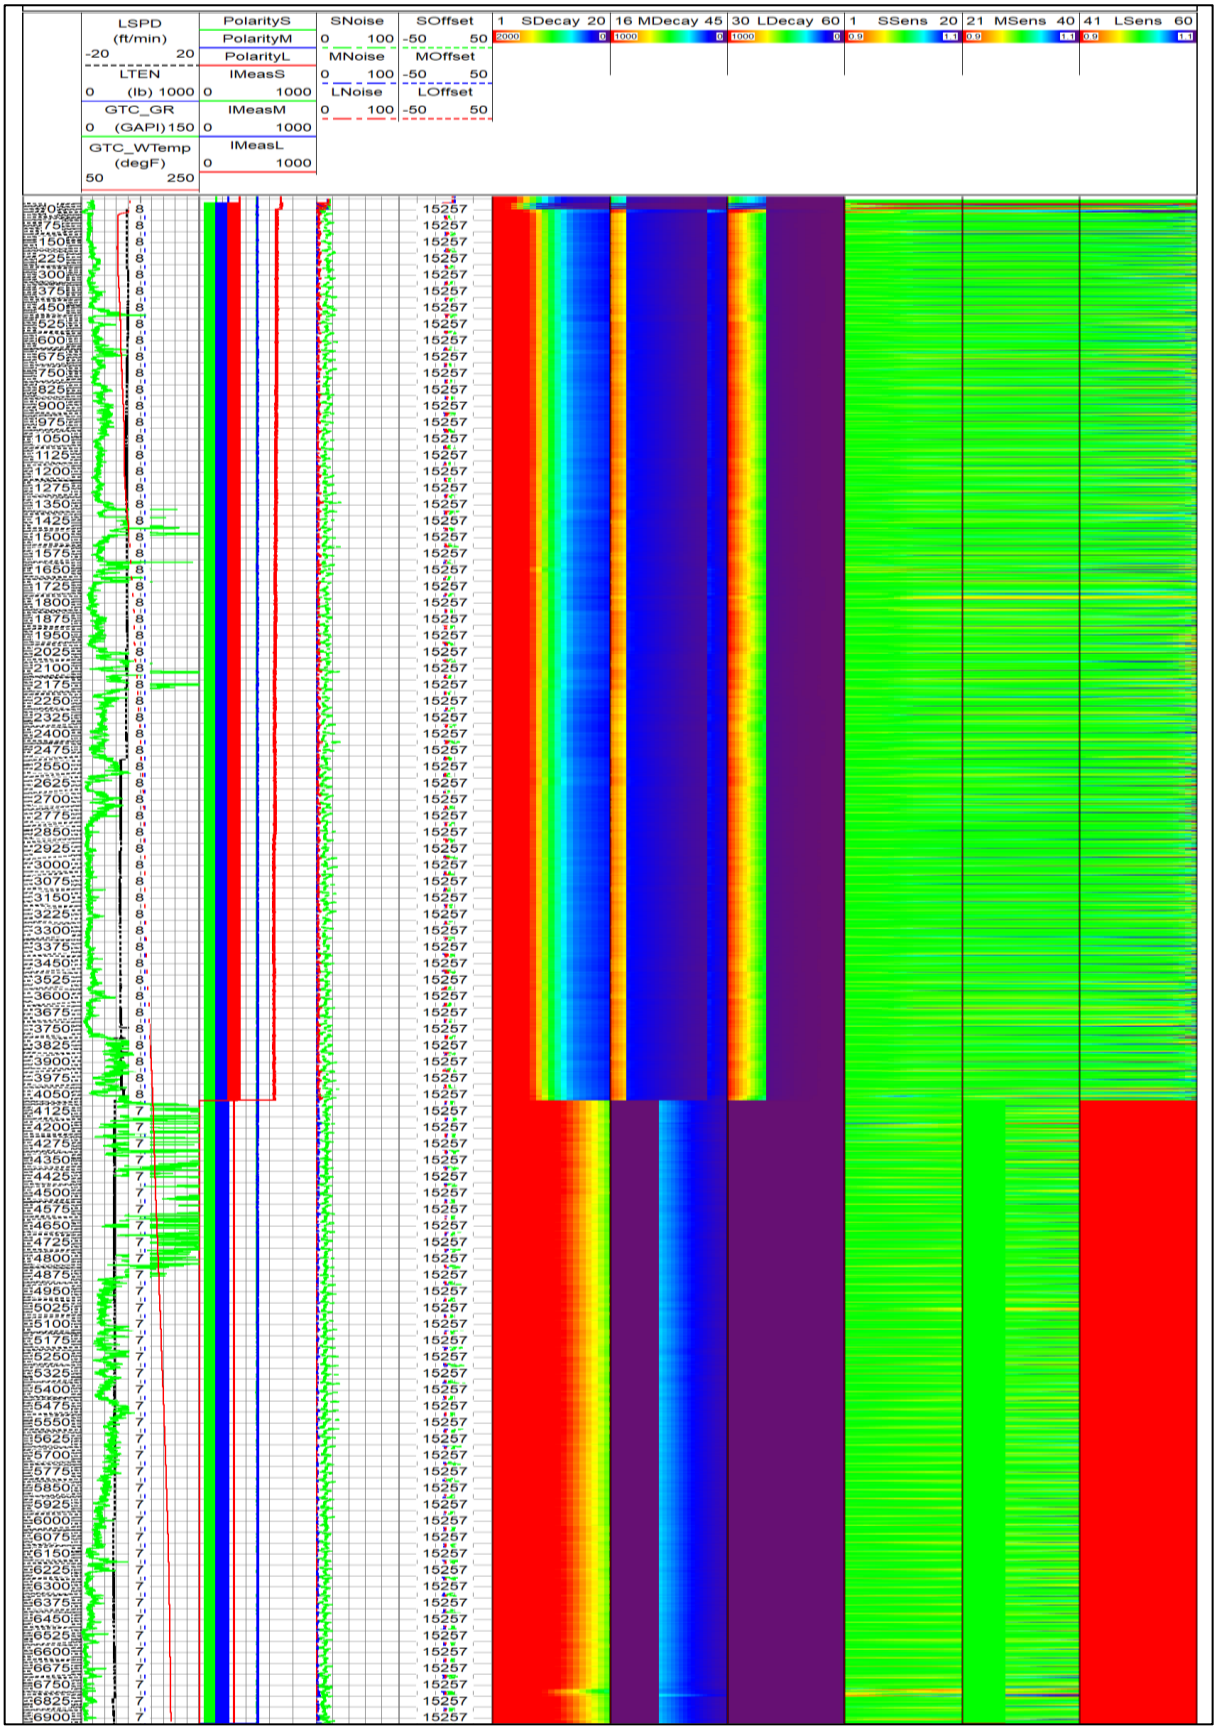
Figure 16 - Main Pass Quality Control

Quality control curves for the IL, IM and IS (long, medium, and short spacing coils currents) are within 700 mA and 500 mA.

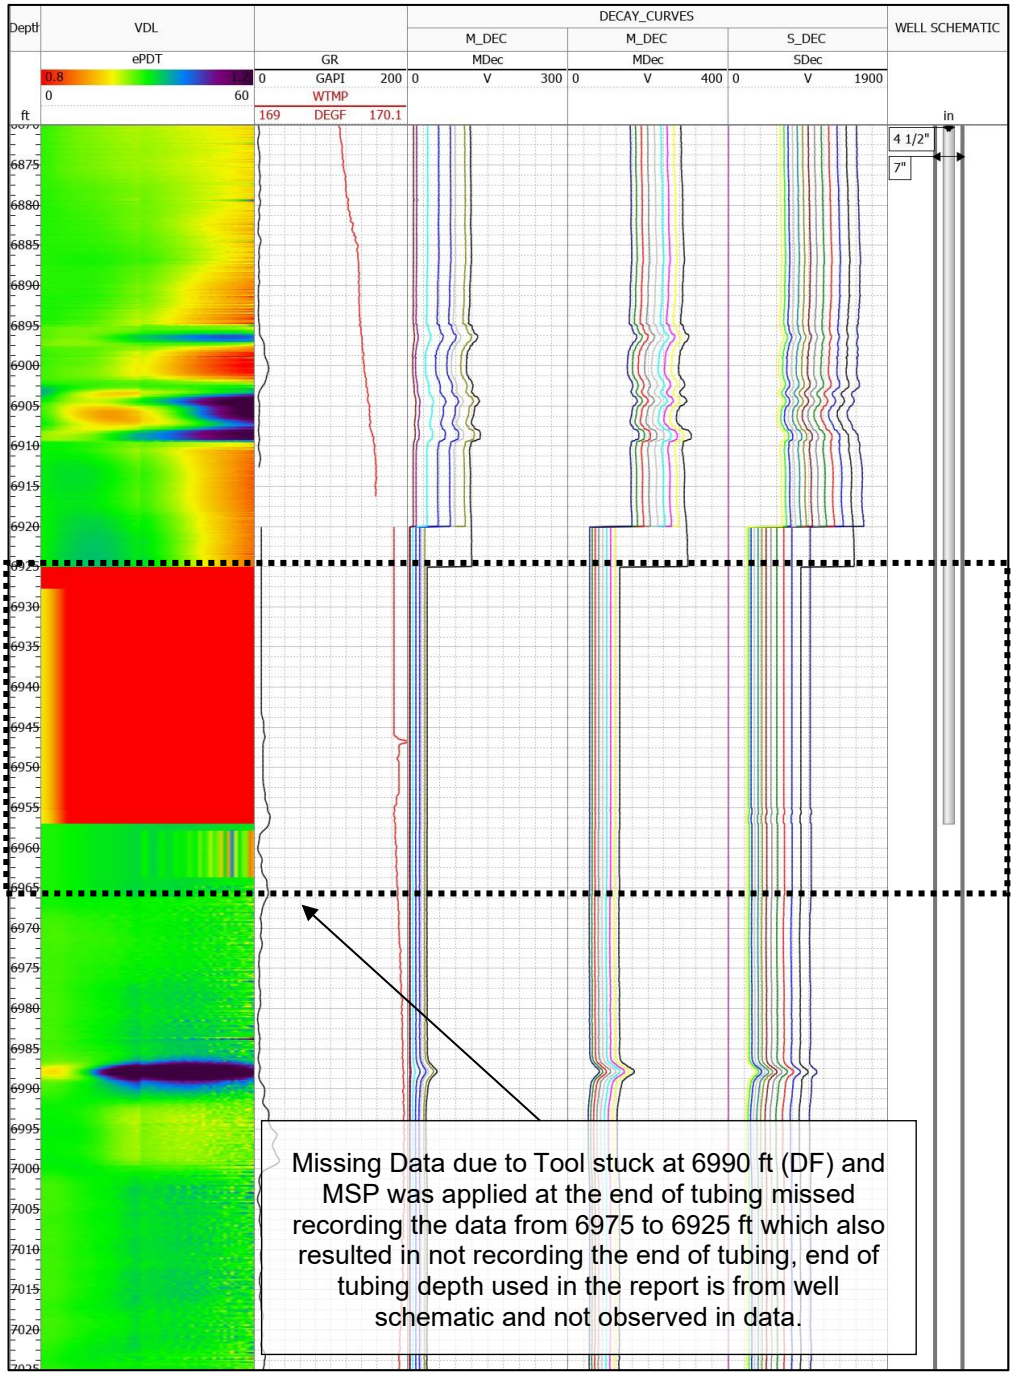
Figure 19 – Processing Observations

- Tool stuck at 6990 ft (DF) and MSP was applied at the end of tubing after PE approval. We went up and down multiple times on OH sections with different speeds (60, 80, 100, 140, 160 ft/min) which resulted in missing recording the data from 6975 to 6925 ft.
