Four Barriers Corrosion Evaluation

Company:	SAUDI ARAMCO
Well:	HRDH_1702_1
Field:	HARADH
Country:	SAUDI ARABIA
Log Date:	15-May-2026
Report Delivery Date:	22-May-2026

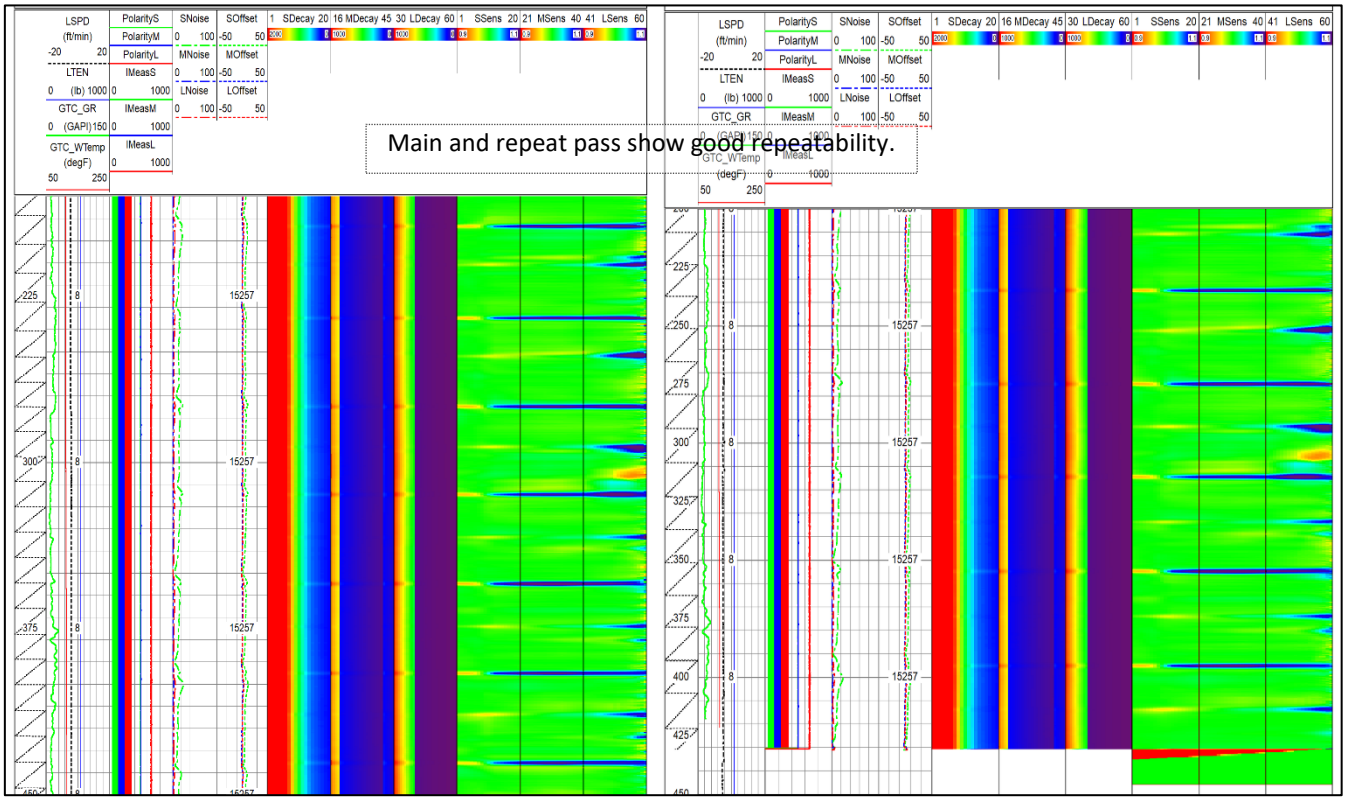
Figure 15 - Raw Data Repeatability

Quality control curves for the IL, IM and IS (long, medium, and short spacing coils currents) are within 700 mA and 500 mA.

- S, M, L polarities alternate from 0 - 1.
- Equivalent ADEC curves, with 60 channels, are derived from combining the curves of the three long, medium, and short coils.

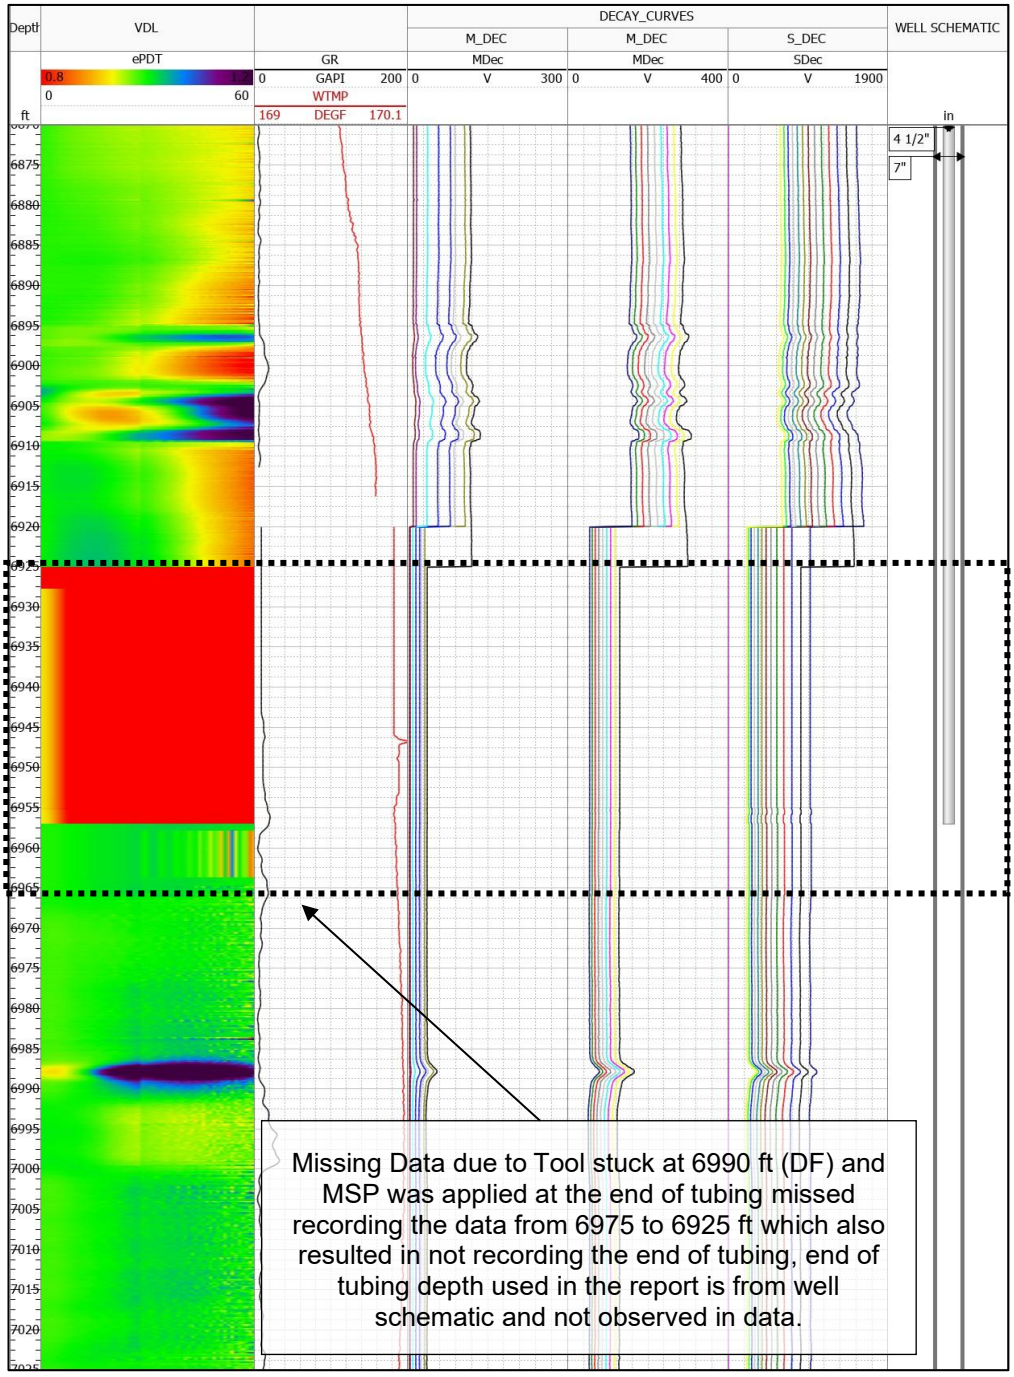
Figure 19 – Processing Observations

- Tool stuck at 6990 ft (DF) and MSP was applied at the end of tubing after PE approval. We went up and down multiple times on OH sections with different speeds (60, 80, 100, 140, 160 ft/min) which resulted in missing recording the data from 6975 to 6925 ft.
