Four Barriers Corrosion Evaluation

Company:	SAUDI ARAMCO
Well:	HRDH_1702_1
Field:	HARADH
Country:	SAUDI ARABIA
Log Date:	15-May-2026
Report Delivery Date:	22-May-2026

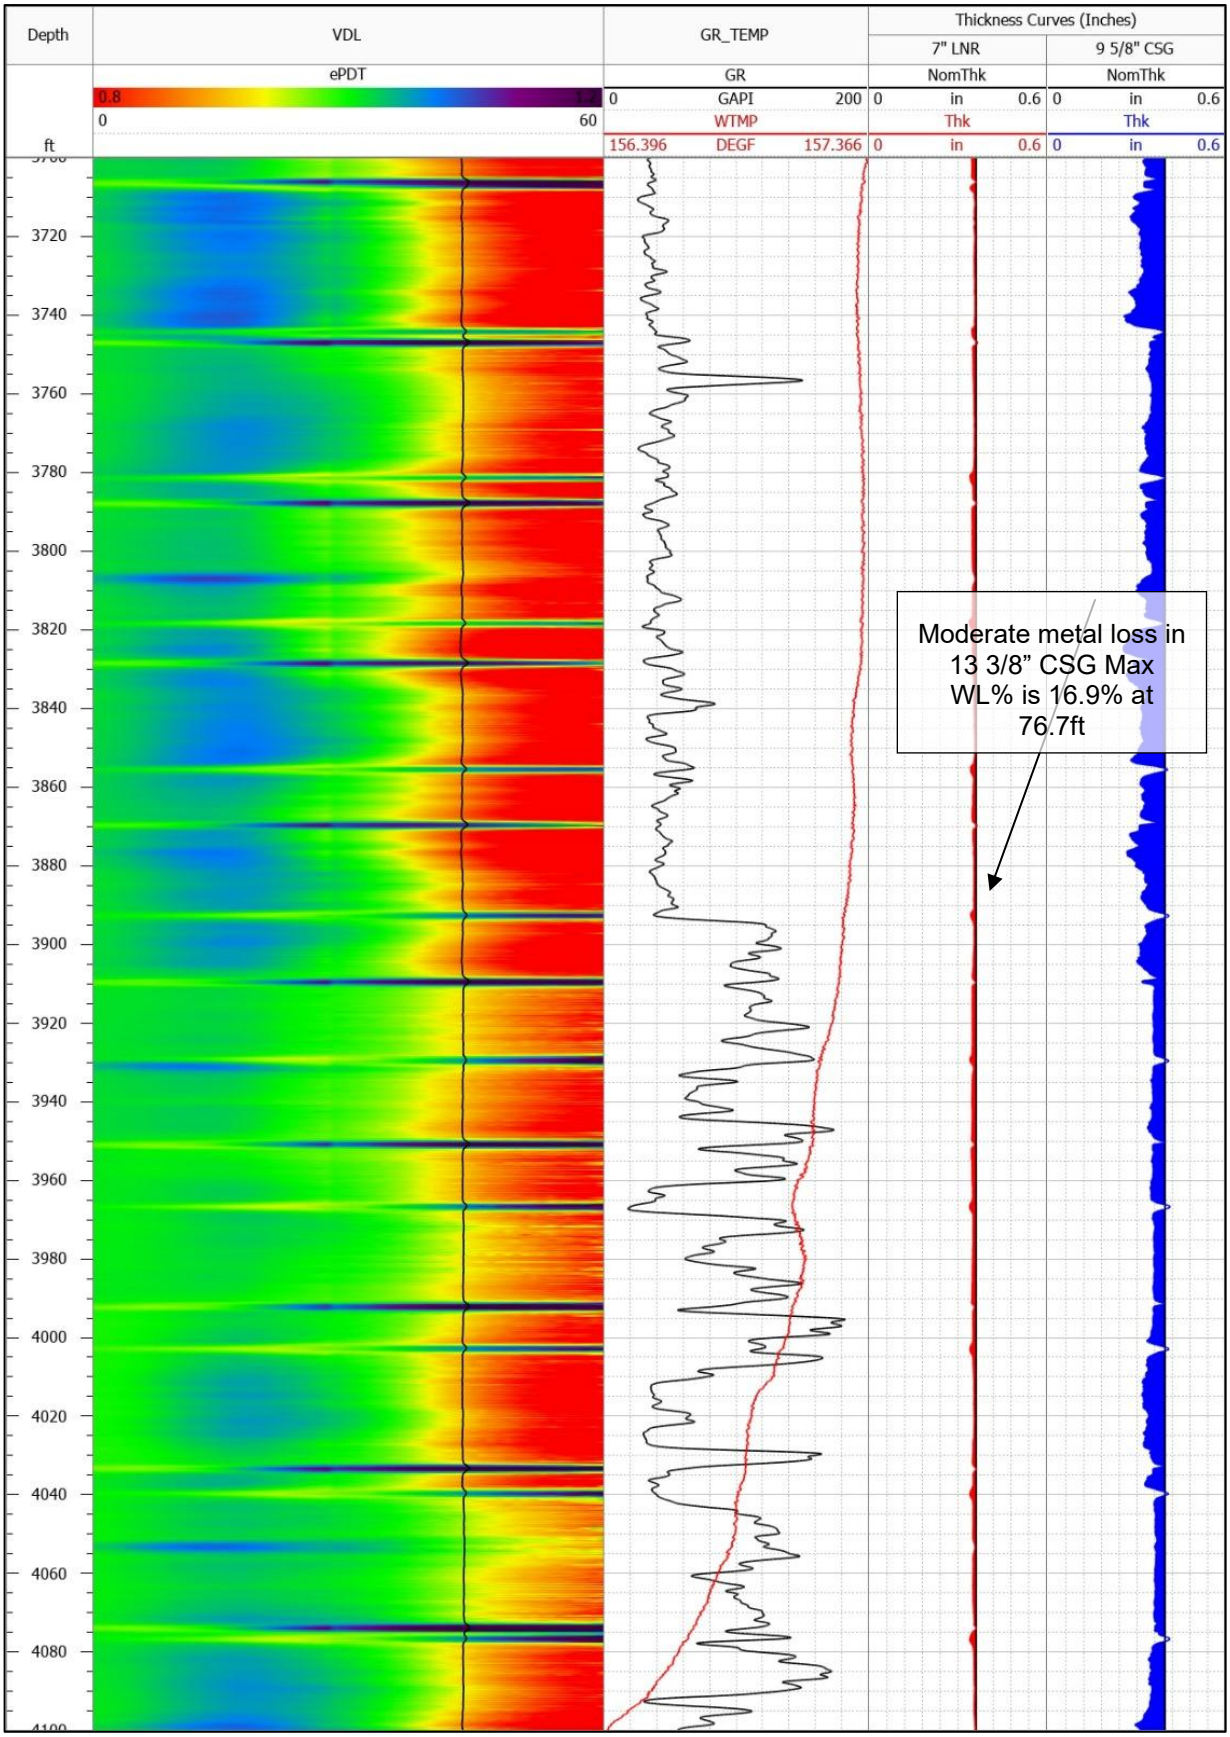
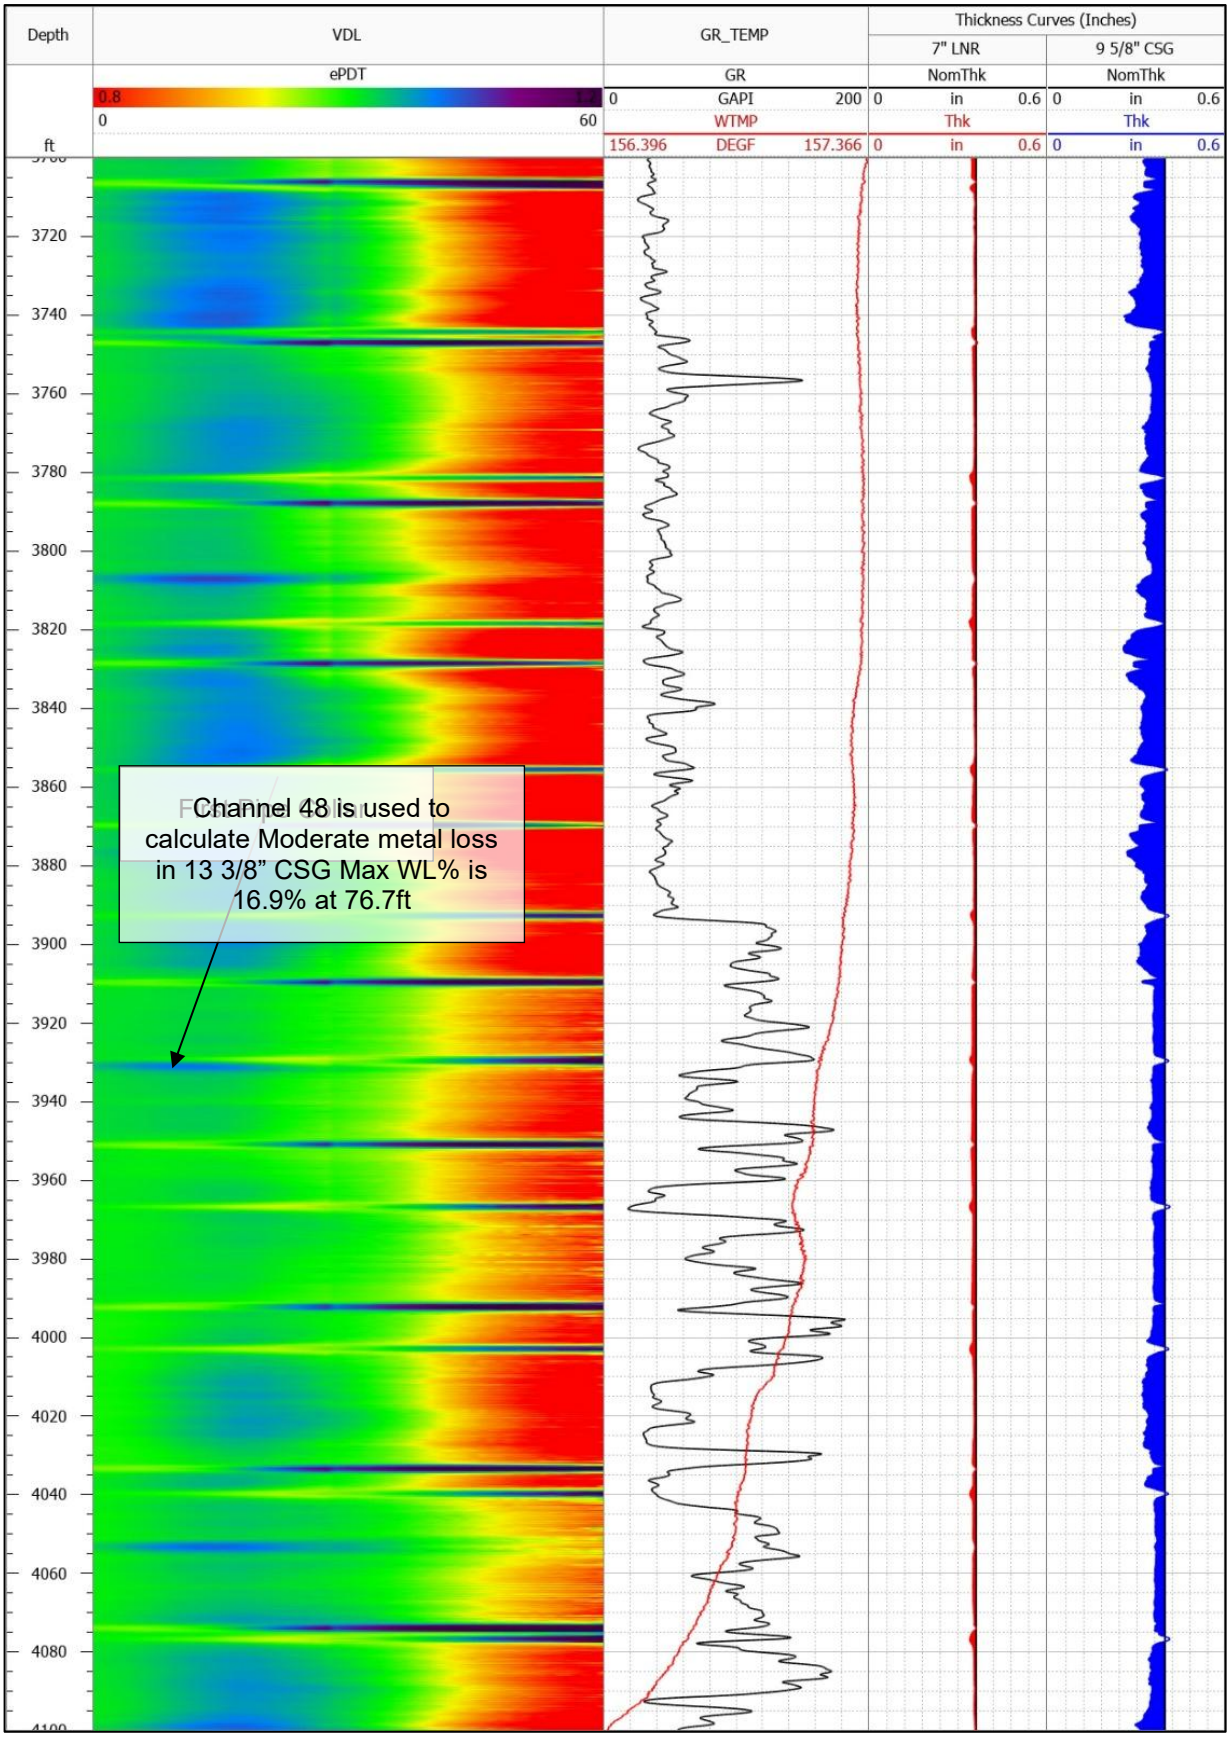
Figure 5 - Highest Metal Loss Channel Selection

Pipe OD	Max WL	Grade of Metal Loss	Hot Spot Depth (ft)
18 5/8" CSG	5.1%	B	18.3
10 3/4" CSG	6.2%	B	457.1
8 5/8" LNR	8.7%	B	1345.6
7 5/8" LNR	11.2%	C	4027.0
7" CSG	31.2%	D	4180.4
4 1/2" TBG	7.0%	B	4180.2
