Cause Analysis of Whole Vehicle NVH Performance Degradation under Idle Conditions

Keywords: Automotive NVH; Idle condition; Performance degradation

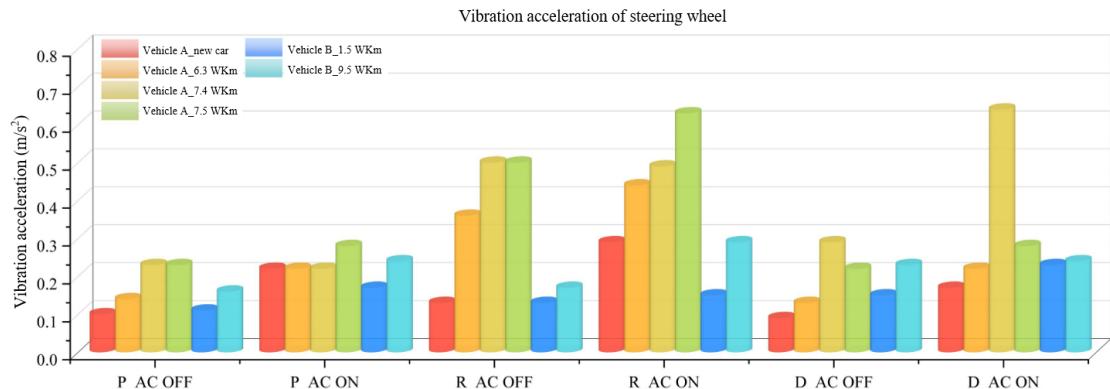
Figure 4. Vibration acceleration of steering wheel

As can be seen from Figure 4, with the increase in mileage, the vibration acceleration at the steering wheel measurement point of both Vehicle types A and B gradually increases, with Vehicle B's increase slightly less than Vehicle A; Vehicle A shows a significant increase in vibration acceleration at the R gear position of the steering wheel measurement point, with smaller changes in other gear positions. The vibration acceleration with the air conditioning on is significantly higher than when it is off.

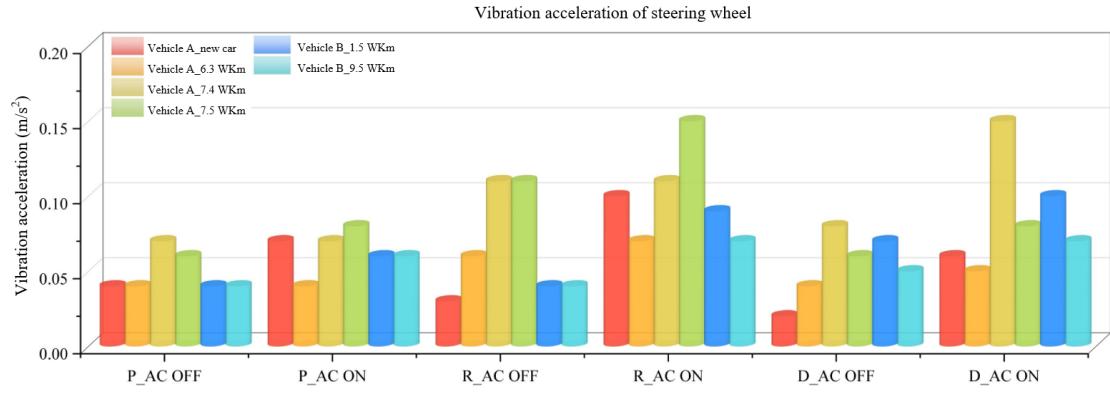
Figure 5. Seat rail vibration acceleration

As can be seen from Figures 4 and 5, with the increase in driving mileage, the vibration acceleration at both measurement points for Vehicles A and B gradually increases, with Vehicle B's increase slightly smaller than Vehicle A. Vehicle A shows a significant increase in vibration acceleration at the R gear position at the steering wheel measurement point, with smaller changes in other gear positions. The vibration acceleration with the air conditioning on is significantly greater than when it is off.

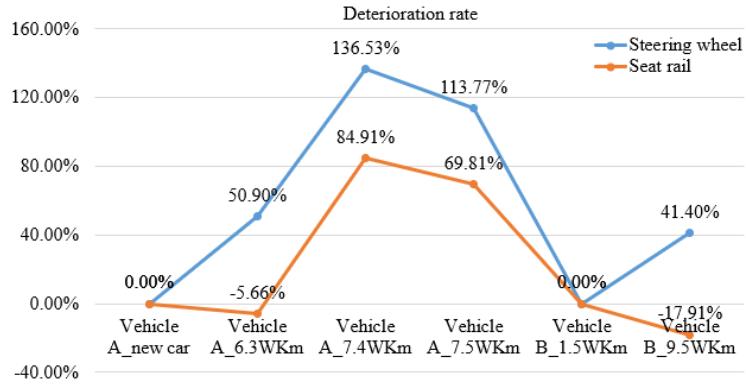
Figure 6. Trend of driver's sensory changes

As shown in Figure 6, by taking the average vibration value of each gear position for each vehicle and comparing the high mileage vehicles with the new car (Vehicle B model at 1.5 WKm), the changes in vibration amplitude at the two points can be seen more clearly.

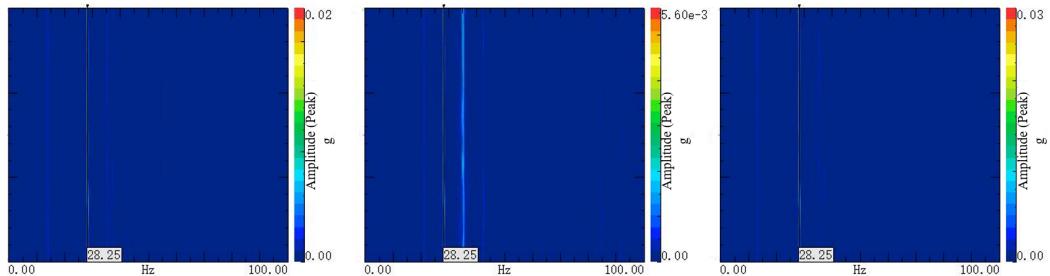
Figure 7. Vibration frequency domain analysis diagram

To explore the source of vibration excitation, we collected frequency domain data for vibrations at each point. The data were processed, marking the frequency of the highest vibration within 100Hz, as shown in Figure 7.

Note: Steering Wheel +X+Y+Z P Gear AC off (Sensor at steering wheel position, sensor X direction as the vehicle's +X direction, sensor Y direction as the vehicle's +Y direction, sensor Z direction as the vehicle's +Z direction, P gear, air conditioning system off)

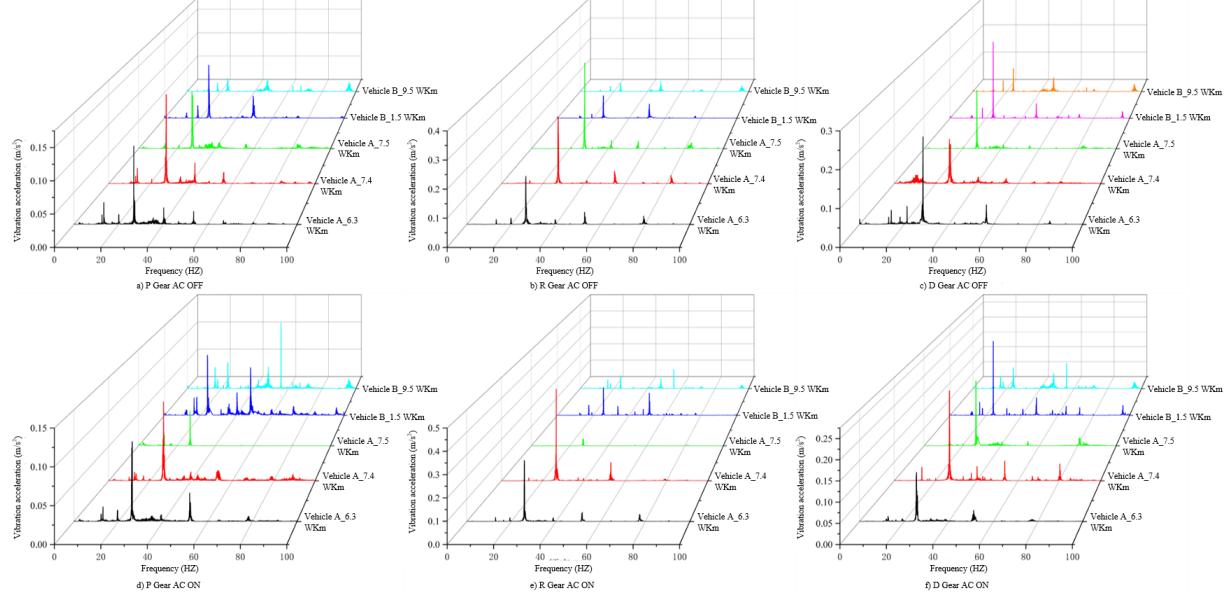
Figure 8. Steering wheel frequency spectrum

The vibration acceleration frequency spectrum analysis results of the steering wheel position are shown in Figure 8. It can be observed that under idle conditions, the frequencies with larger amplitudes are around 27 Hz and 42 Hz. The amplitude within this range shows a trend of being smallest in P gear and largest in R gear, with the amplitude slightly greater when the air conditioning is on compared to when it is off. The vibration acceleration frequency spectrum analysis results at the seat rail are shown in Figure 9. It can be seen that the frequency spectrum distribution is similar to that at the steering wheel, but with a smaller amplitude. The amplitude is generally smallest in P gear and largest in D gear.

Both vehicle models have an engine idle speed of 800 rpm, corresponding to a 2nd order engine vibration frequency of around 27 Hz. This indicates that the main source of vehicle vibration is the powertrain. Therefore, the next focus is the vibration magnitude and vibration isolation rate at the engine mounts.

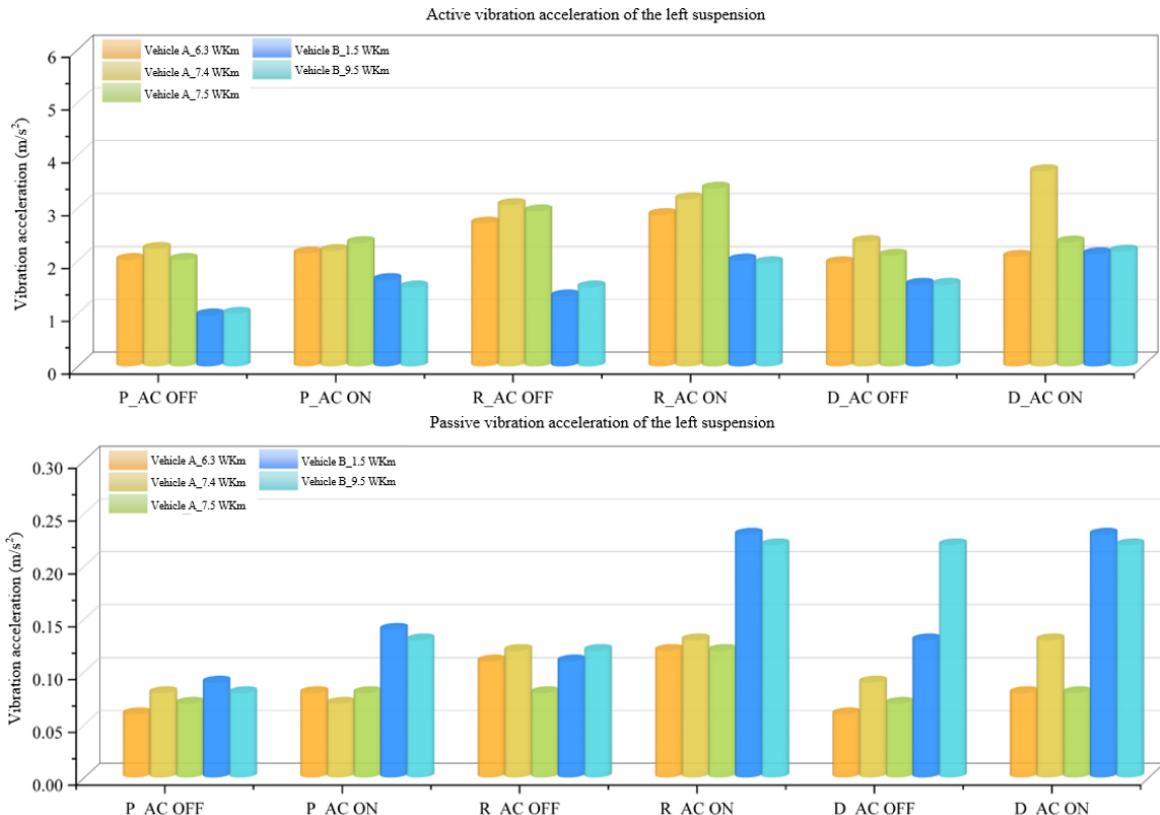
Figure 10. Vibration acceleration of the left suspension

Figures 10-12 show the comparison of vibration acceleration for the left, right, and rear suspensions respectively. It can be observed that as the mileage increases, the vibration magnitude at the active ends of each suspension point for both vehicle models increases. Therefore, it is believed that a significant reason for the decline in whole vehicle NVH performance is the intensification of engine vibration itself [18]. Analysis of the passive end data shows that the vibration magnitude at the passive end of Vehicle A is consistent with the trend at the active end, while Vehicle B maintains better passive end vibration relative to Vehicle A. It is speculated that the degradation of the rubber suspension in Vehicle A is greater than in Vehicle B. The following section will compare and analyze the isolation rates at each point.

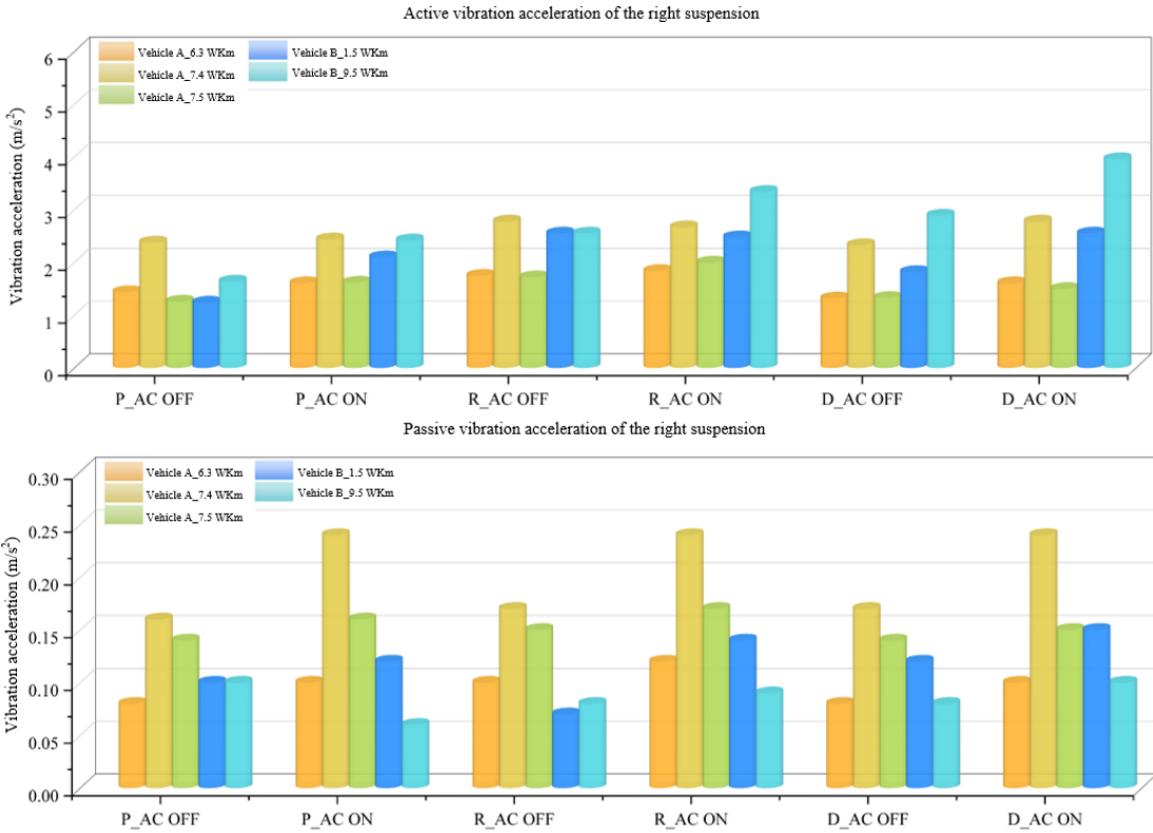
Figure 11. Vibration acceleration of the right suspension

Analysis from Figures 13-15 shows that the suspension vibration isolation performance of Vehicle B does not significantly degrade. Despite the increase in engine vibration due to higher mileage, the isolation rate of Vehicle B at 9.5 WKm even shows an increase. In contrast, Vehicle A exhibits a decrease in suspension isolation rate, especially noticeable in the right suspension.

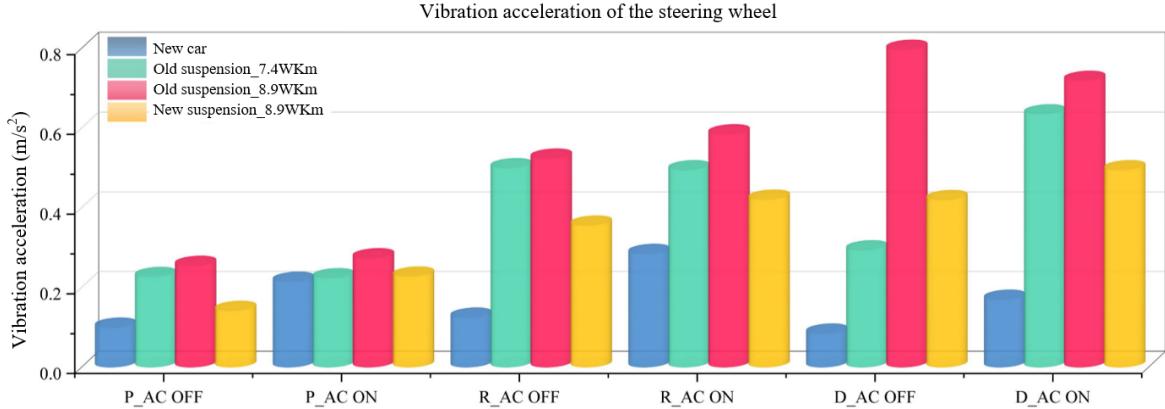
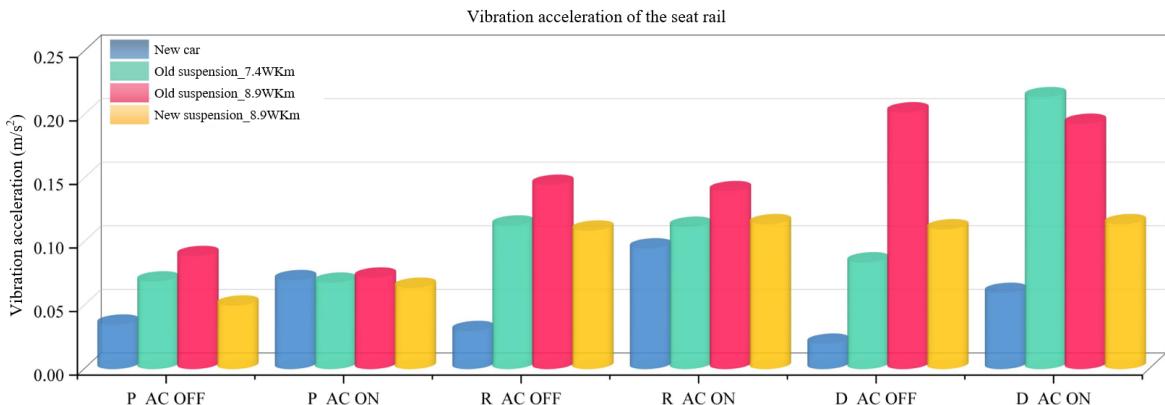
As can be seen from Figures 16 and 17, under P gear, the vibration condition at the steering wheel changes little. After replacing with new suspension at 8.9 WKm, the vibration acceleration values are close to the original factory

data. However, the changes in R and D gears are more significant, consistent with the previous text. When using the old suspension, the vibration acceleration at 8.9 WKm is slightly higher than at 7.4 WKm, but significantly decreases after replacing with the new suspension.

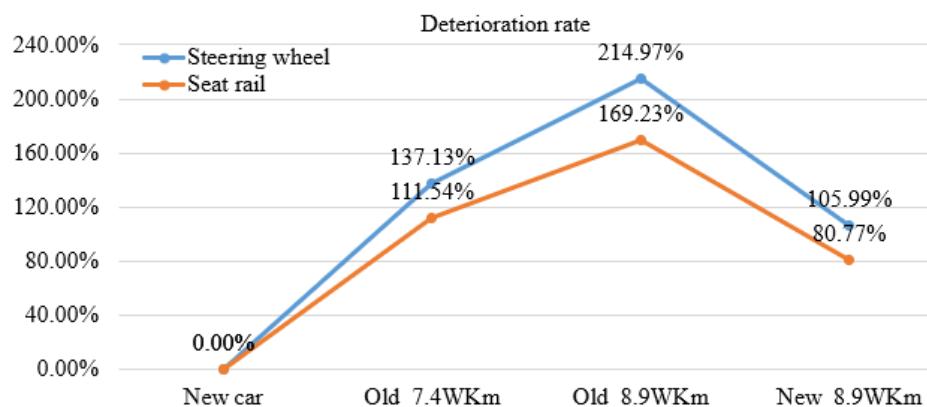
Figure 18. Trend of driver's sensory changes

Figure 18 shows the deterioration comparison of the steering wheel and seat rail when using the old and new suspensions.

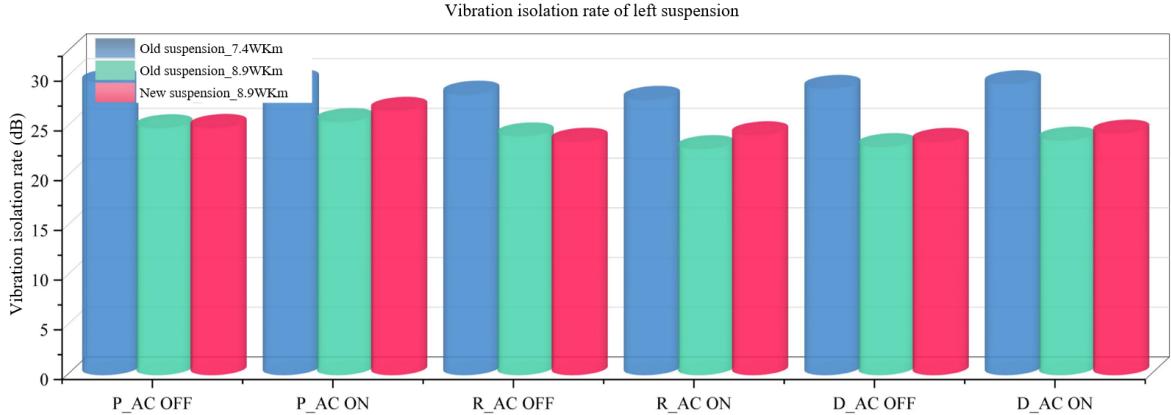
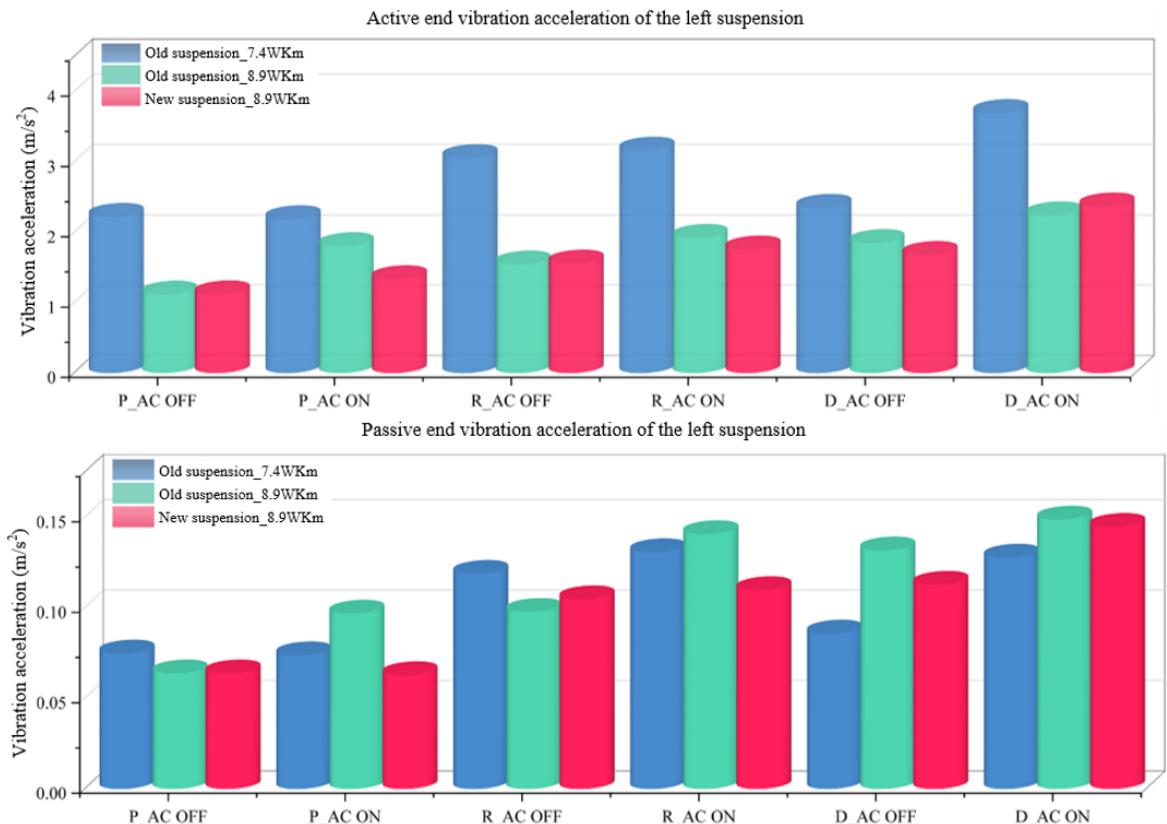
As shown in Figures 19 and 20, at the left suspension point, when using the old suspension, although the active end amplitude is clearly larger at 7.4 WKm than at 8.9 WKm, the passive end amplitude data at 8.9 WKm is slightly larger than at 7.4 WKm, and the isolation rate is also higher at 7.4 WKm than at 8.9 WKm. This indicates that the vibration isolation performance of the left suspension has already declined. After replacing with new suspension,

the isolation rate slightly increases, but since the active end amplitude is much lower than the 7.4 WKm state with old suspension, the isolation rate does not exceed it. However, the amplitude at the passive end is smaller with the new suspension.

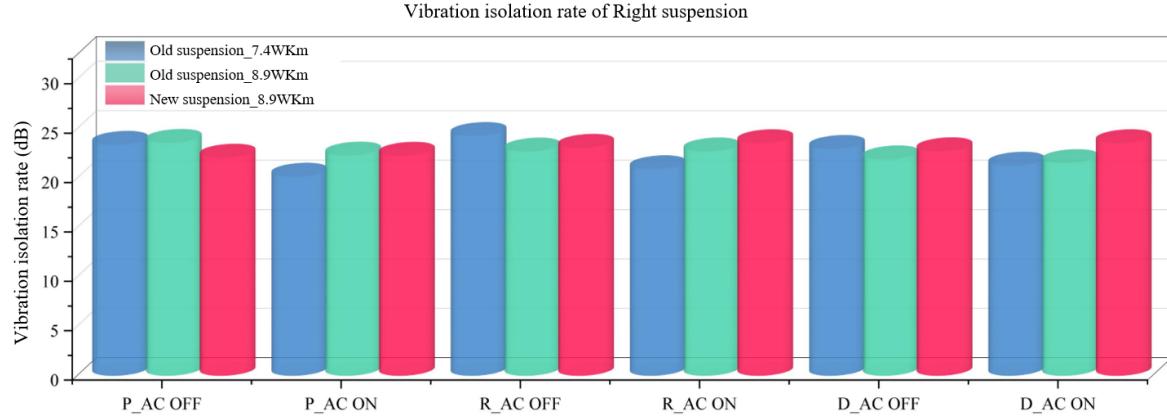
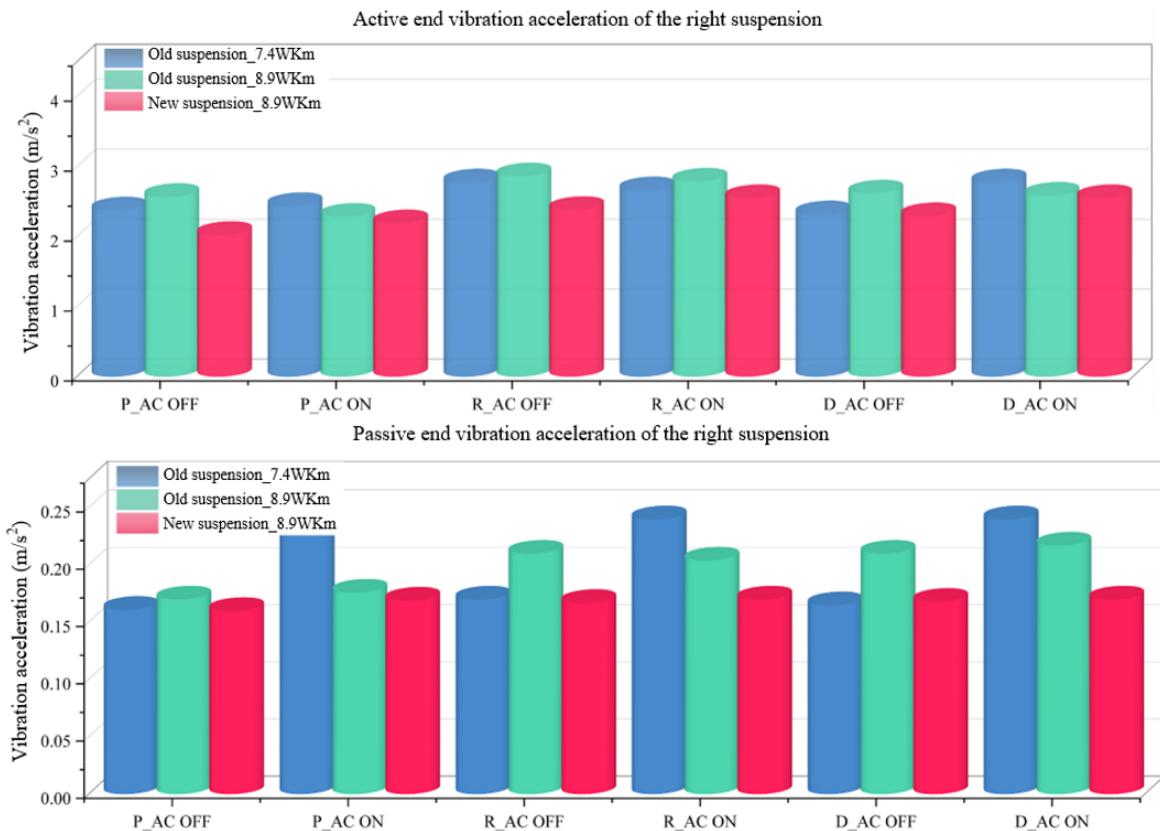
As shown in Figures 21 and 22, at the right suspension point, there is not much difference in the isolation rates between the three conditions. In terms of vibration, with the old suspension, the active end vibration acceleration at 8.9 WKm is greater than at 7.4 WKm, but the passive end values are close. After replacing with new suspension, vibration at both the active and passive ends significantly decreases, and the isolation rate is the best.

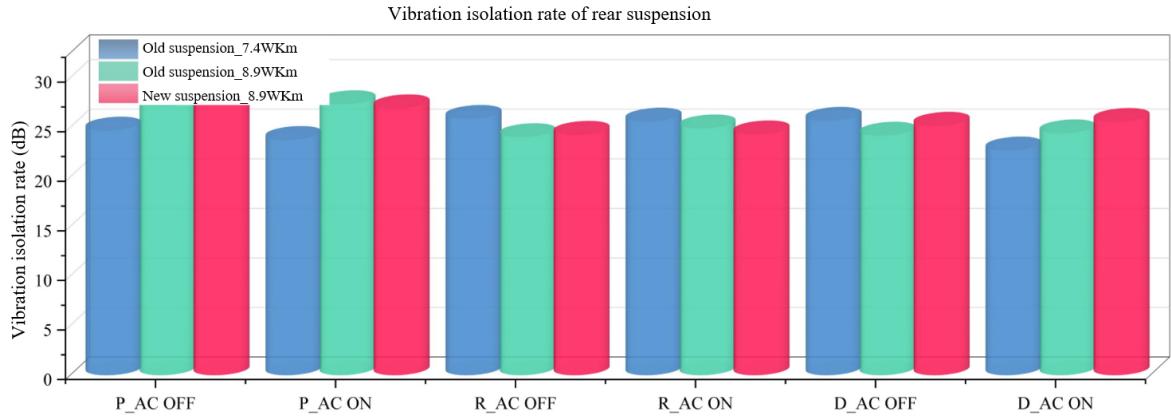
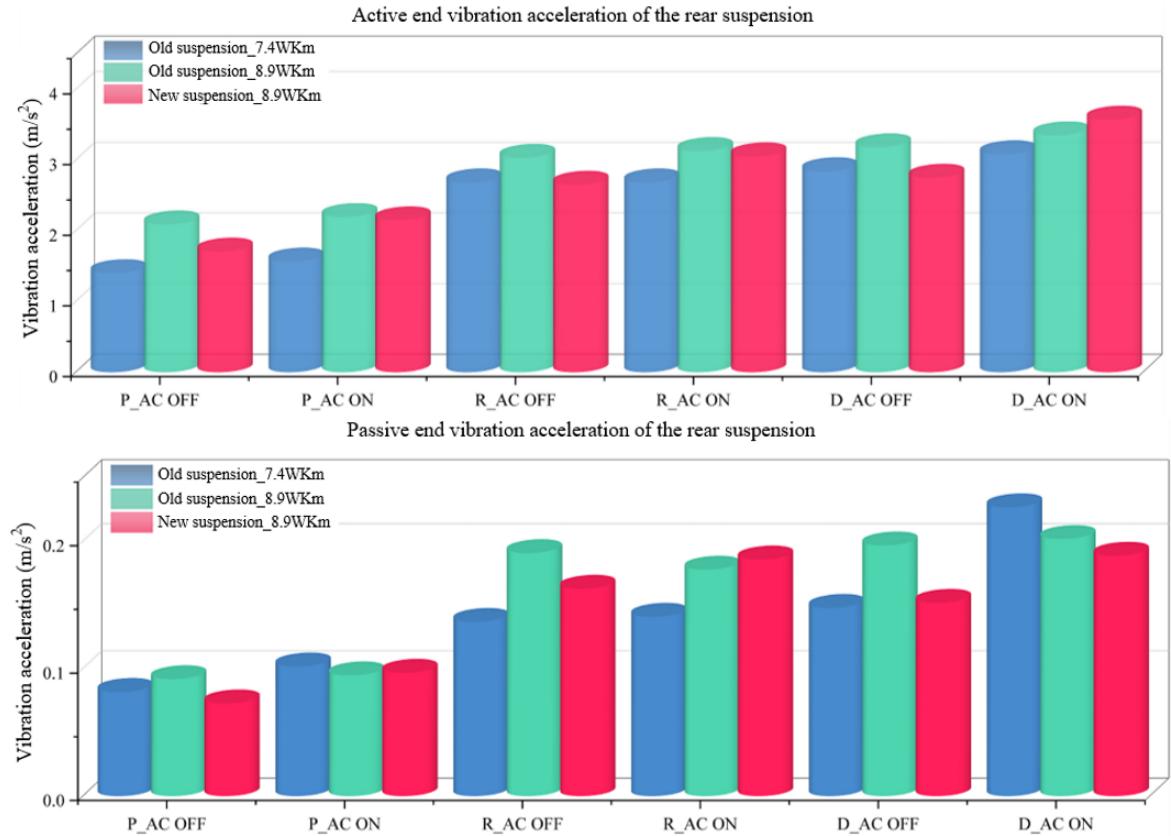
As seen in Figures 23 and 24, at the rear suspension point, the old suspension isolation rate at 8.9 WKm is higher than at 7.4 WKm, but still, the new suspension offers the best isolation rate. Analyzing the vibration at the active and passive ends reveals that, with the old suspension, the active end vibration at 8.9 WKm is greater than at 7.4 WKm. Although the isolation rate is better, the passive end vibration is still high. After replacing with new suspension, vibration at both the active and passive ends decreases.

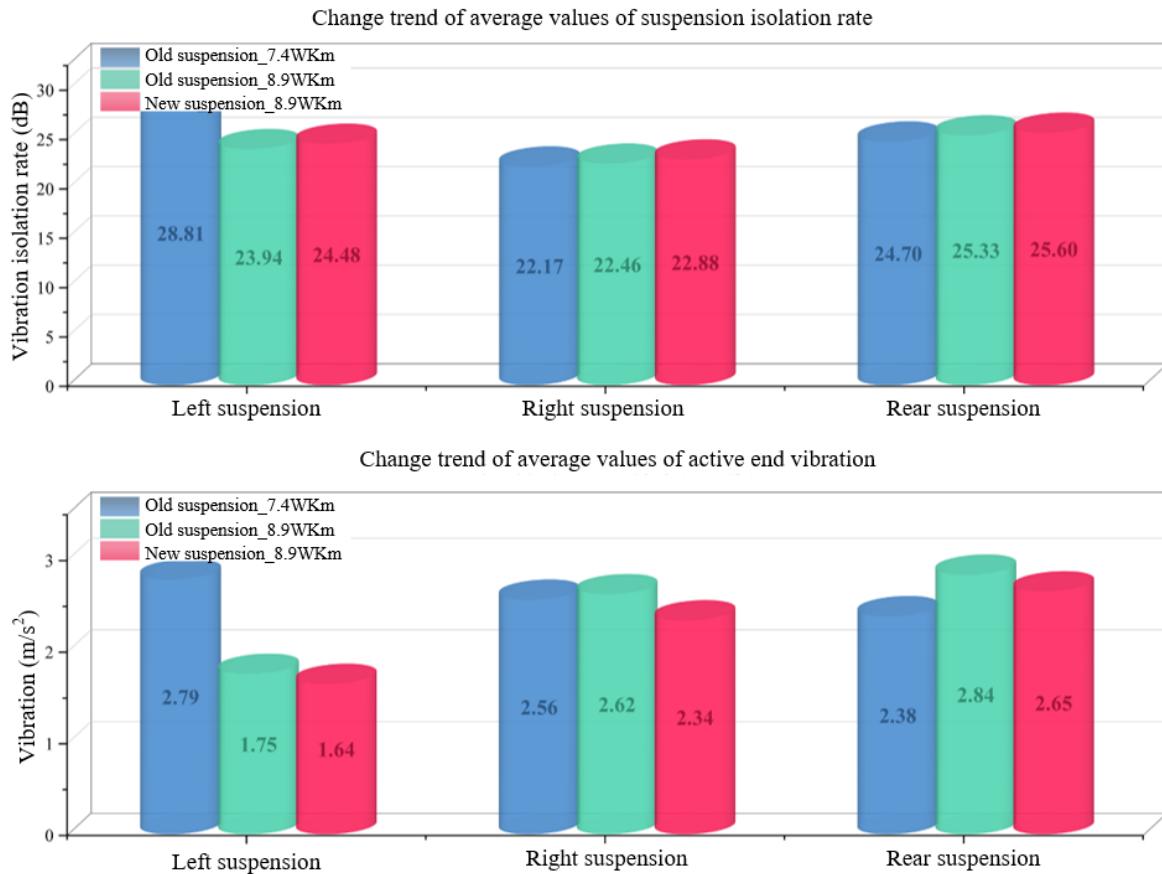
Figure 25. Change trends of average values of isolation rates and vibrations of suspensions

This paper summarizes the comparison of the average values of isolation rates and vibration at each suspension point when using old and new suspensions, as shown in Figure 25. It can be concluded that with the increase in vehicle mileage, the suspension isolation rate does not significantly decrease and may even increase due to the increase in active end vibration. However, after replacing with new suspension, there is a significant decrease in active end vibration, and the isolation rate is also better.

(3) Through follow-up tests on the same vehicle and tests with new suspension replacements, it is concluded that the deterioration of the vehicle's NVH performance is due to two factors: increased engine vibration and degradation of rubber suspension performance.

(2) Optimize the vibration isolation and durability performance of the suspension rubber blocks to prevent performance degradation over long-term use.
