123 River Street

Owner Example, Pat
NFIP Community 399990 Exampleville, City of
Date of Assessment 09/21/2026

Percent Damaged
75.0%
Substantially Damaged

400 Front Street

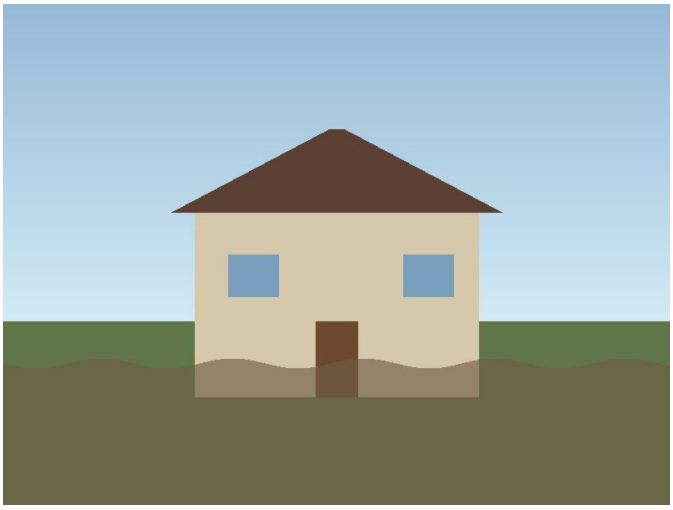
Year of Construction	1962	Cause of Damage	Flood
Date of Damage	09/14/2026	Duration of Flood	2 Days
Residence Type	Single Family Residence	Structure Type	Residential
Foundation	Crawlspace	Exterior Finish	Siding or Stucco (Standard)
Superstructure	Stud-framed (Standard)	HVAC	Heating and/or Cooling
Roofing	Shingles - Asphalt, Wood (Standard)	Story	One Story (Standard)
Quality	Good	Flood Elevation	490.75
Date of Assessment	09/21/2026	Est. Depth of Flood Above Lowest Floor	4.25
Inspector Name	Inspector A	NFIP Community ID	399990
Inspector Phone	(555) 555-0100		
Residence Information	Brick ranch, attached one-car garage.

Element	Percent Damaged	Element Percentage	Element Cost	Damage Values
Foundation	10.0%	9.0%	$15,339.09	$1,533.91
Superstructure	20.0%	16.4%	$27,951.24	$5,590.25
Roof Covering	0.0%	4.3%	$7,328.68	$0.00
Exterior Finish	35.0%	6.9%	$11,759.97	$4,115.99
Interior Finish	90.0%	13.0%	$22,156.47	$19,940.82
Doors and Windows	60.0%	15.5%	$26,417.33	$15,850.40
Cabinets and Countertops	100.0%	4.4%	$7,499.11	$7,499.11
Floor Finish	100.0%	7.7%	$13,123.45	$13,123.45
Plumbing	50.0%	8.4%	$14,316.49	$7,158.24
Electrical	70.0%	4.8%	$8,180.85	$5,726.60
Appliances	100.0%	4.1%	$6,987.81	$6,987.81
HVAC	100.0%	5.5%	$9,373.89	$9,373.89
		100%	Total Replacement Cost	Total Estimated Damages
			$170,434.38	**$96,900.46**

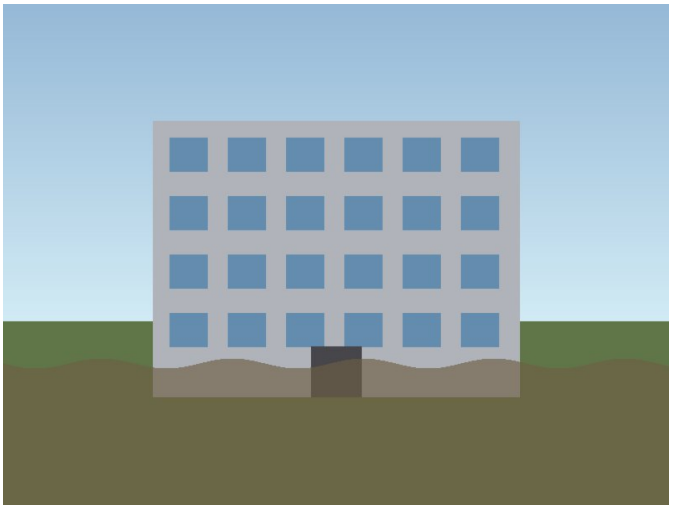
(Default Image)

Basis for Value of Structure	Percent Damaged	Basis for Cost of Repairs
Computed Actual Cash Value	**75.0%** **Substantially Damaged**	Computed Damages

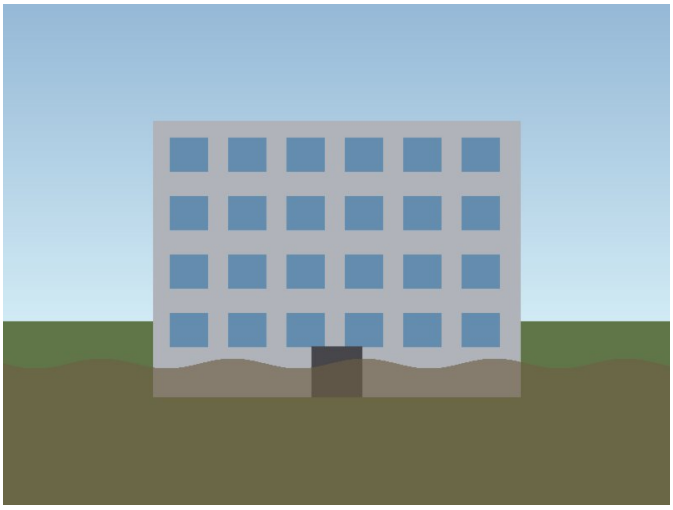
Percent Damaged
51.6%
Substantially Damaged

Year of Construction	1978	Cause of Damage	Flood
Date of Damage	09/14/2026	Duration of Flood	3 Days
Number Of Stories	2 thru 4	Structure Use	Office Building
Sprinkler	Yes	Structure Type	Non-Residential
Conveyance	No	Flood Elevation	
Quality	Good	Est. Depth of Flood Above Lowest Floor	2.50
Date of Assessment	09/22/2026	NFIP Community ID	399990
Inspector Name	R. Inspector		
Inspector Phone			
Structure Information	Three-story steel frame office.

Element	Percent Damaged	Element Percentage	Element Cost	Damage Values
Foundation	5.0%	3.7%	$68,501.80	$3,425.09
Superstructure	10.0%	30.8%	$570,231.20	$57,023.12
Roof Covering	0.0%	1.9%	$35,176.60	$0.00
Plumbing	40.0%	4.7%	$87,015.80	$34,806.32
Electrical	45.0%	26.2%	$485,066.80	$218,280.06
HVAC	60.0%	11.2%	$207,356.80	$124,414.08
Interiors	55.0%	21.5%	$398,051.00	$218,928.05
		100%	Total Replacement Cost	Total Estimated Damages
			$1,851,400.00	**$656,876.72**
