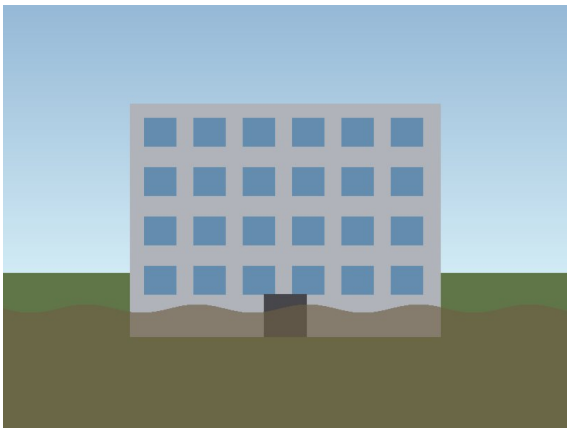
# 400 Front Street

**Percent Damaged**
**51.6%**
**Substantially Damaged**

Basis for Cost of Repairs
**$656,876.72**
Computed Damages
