## KENYA RURAL ROADS AUTHORITY

Ref: KeRRA/16/1/LVSR/RWC150/RE-02/VOL.1/37A

## <u>UPGRADING TO BITUMEN STANDARDS AND PERFORMANCE BASED ROUTINE</u> MAINTENANCE OF CHOGORIA WERU-KIRIANI ROAD; CONTRACT NO.RWC 150.

## REF: UNDEFINED DRAINAGE AND BLOCKED ACCESS CULVERTS

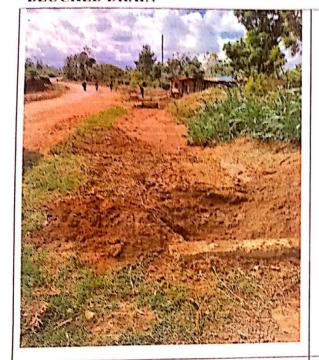
KM.3+279 LHS

This office has noted with concern the high level of siltation on our drainage system due to the ongoing rains. This is in particular for the section at Km 3+200 L.H.S & R.H.S along the Marima-Kiriani road, where the culverts are completely silted and as a result, the water has overtopped the culverts and ended up in the adjacent residence making life unbearable for the occupants. (*Photos attached*)

## BLOCKED DRAIN

- 1. To define the affected drains and channel the water to the culverts.
- 2. To open up all silted drains and blocked access culverts.

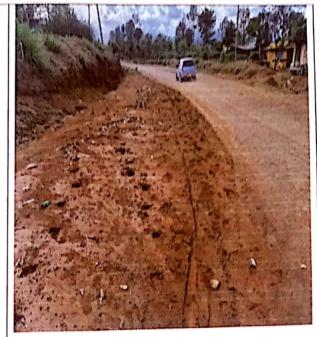
KM.3+200 RHS

Further to this, the drain before the culvert at Km 3+200 R.H.S is undefined resulting in rainwater crossing our road from the R.H.S to the L.H.S at that particular section.
