ÇALIŞMA SAYFASI/STUDY PAGE

Yapılan İş/Work Accomplished	Tarih/Date
Cessna 310 overview- Wings and Engines	05.10.2023 / Thursday
<i>The Cessna 310 is a twin-engine, low-wing general aviation aircraft manufactured by the Cessna Aircraft Company. Introduced in 1954, the 310 quickly became one of the most popular light twin-engine aircraft of its time and has remained a favorite among pilots and owners for its versatility, reliability, and performance.</i> ➤ Twin-Engine Configuration checked <i>The Cessna 310 has a twin-engine configuration, usually powered by piston engines. This design provides redundancy and increases security; this makes it suitable for long-range flights and various mission profiles.</i> ➤ Low-Wing Configuration checked <i>With its low-wing configuration, the 310 offers enhanced stability and aerodynamics efficiency. This design also allows for easy access to the cabin and baggage compartments.</i> <i>By closely examining the wing structure and engine structure on the aircraft, both theoretical and practical information about the aircraft was obtained.</i>

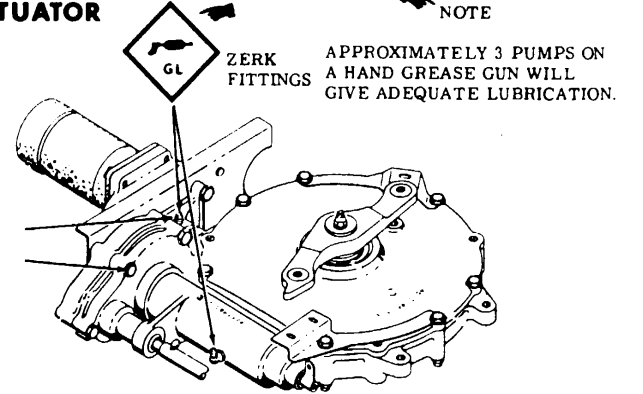
LANDING GEAR ACTUATOR GEAR BOX

*Landing Gear Actuator, Gear Box, Cessna Model 310P, 310Q Service Manual.

- Removed bolts to prevent breaking seal. Reinstalled when finished greasing.
- After lubrication, wiped off excess lubricant on the crank handle.
- Wiped chain with a clean dry cloth.

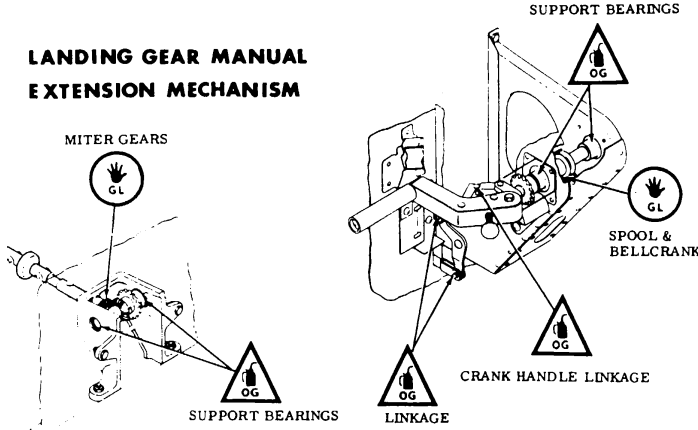
LANDING GEAR MANUAL EXTENSION MECHANISM

*Landing Gear, Extension Mechanism, Cessna Model 310P, 310Q Service Manual.

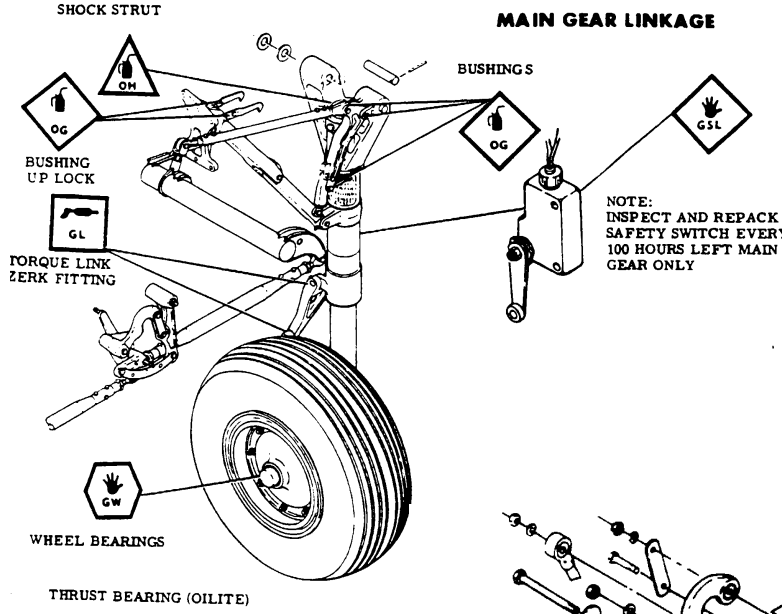
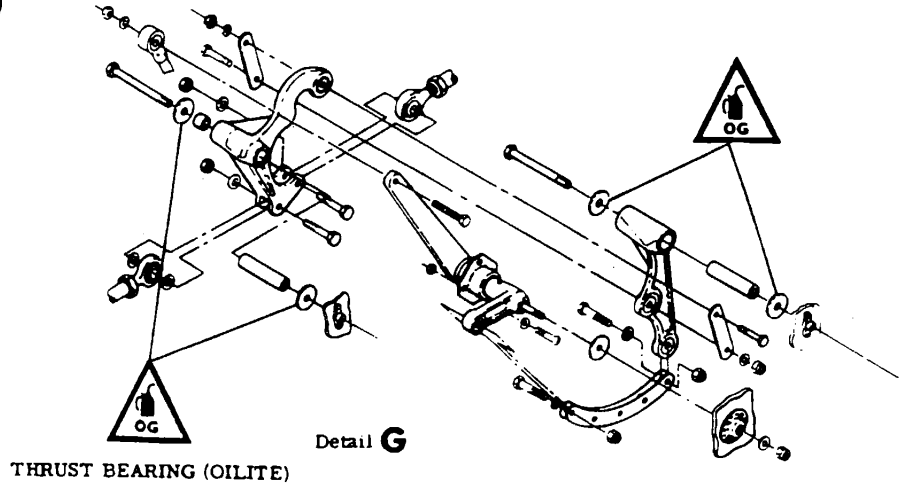
*Landing Gear , Main Gear Linkage,
Cessna Model 310P, 310Q Service
Manual.

- Lubricated all spherical rod ends with low temperature aircraft lubricating grease.
- Wiped polished surface of landing gear shock strut with a clean dry clothes.
- Cleaned wheel bearings.

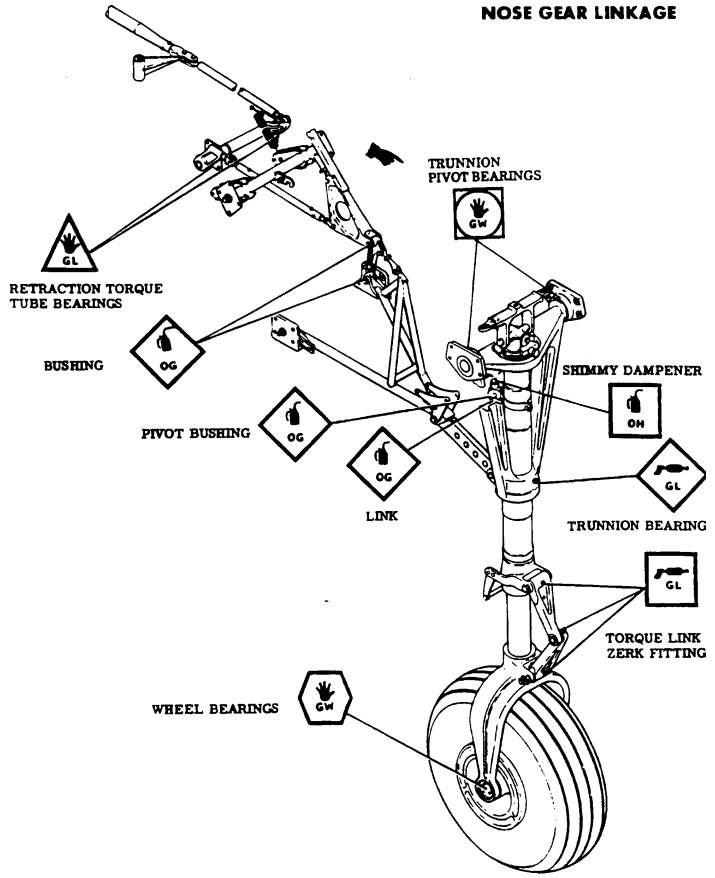
*Landing Gear , Nose Gear Linkage, Cessna Model 310P, 310Q Service Manual.

Yapılan İş/Work Accomplished	Tarih/Date
Cessna 310 - Lubrication Diagram-Landing Gear	26.10.2023 / Thursday
➤ Lubricated all spherical rod ends with low temperature aircraft lubricating grease. ➤ Wiped the polished surface of landing gear shock strut with a clean dry cloth. ➤ Cleaned wheel bearings.  The diagram illustrates the nose gear linkage assembly of a Cessna 310P/310Q. It shows the main strut, torque tube, and various linkages. Lubrication points are marked with icons: a triangle with 'GL' for grease, a diamond with 'OG' for oil, and a hexagon with 'GW' for grease. Specific components labeled include: RETRACTION TORQUE TUBE BEARINGS, BUSHING, PIVOT BUSHING, LINK, TRUNNION PIVOT BEARINGS, SHIMMY DAMPENER, TRUNNION BEARING, TORQUE LINK ZERK FITTING, and WHEEL BEARINGS. A 'Detail H' label is present near the wheel assembly.

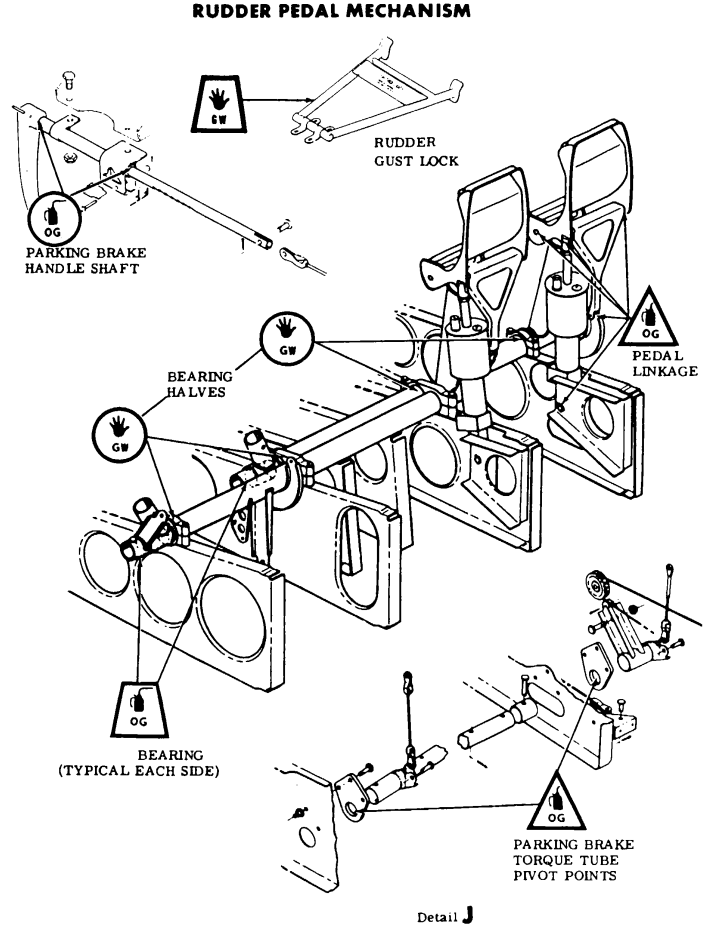
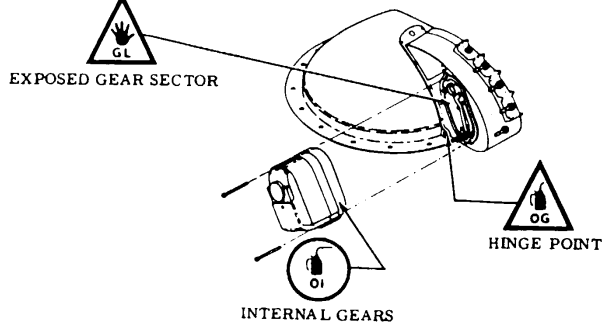
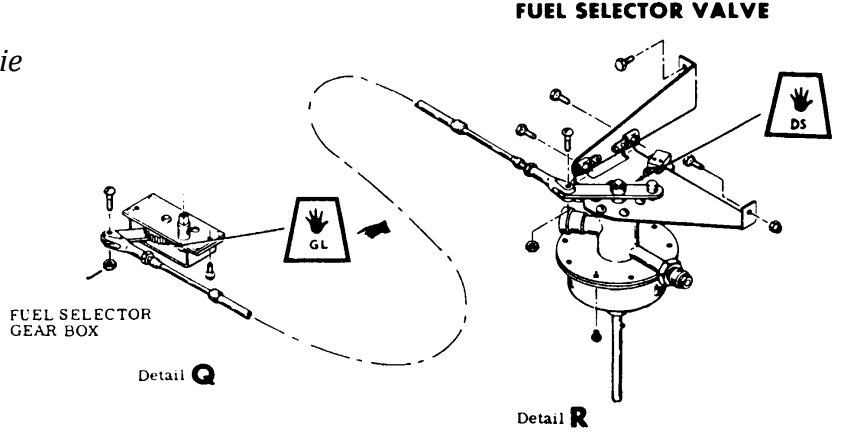
*Rudder, Rudder Pedal Mechanism, Cessna Model 310P, 310Q Service Manual.

- After lubricating, actuated the rudder pedals and parking brake several times to ensure separate lubricant and wiped out any oil on the rudder pedals.
