Victa

SERVICE BULLETIN NO. 13

SUBJECT: Redesigned tailplane to fuselage attachment fittings. MOD. NO. B.53

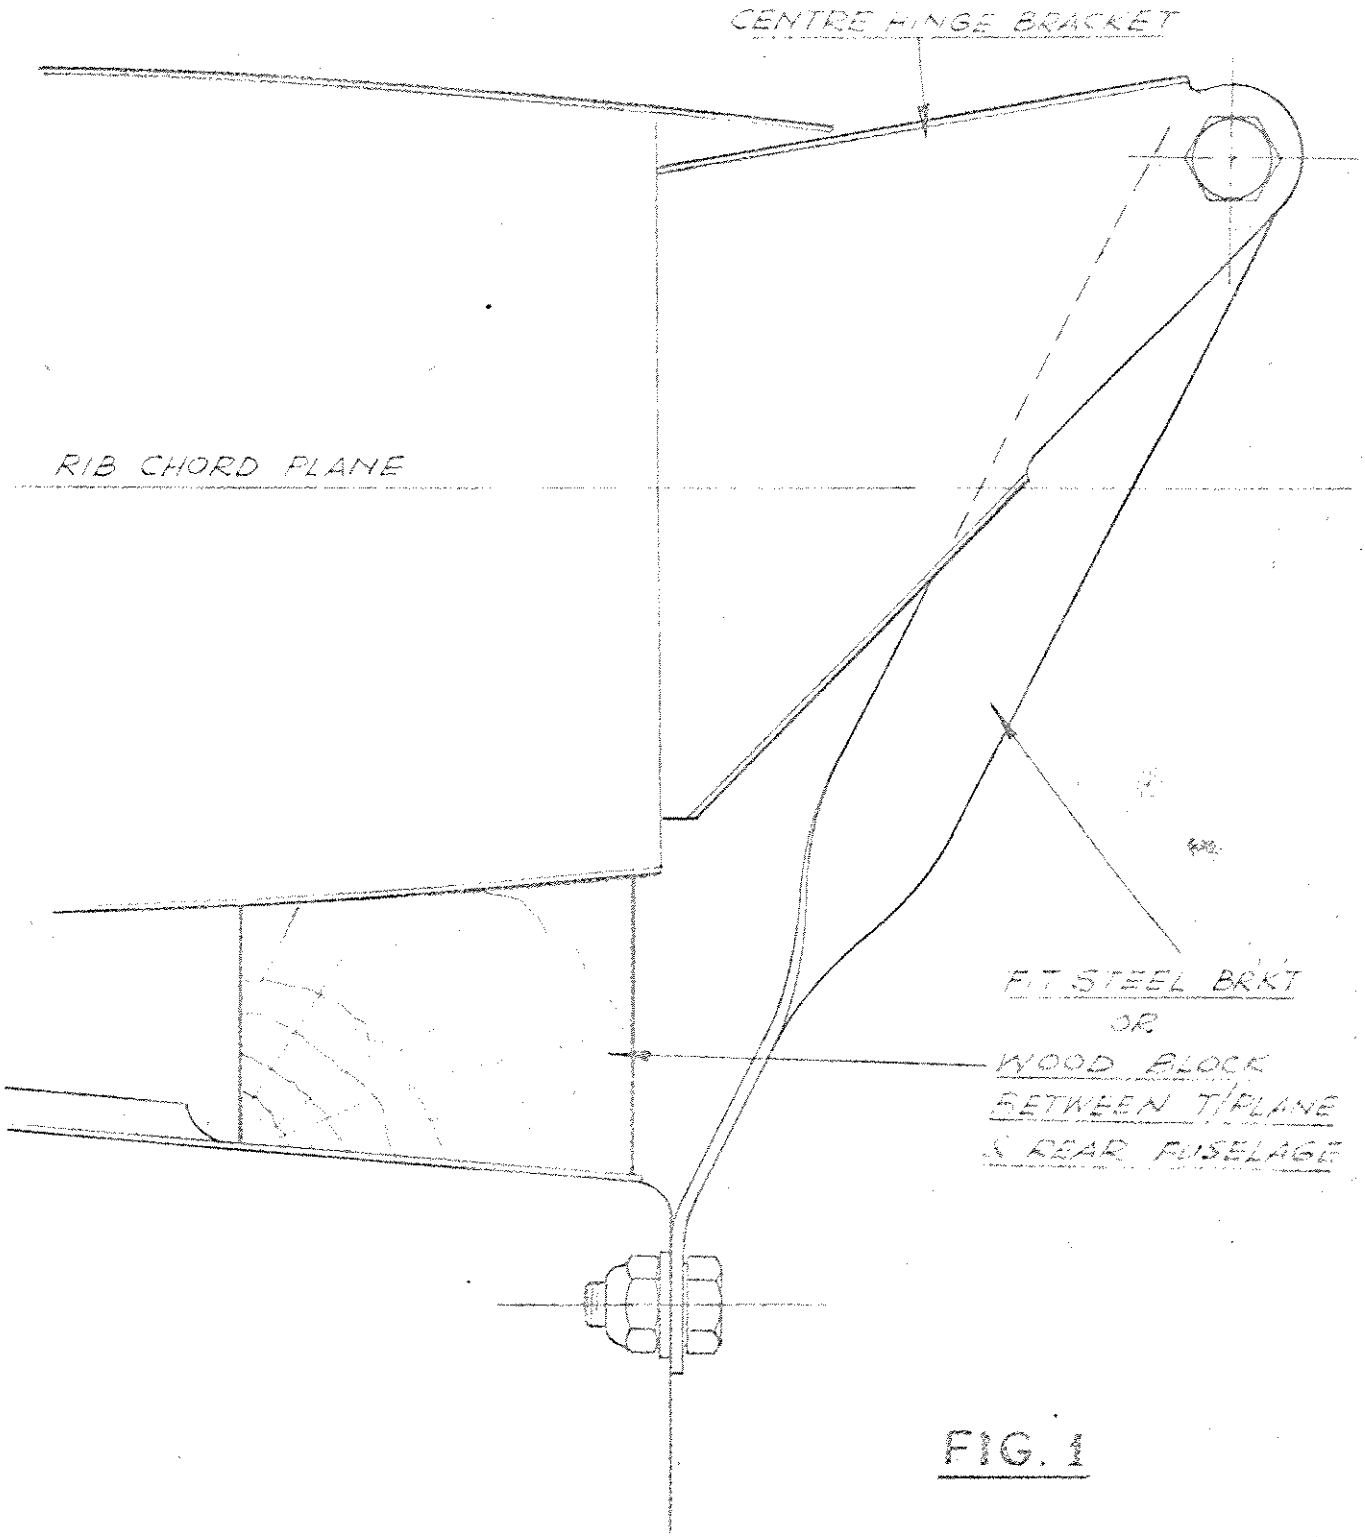
FIG. 1

REASON: Cracking on the rear attachment brackets has occurred in service.

(b) In order to maintain the correct tailplane position during rework it is suggested that one of the following two methods be adopted before removing the tailplane rear attachments:-

(i) Place a block or wedge between the rear fuselage and the tailplane in the vicinity of the rear frame and the tailplane spar. See Fig. 1.

(ii) Make up a steel bracket to pick up between the top centre tooling hole in the rear frame and the hole in the elevator centre hinge bracket. See Fig. 1.

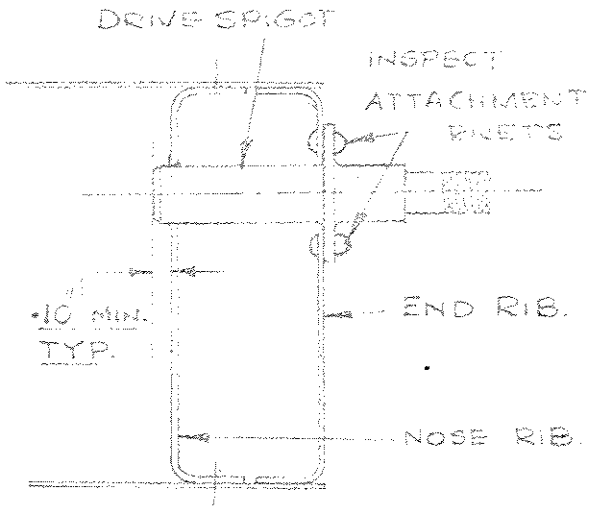
DETAIL 'A'

Immediate inspection of the drive spigot attaching rivets on the inboard ends of the ailerons and the outboard ends of the flapperons is advised. (Refer Detail A). If the rivets show signs of working then a further internal inspection of the spigot to determine the amount of penetration through the nose rib will be necessary before the next flight. A minimum of .10" total penetration of the spigot through the nose rib is required. (See detail A). (If no signs of working are apparent then further internal inspection can be deferred until the next 25 hourly inspection).

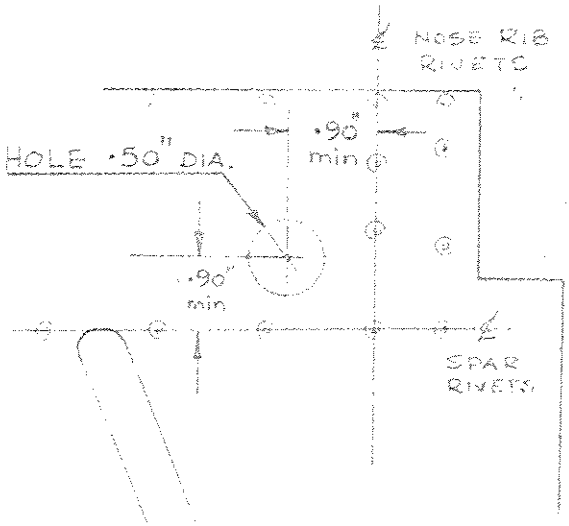
DETAIL 'B'

UPPER SURFACE OF AILERON.
(PORT SHOWN - STBD SIMILAR.)

To accomplish internal inspection, drill a hole .50" dia. in upper surface of ailerons and flapperons as shown in Details B and C respectively, and with the aid of a flashlight ascertain degree of penetration of spigots. If penetration is less than .10" inform Victa Limited, Aviation Service Department and a new longer spigot will be despatched.

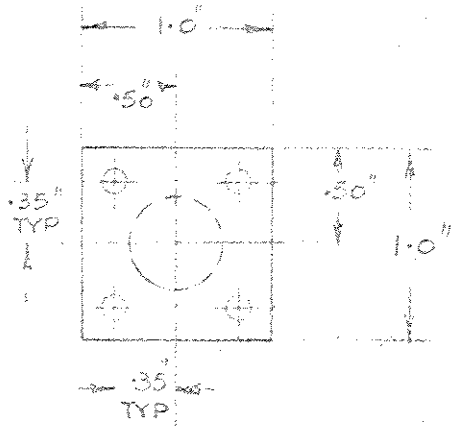
DETAIL 'D'

COVERPLATE - MAKE FROM
28 SWG AL. ALLOY SHEET.

After inspection, cover hole with 28 swg. cover plate and rivet with Tucker 'Pop' rivets as shown in Detail D.

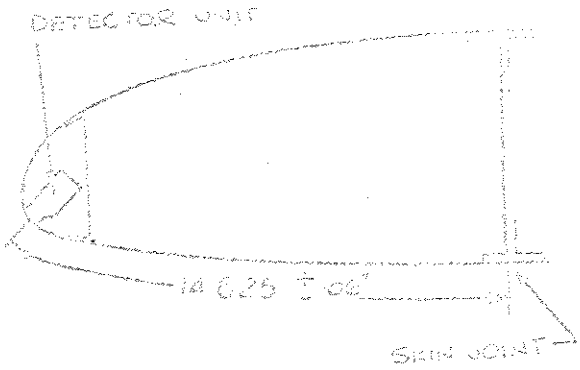
Fig. 1

1. A check on the position of the detector vane around the profile may be obtained by measurement along the contour between the bottom edge of the vane and the skin join on the bottom surface of the spar, refer Fig. 1.

Because the detector is at the mid-point of [illegible] adjustment when measuring. The position of the skin join is not fixed however, production techniques [illegible] and [illegible] that it may be used as a reliable and easy check on the [illegible] to position the detector as shown on Victa Drg. No. 02-03076.

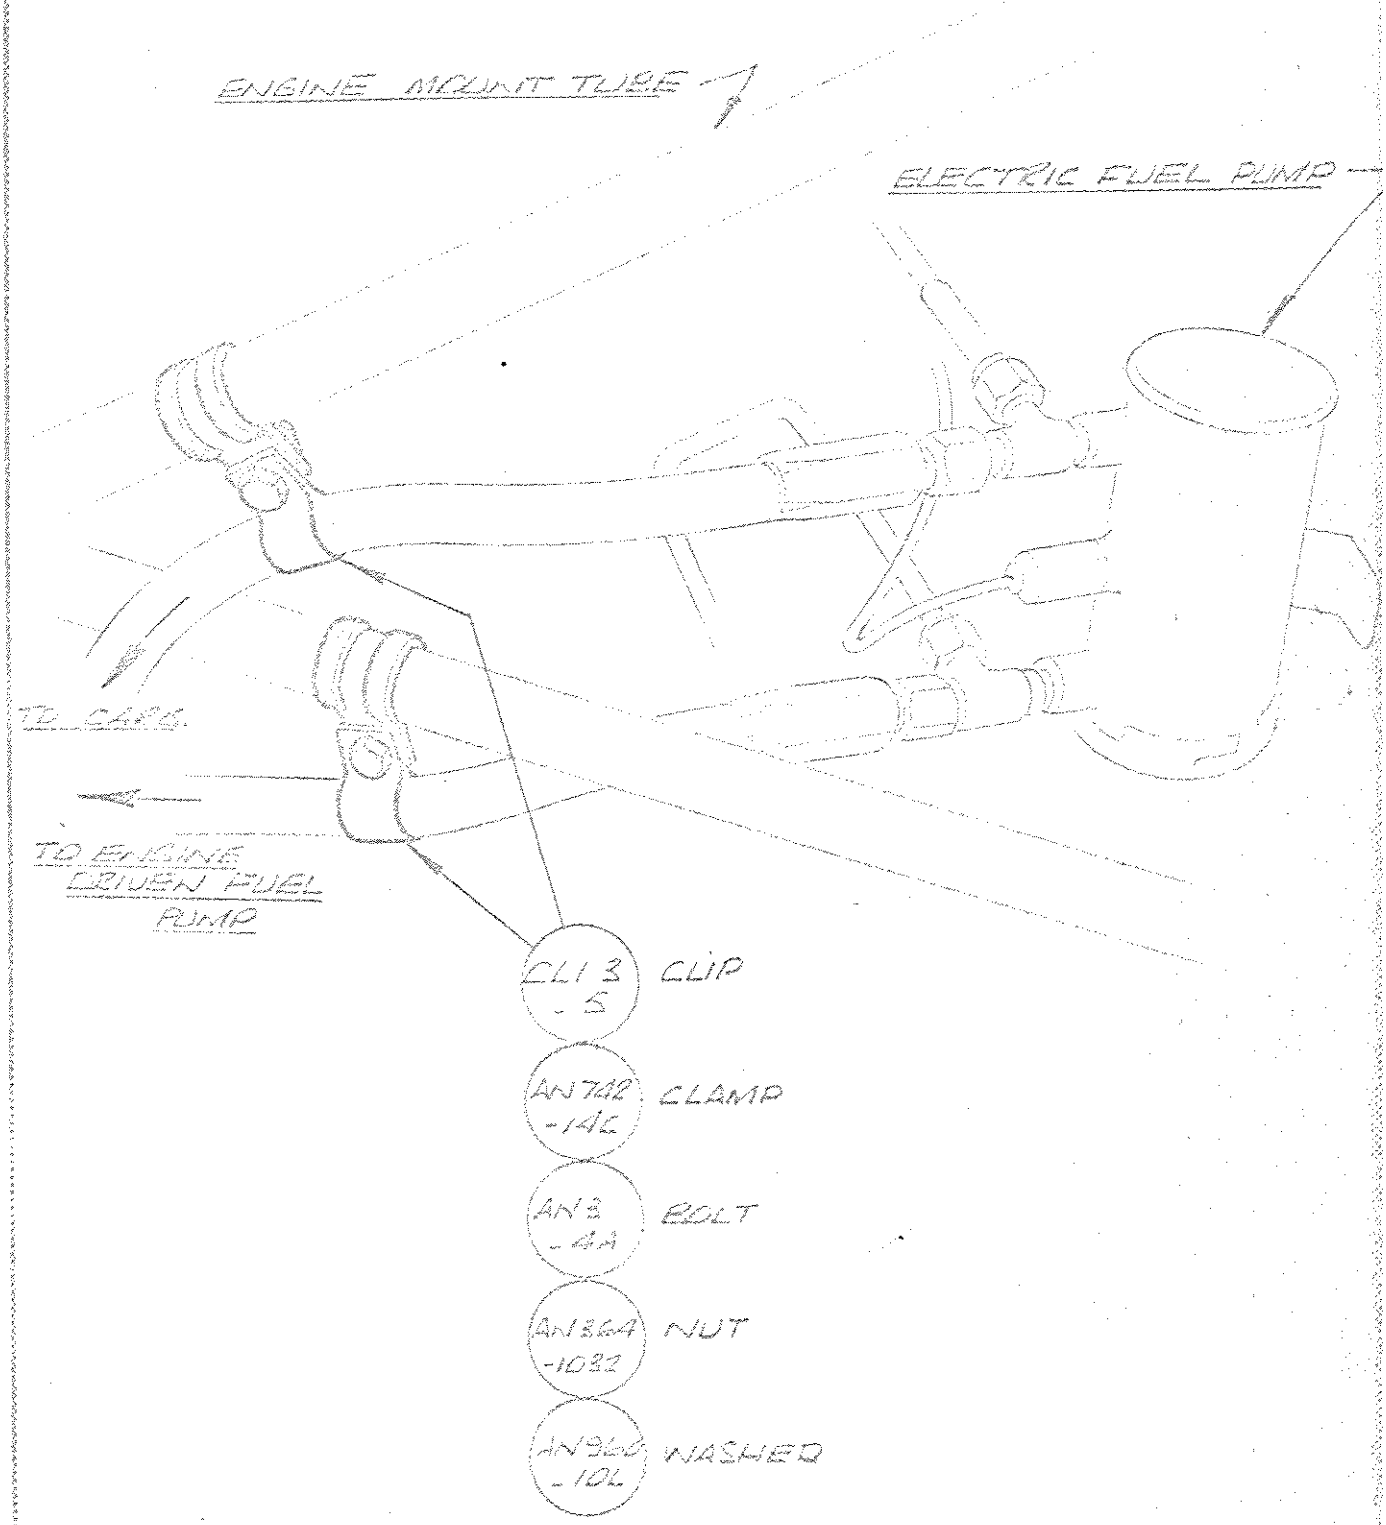
SERVICE BULLETIN NO. 27

REASON: Existing plastic strip fails under elevated temperatures and allows fuel lines to sag near muffler and cause vapour lock.

DETAILS: (a) Remove plastic strap beinding flexible fuel lines to port engine mount.

(b) Instal new metal clips in accordance with sketch avoiding sharp bend radii and kinks in the flexible lines.
