VICTA

SERVICE BULLETIN NO. A.1.

ALERT SERVICE BULLETIN

SUBJECT: Dunlop main wheel and brake assembly. Pt.Nos. DM 1050 & 1

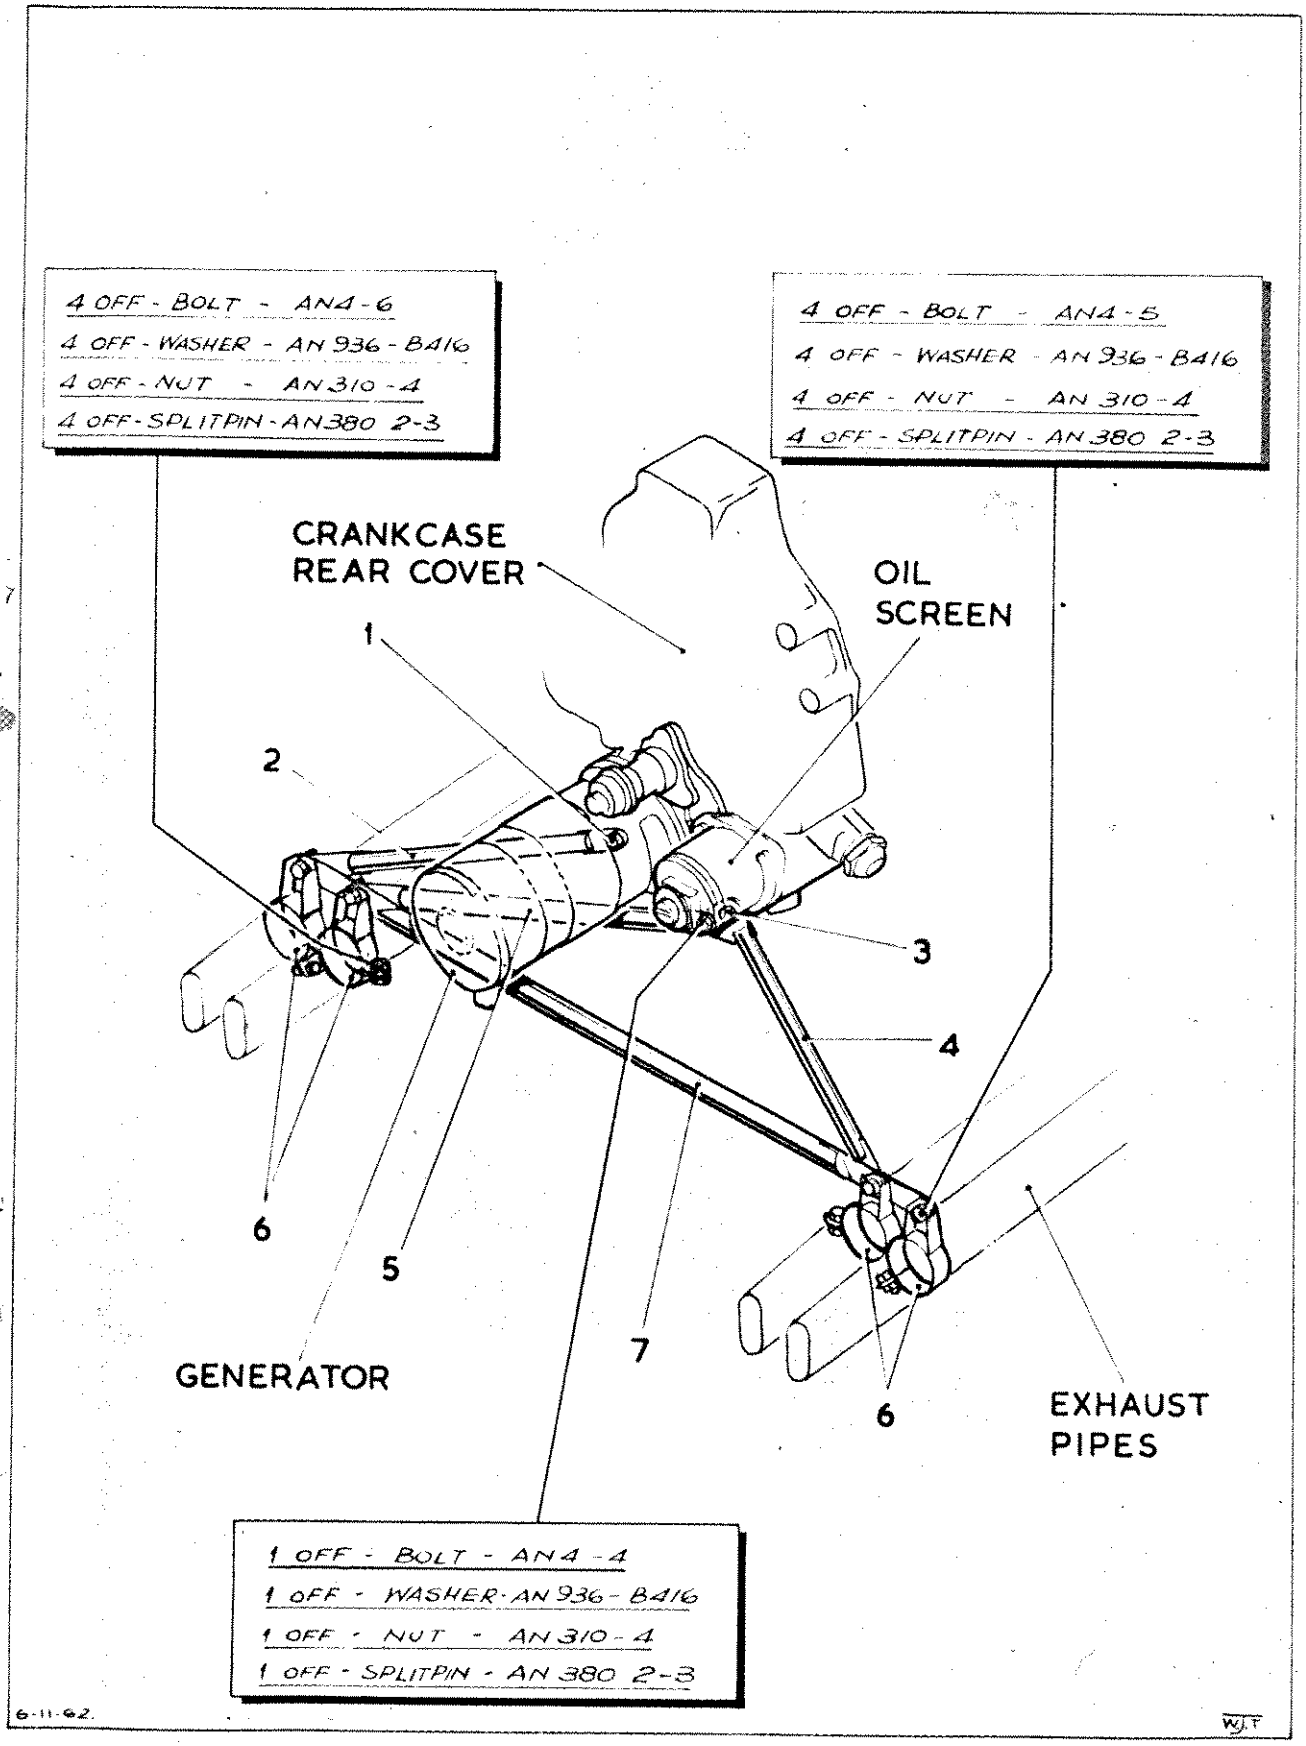
FIG. 1 EXHAUST STAY ATTACHMENT.

PURPOSE To prevent exhaust pipe flanges cracking

REASON Instances have occurred when the exhaust pipe flanges have failed due to the vibration of the unsupported exhaust pipes.

DETAILS Rectification of the exhaust flange cracking consists of installing a triangulated tubular structure picking up on two points at the rear of the engine and supporting the rear ends of the exhaust pipes. Refer to attached Fig. 1 in conjunction with details listed below when installing the stay structure.

(e) (Refer to Fig.1) Remove bottom left hand nut and washer (1) from generator attachment flange. Discard washer and fit L/H. outer stay (2).

(f) Remove bottom nut and washer (3) from oil screen attachment flange. Discard washer and fit R/H. outer stay (4).

(g) Attach inner stay (5) to lug on R/H. outer stay

(h) Fit exhaust pipe clamps (6) to rear of exhaust pipes.

(j) Attach bottom stay (7) to exhaust pipe clamps and inner and outer stays. DO NOT TIGHTEN BOLTS AT THIS STAGE

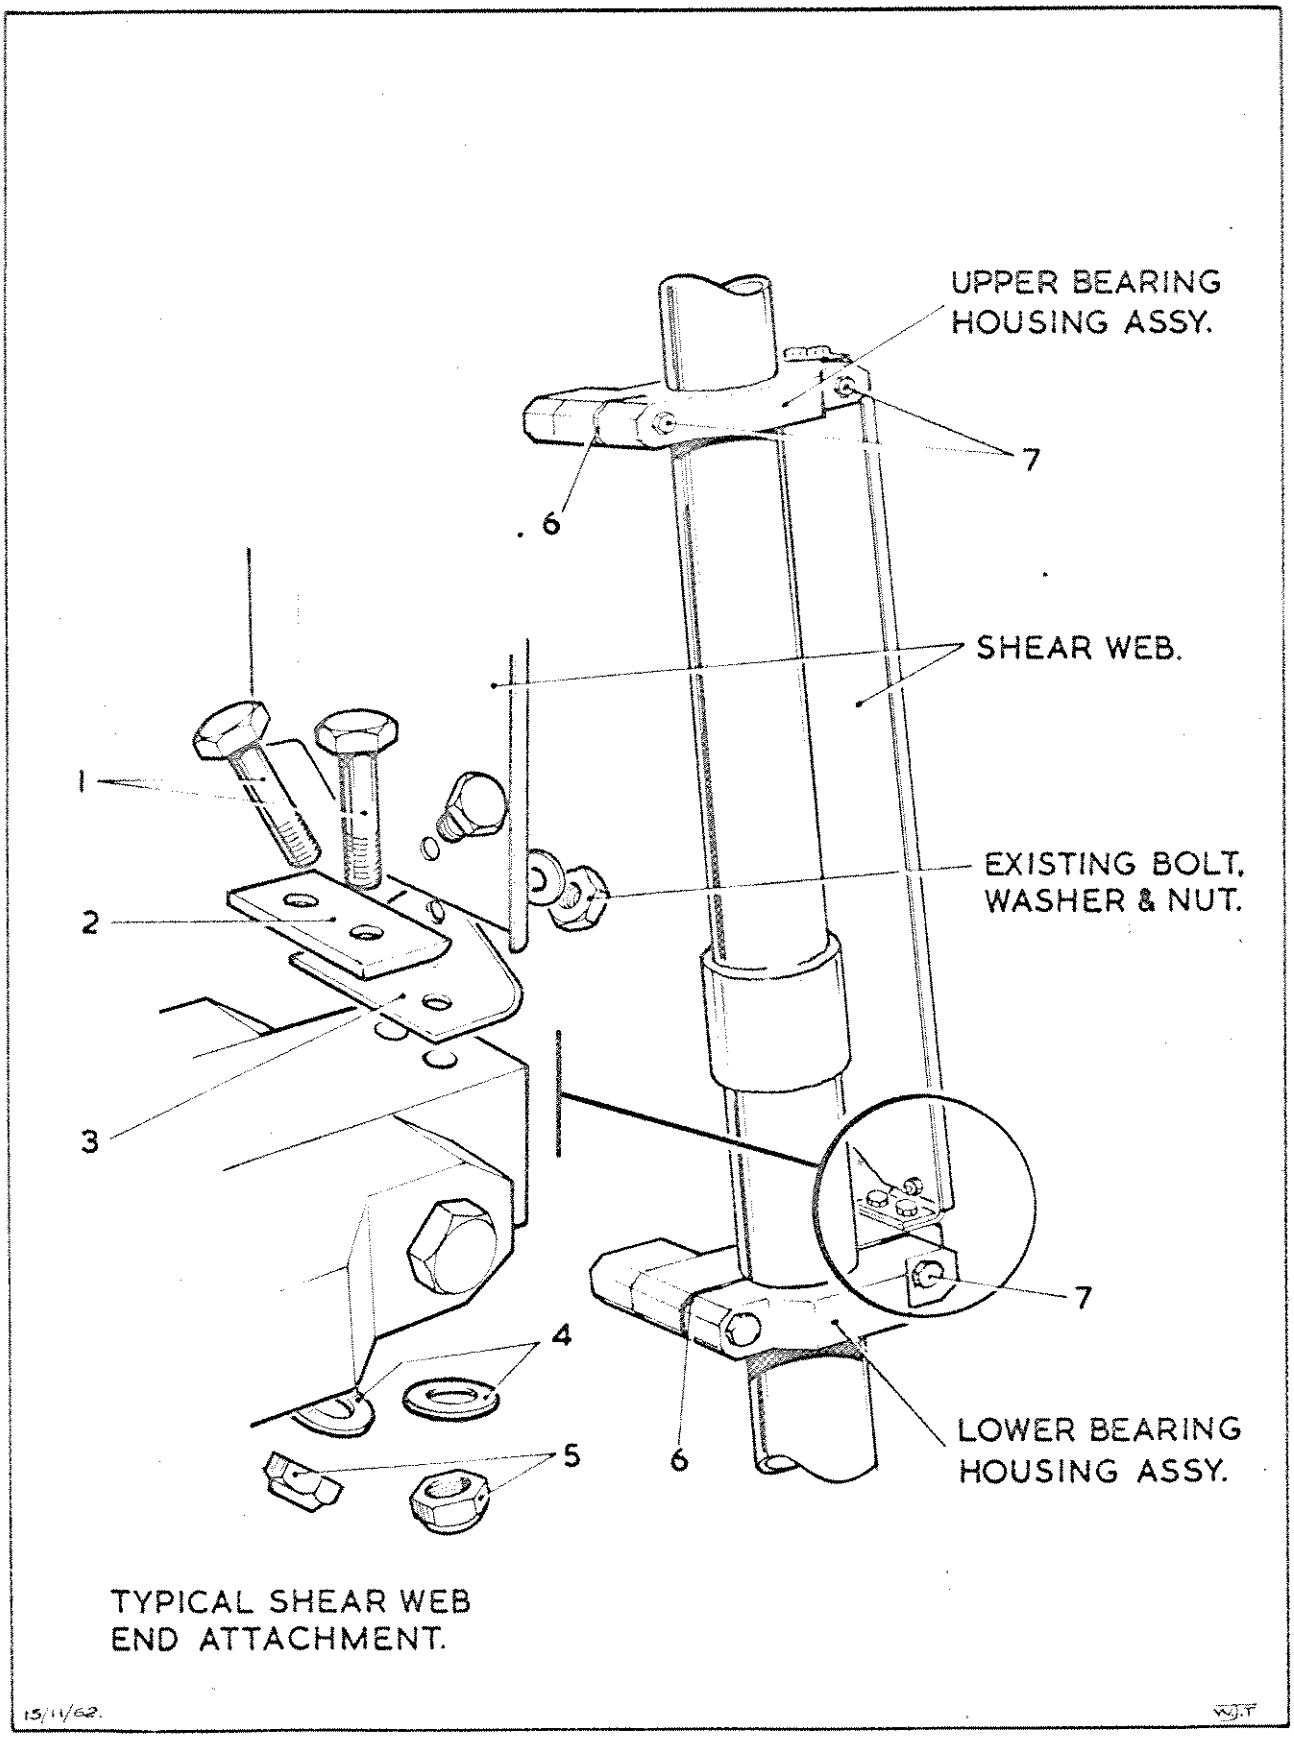
FIG. 1. NOSE-LEG SHEAR WEB ATTACHMENT

PURPOSE To prevent cracking of attachment angles.

REASON Failure of the top and bottom attachment angles has occured due to flexing of the upper and lower nose leg bearing housings.

DETAILS Rectification of the failure of the attachment angles is achieved by fitting heavier gauge steel angles in place of aluminium alloy angles and 10 SWG aluminium alloy packers under the attachment bolts.
Refer to Fig. 1 attached in conjunction with details listed below

(a) Check that upper and lower bearing housing attachment bolts (7) have not worked loose.

(b) Check that the packer (6) is in position between the faces of the bearing housing segments and that tightening of the attachment bolts (7) does not tighten bearing onto nose leg.

(e) Replace old aluminum angles with steel angles (3) and aluminium packer (2) which is inserted beneath the heads of new bolts (1) which secure the angles to the bearing housing in conjunction with washers (4) and nuts (5).

(f) Before securing shear web to angles in it may be necessary to trim the end of the web to clear the aluminium packer.
