WICTA

SERVICE BULLETIN NO. 54 Iss.

SUBJECT: Mandatory Inspection of Nose Leg Spring Characteristics.

SERVICE BULLETIN NO. 55

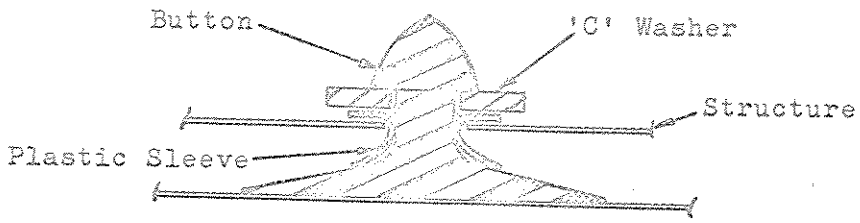
REASON: It has been found in service that some aircraft sustain damage to the tank retention buttons caused by the edge of the mounting hole cutting into the neck of the button. On several occasions this has resulted in the head of the button being severed. The most susceptible location has been the two lower front, and the first indication is normally a "spongy" feel on the tank bottom with the dip stick. While it is not considered dangerous to have several buttons not retaining the tank bag to the structure, the resultant transfer of load to the remaining buttons may hasten their deterioration.

(g) Install C washers (Pt.No. 02-48023/1) making sure they pass between the end of the plastic sleeve and the head of the button. Rotate the washer when in position to flare out the ends of the sleeve as shown in the sketch.

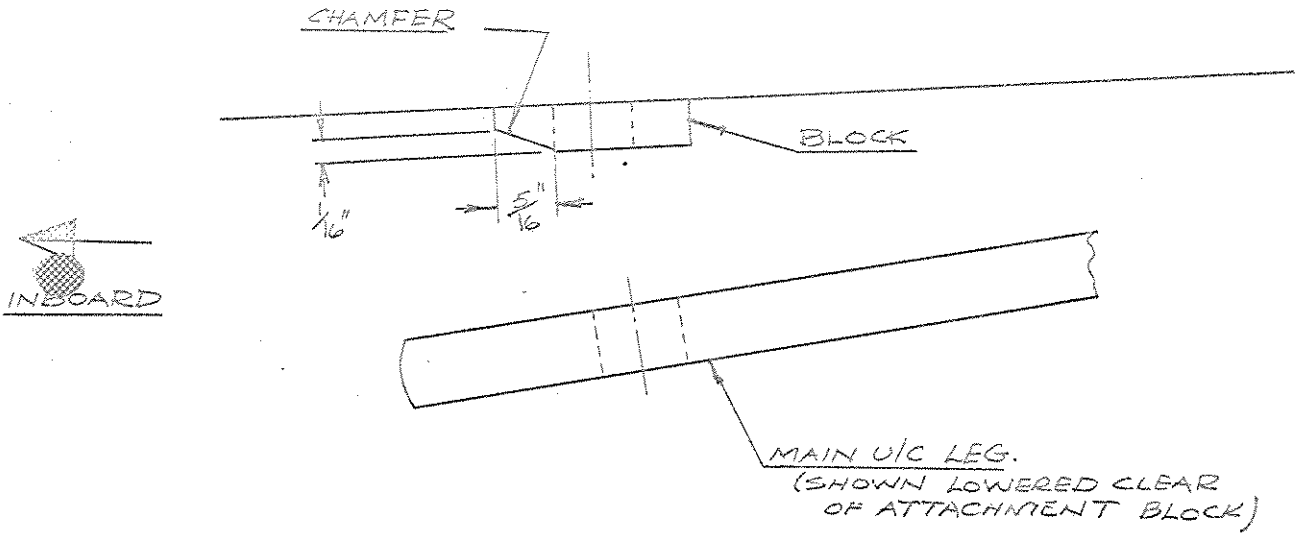
PURPOSE: Required as a precautionary measure pending the development of a long life attachment. Standard AN7H-11A bolts have been found cracked at 200 hours replacement.

Remove screws and drop undercarriage fairing.
Trestle wings with main landing gear clear of ground.
Remove inner main leg attachment bolts and loosen clamp plates.
With leg clear of inner attachment block, chamfer inboard edge of block as shown:

Use a piece of scrap sheet metal against wing under skin to prevent damage when filing chamfer.

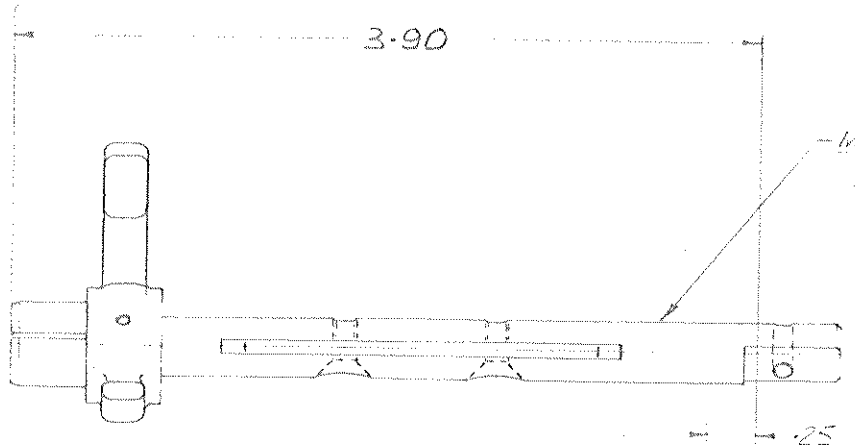
REWORK DETAILS

REASON: Two cases have occurred in service where the shaft has failed at the corner of the valve recess at the end nearest the limit stops and lever. The return spring then rotated the butterfly past full throttle to a reversed part throttle position.

DRILL THRU 1/16" DIA

PART NO 03-43308/1 IS MADE BY
REWORKING MARVEL SCHEBLER
PART NO 413-949 AS SHOWN
