SERVICE BULLETIN NO. 23

AVIATION DIVISION HORSLEY ROAD, MILPERRA, N.S.W., AUSTRALIA.

SUBJECT: Revised gust locks. Mod. No. B83.

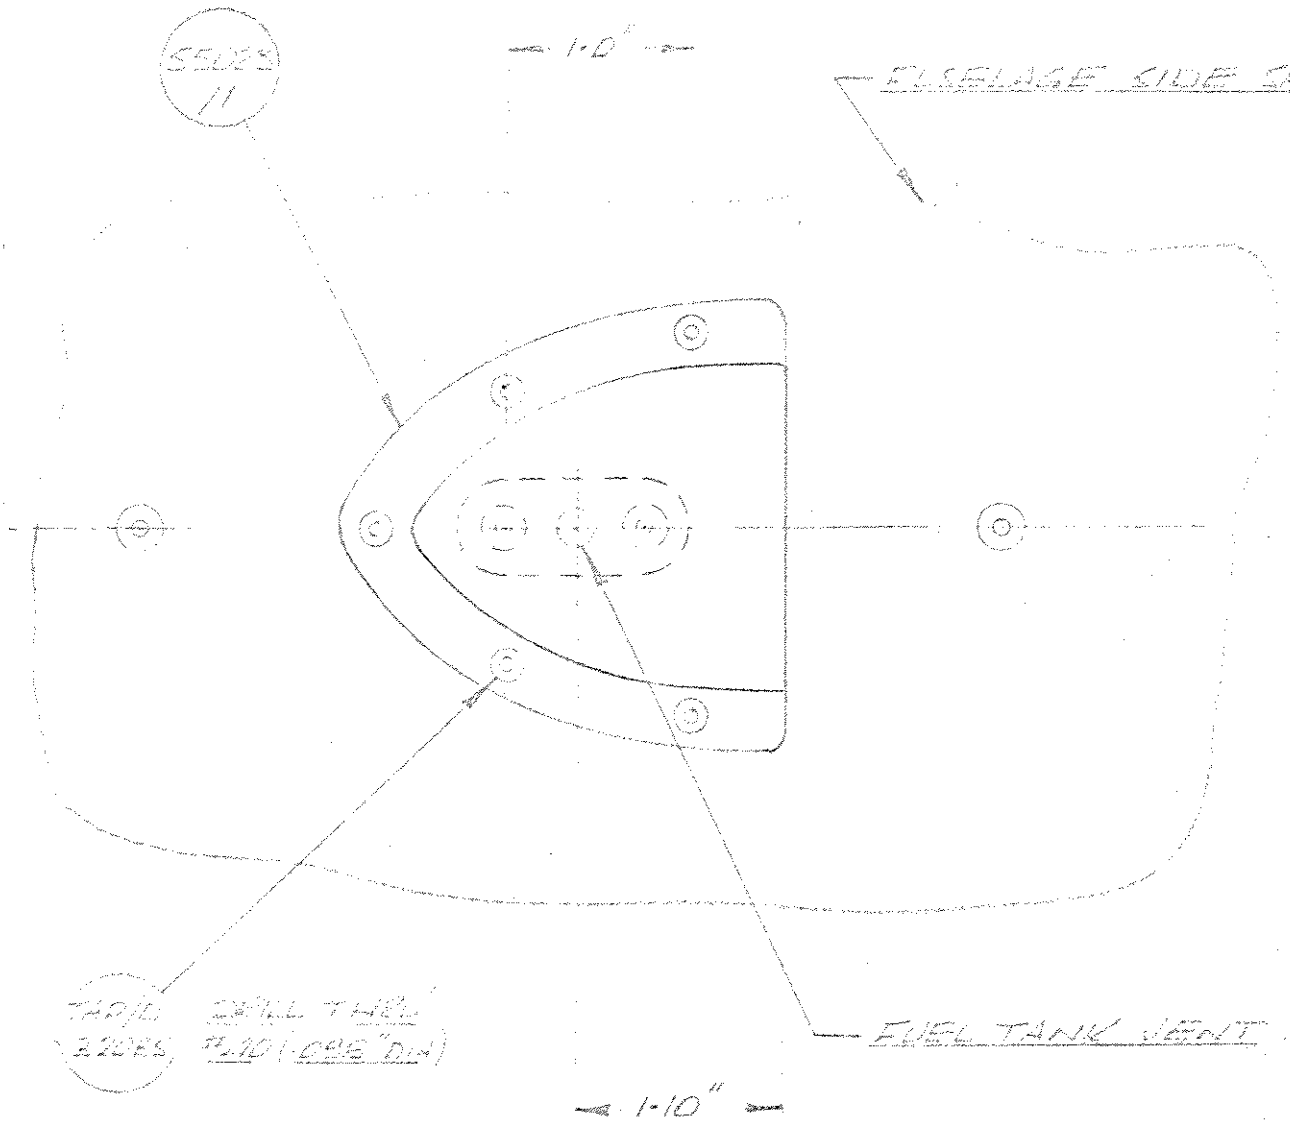
VIEW ON LHS OF REAR FUSELAGE AT APPROX STN SHOWING INSTALLATION OF SCOOP OVER FUEL TANK VENT

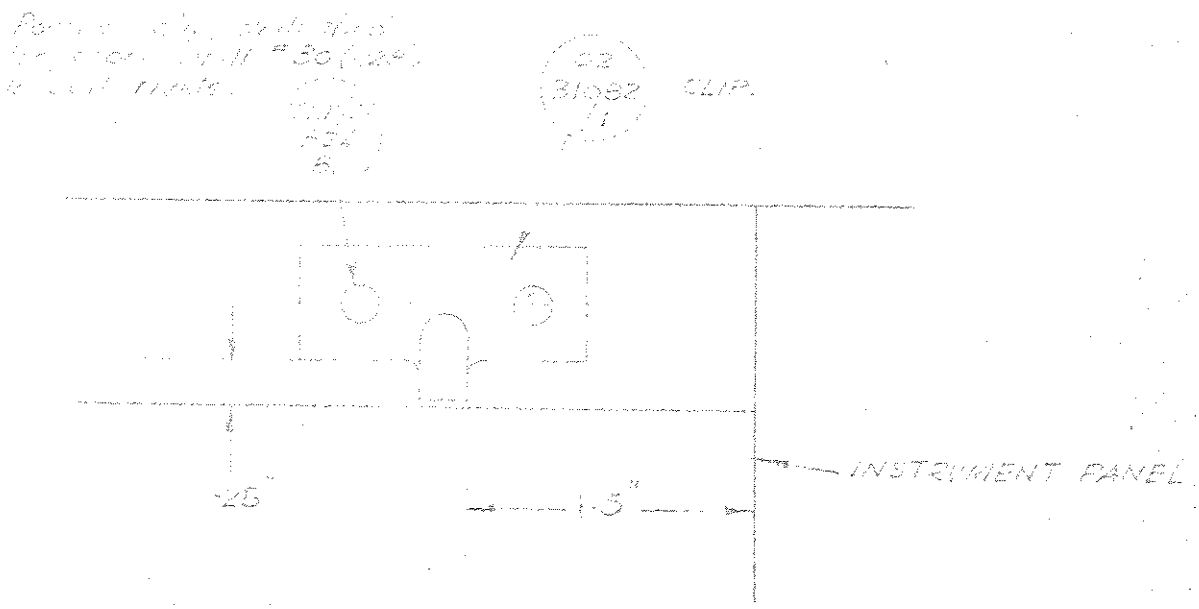
PURPOSE: Improved design to ensure security of outer ends of gust lock.

REASON: To prevent outer ends of gust lock springing from location holes and causing possible injury to occupants.

DETAILS: Attach clips (Part No. 02-31082) to port and starboard upper longeron as shown below:

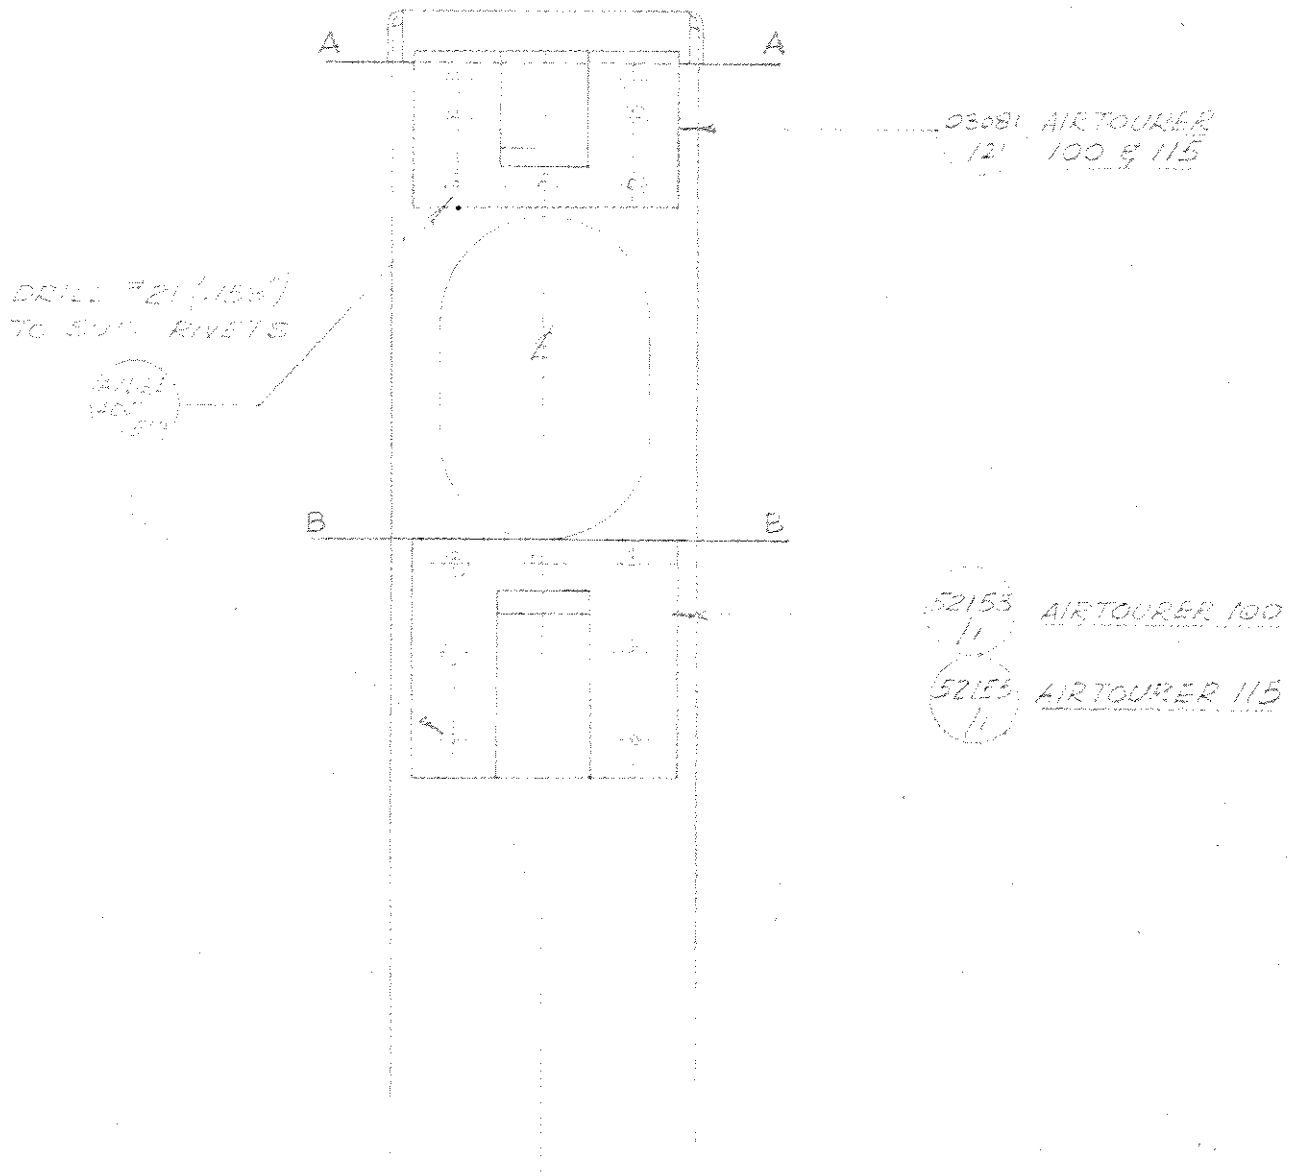
SERVICE BULLETIN NO. 30

PURPOSE: Redesigned to give positive up and down stops to elevator contro

REASON: Stops were found to be bending in service.

(d) With the forward stop bracket in line with the rear edge of the front flange of the torque shaft, line A-A, match up the centre lines of the respective parts. Drill through from bracket into torque shaft with Drill No. 21 (.159") and rivet in position using "AVDEL" 402/510 rivets.

(e) Repeat for rear stop bracket in conjunction with rear edge of cut out, line B-B.

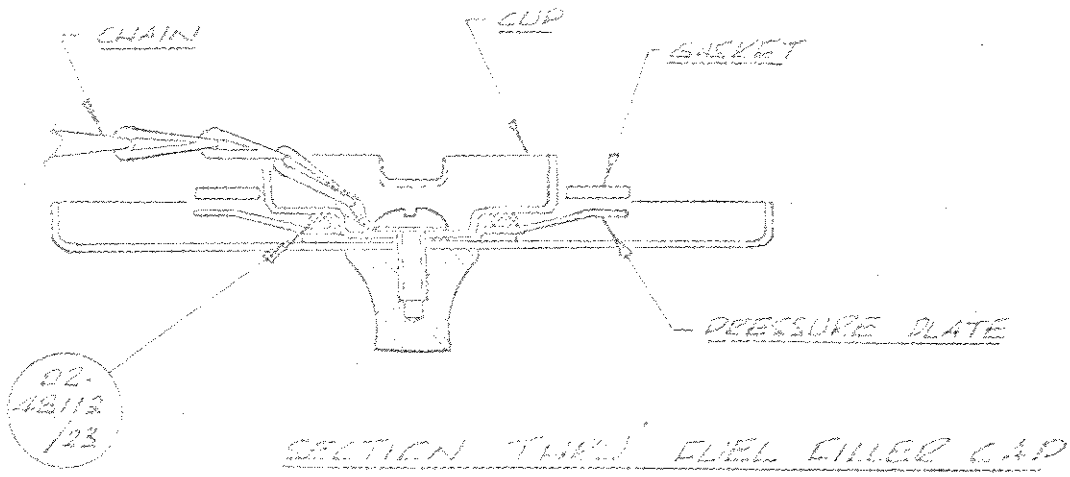
SECTION THRU FUEL FILLER CAP

REASON: Service experience has shown that fuel stains progress back from the filler cap along the fuselage side. Investigation has shown that the leak is from behind the gasket pressure plate.

(b) Wet 'O' ring with mineral hydraulic oil and stretch over centre cup of cap. Using thin blunt edge, push 'O' ring between cup and pressure plate as shown.

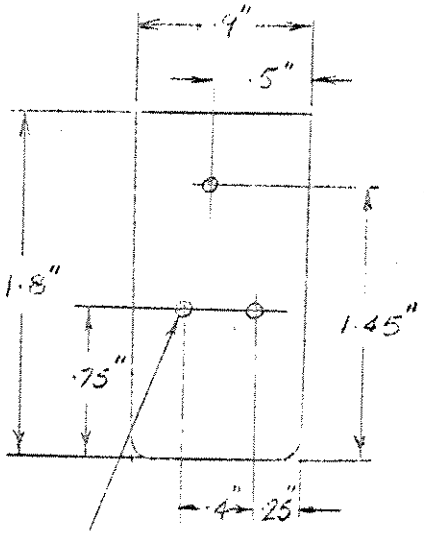
DETAILS: Due to unfavourable flying characteristics with flaps fully down it is necessary to restrict the full flap down movement to 3/4 flap (3 notches).

To prevent any further use of the 4th notch of flap, a light alloy, 16 S.W.G. stop tag should be rivetted to flap quadrant as shown below.

3 holes, No. 30 (.128") to suit rivets

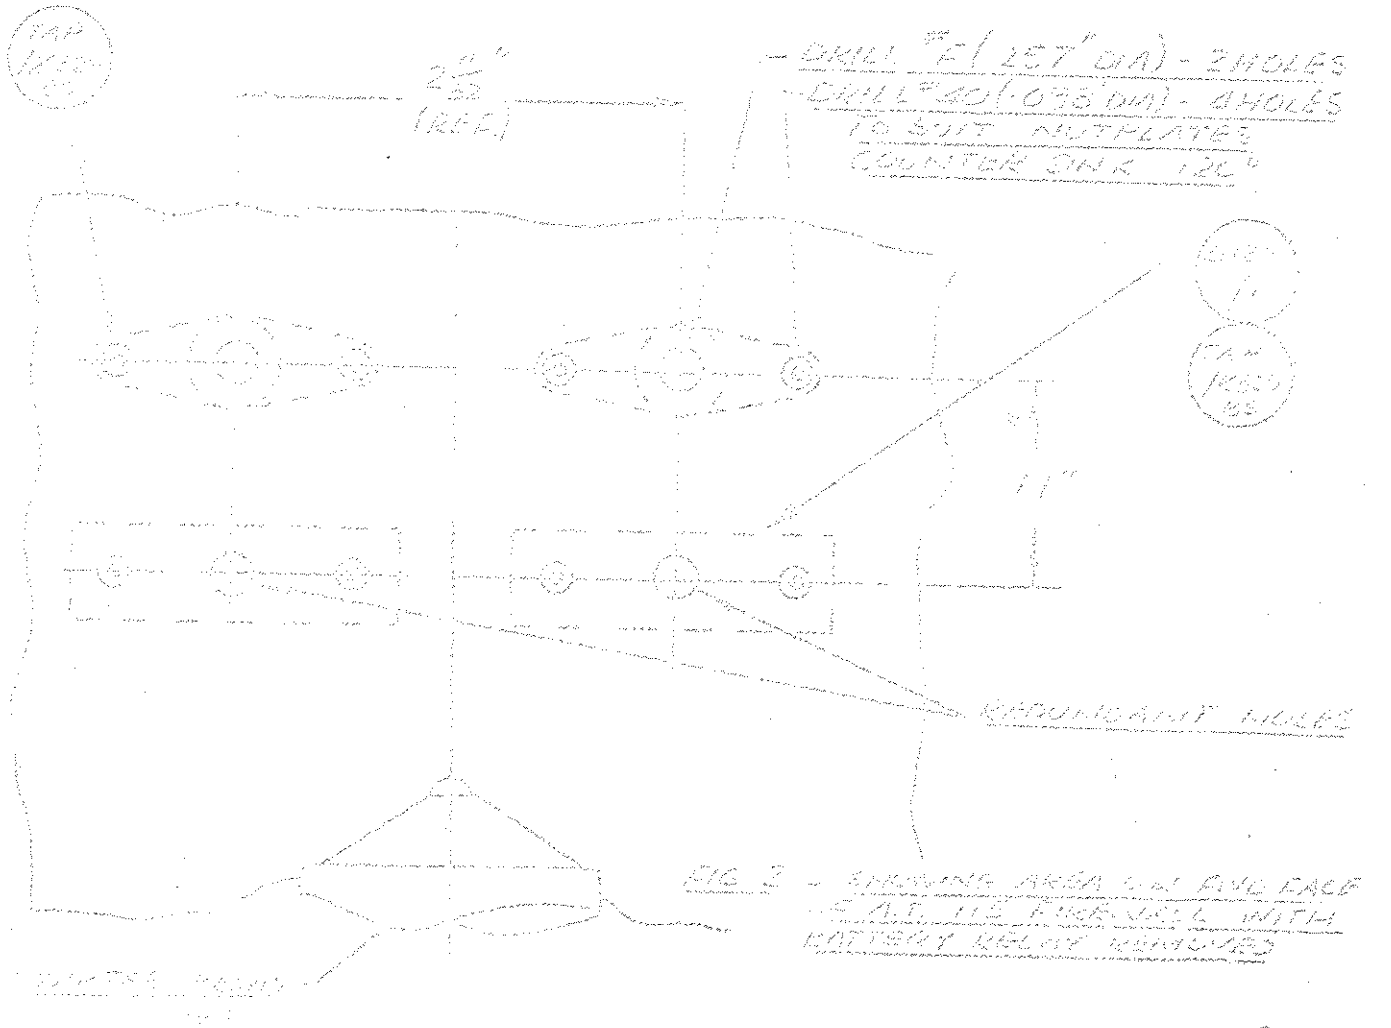
FIG 2 - MOUNTING AREA ON RHS CASE TO BE REMOVED WITH BATTERY RELAY MOUNTED
