VICTA

SERVICE BULLETIN NO. 42

SUBJECT: Replacement of exhaust muffler inner casing part No. 42339/1 by modified type part No. 42339/2 from which baffles have been deleted. MOD B 161.

EQUIPMENT AFFECTED: All Airtourer 115 aircraft fitted with exhaust muffler inner casing part No. 42339/1.

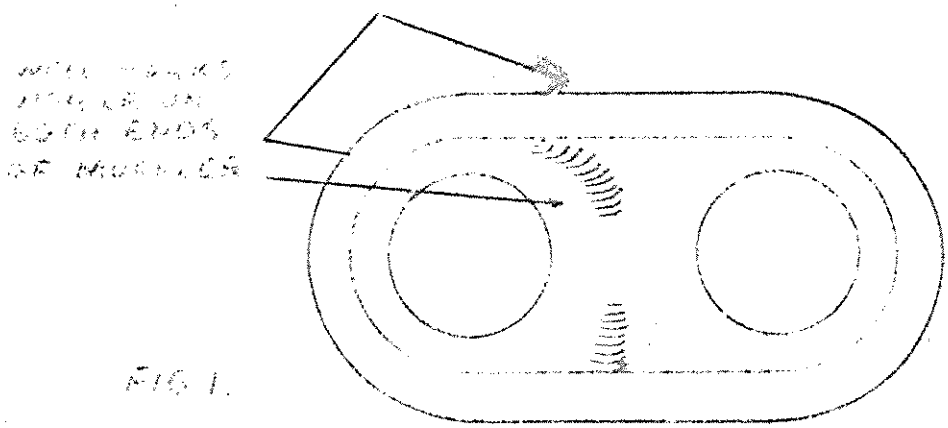
FIG 1.

NOTE: Positive identification of inner casing part No. 42339/1 may be made whilst installed on engine by inspecting end of muffler assembly. Mufflers which have weld marks as shown in Fig. 1 incorporate baffles. If no such weld marks are evident the inner casing conforms to the latest type Part No. 42339/2 and this service bulletin is not applicable.

DETAILS: Method of replacement of muffler inner casing is as follows:-

(6) Remove front and rear covers from muffler assembly and discard inner casing part No. 42339/1.

(7) Reassemble front and rear covers on new inner casing part No. 42339/2.
