VICTA

SERVICE BULLETIN

No. 61
D.C.A. APPROVED

SUBJECT: Auxiliary Trim Bungee

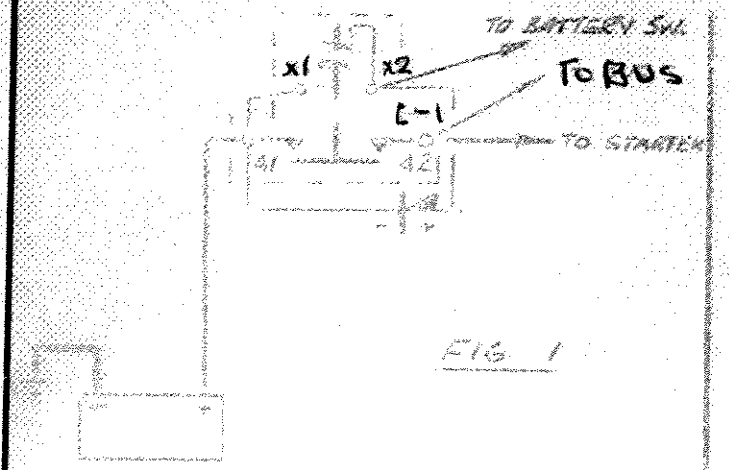
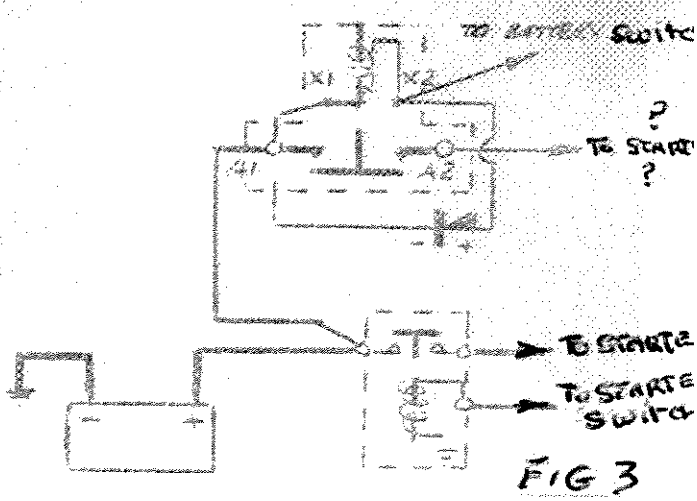
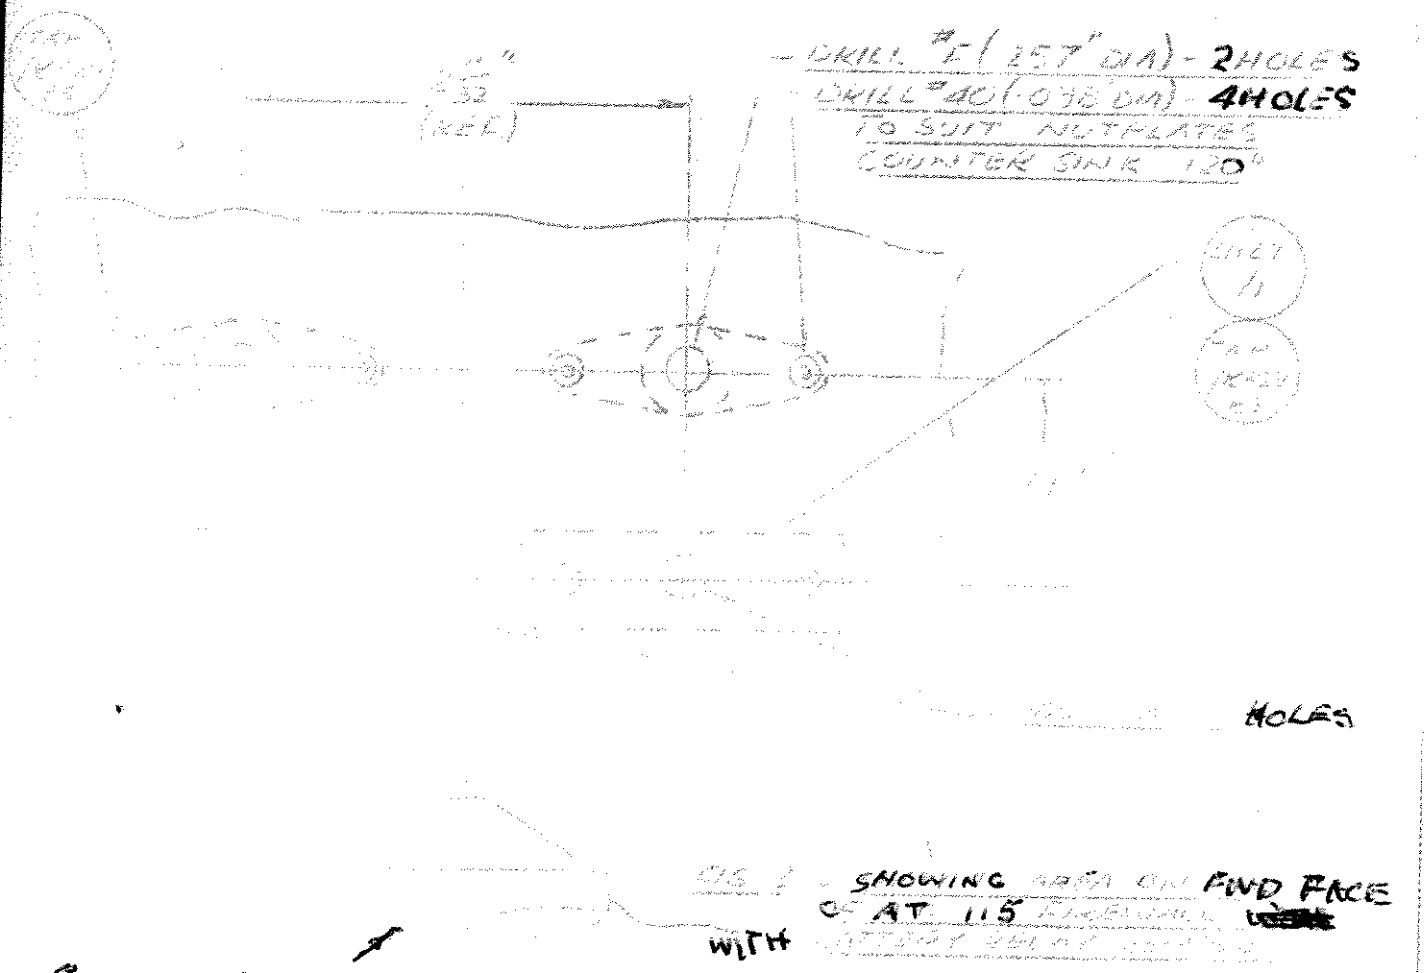
SERVICE BULLETIN NO. 43

STARTER RELAY

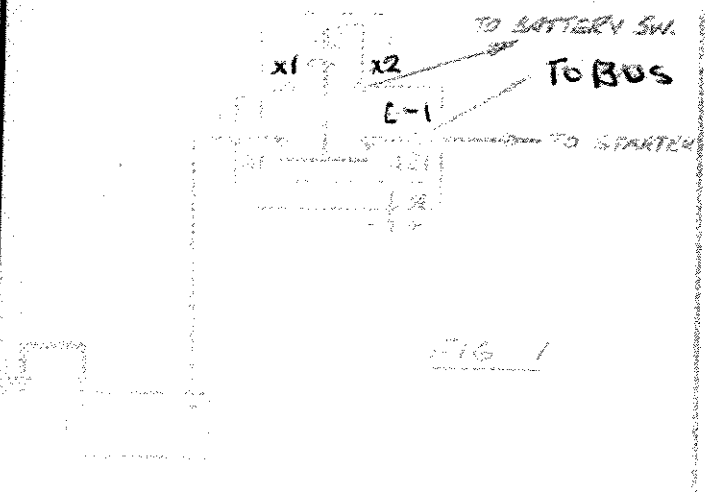
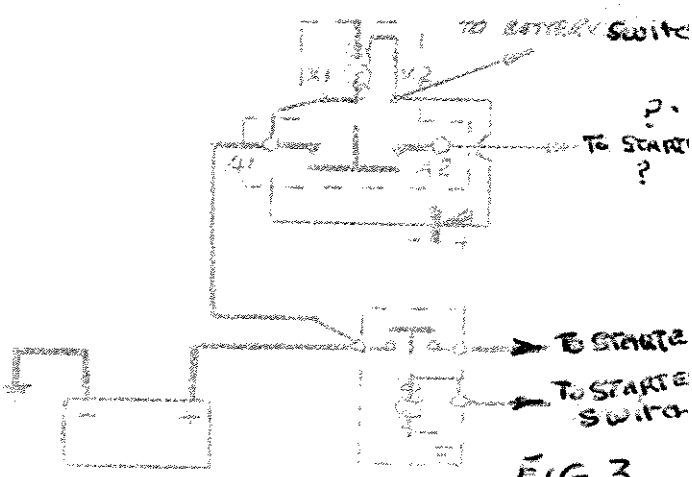
SERVICE BULLETIN NO. 43

SHOWING
AT 115
WITH
FWD FACE

STARTER RELAY

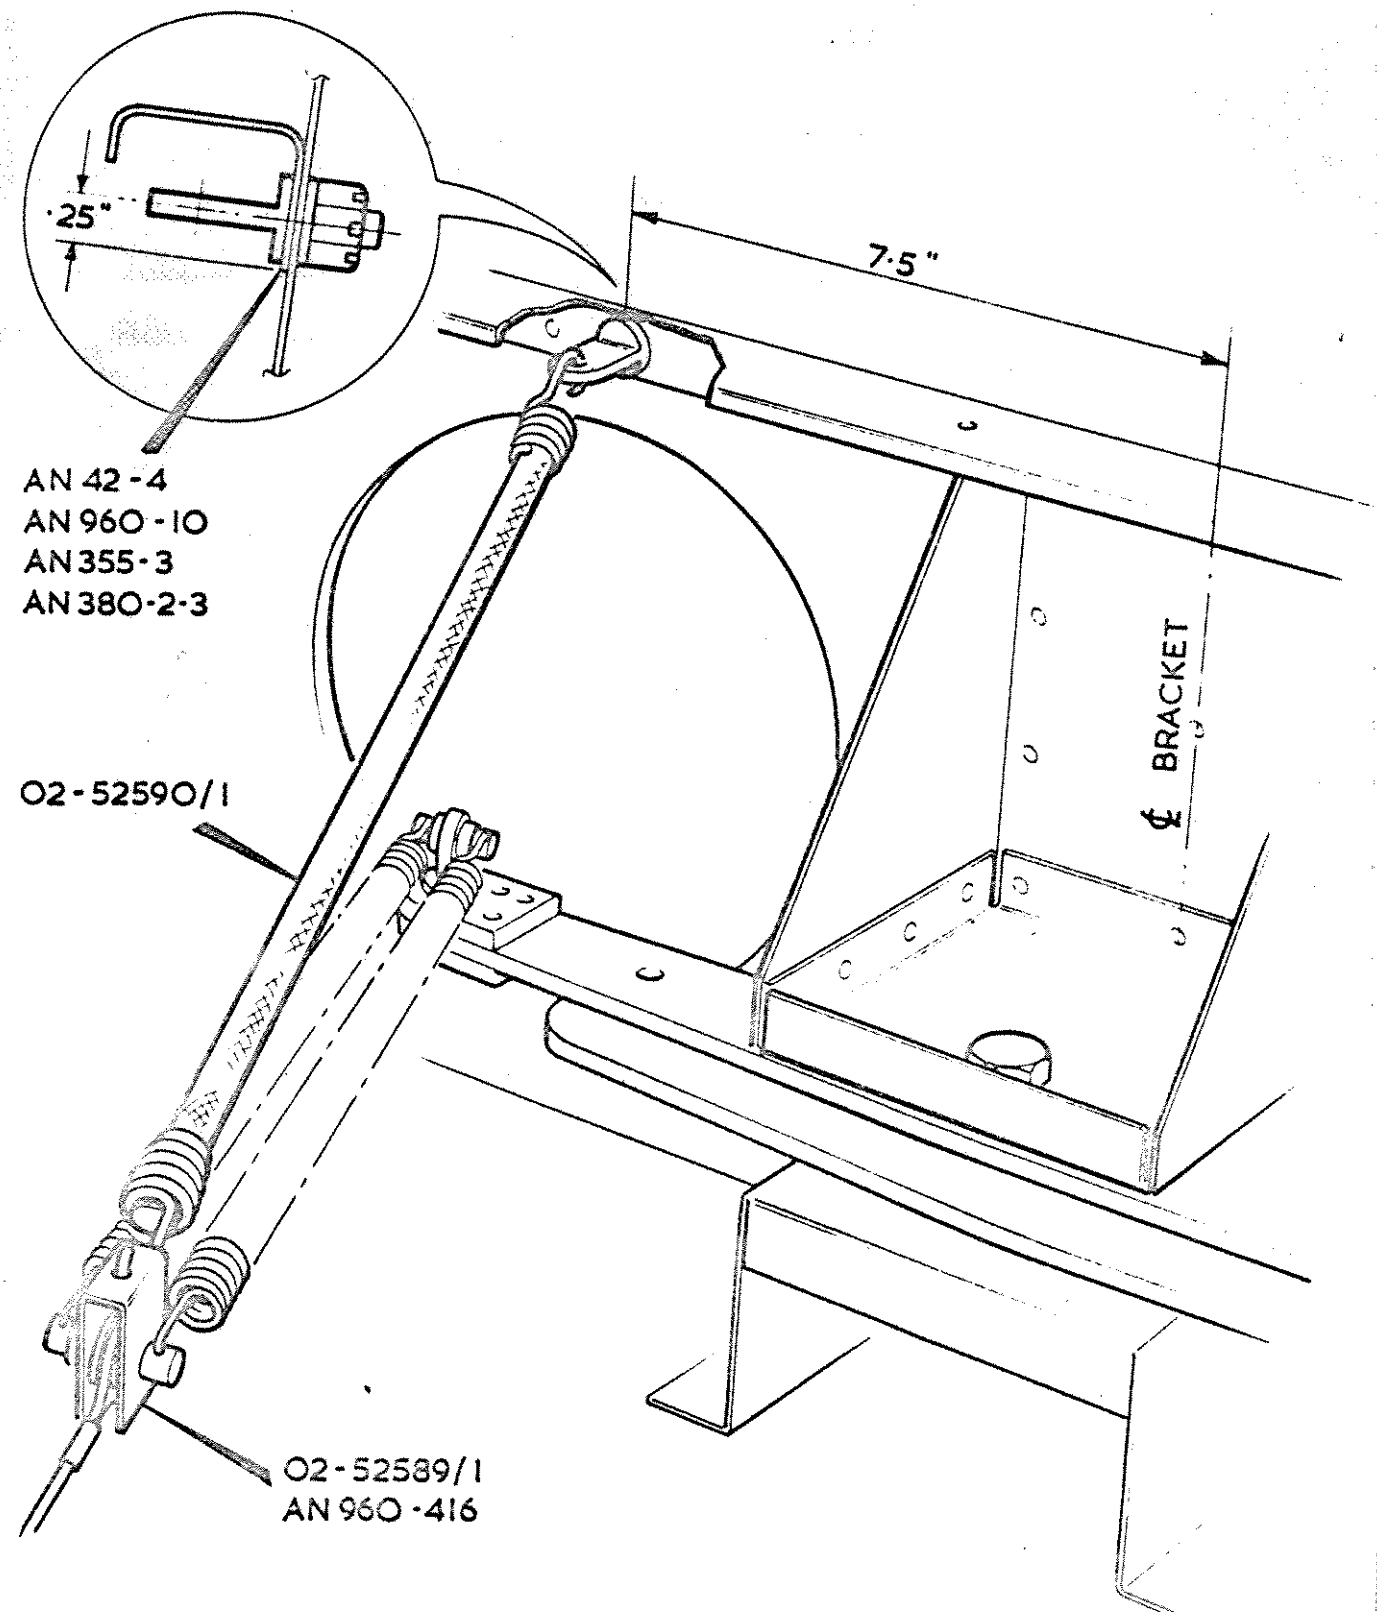
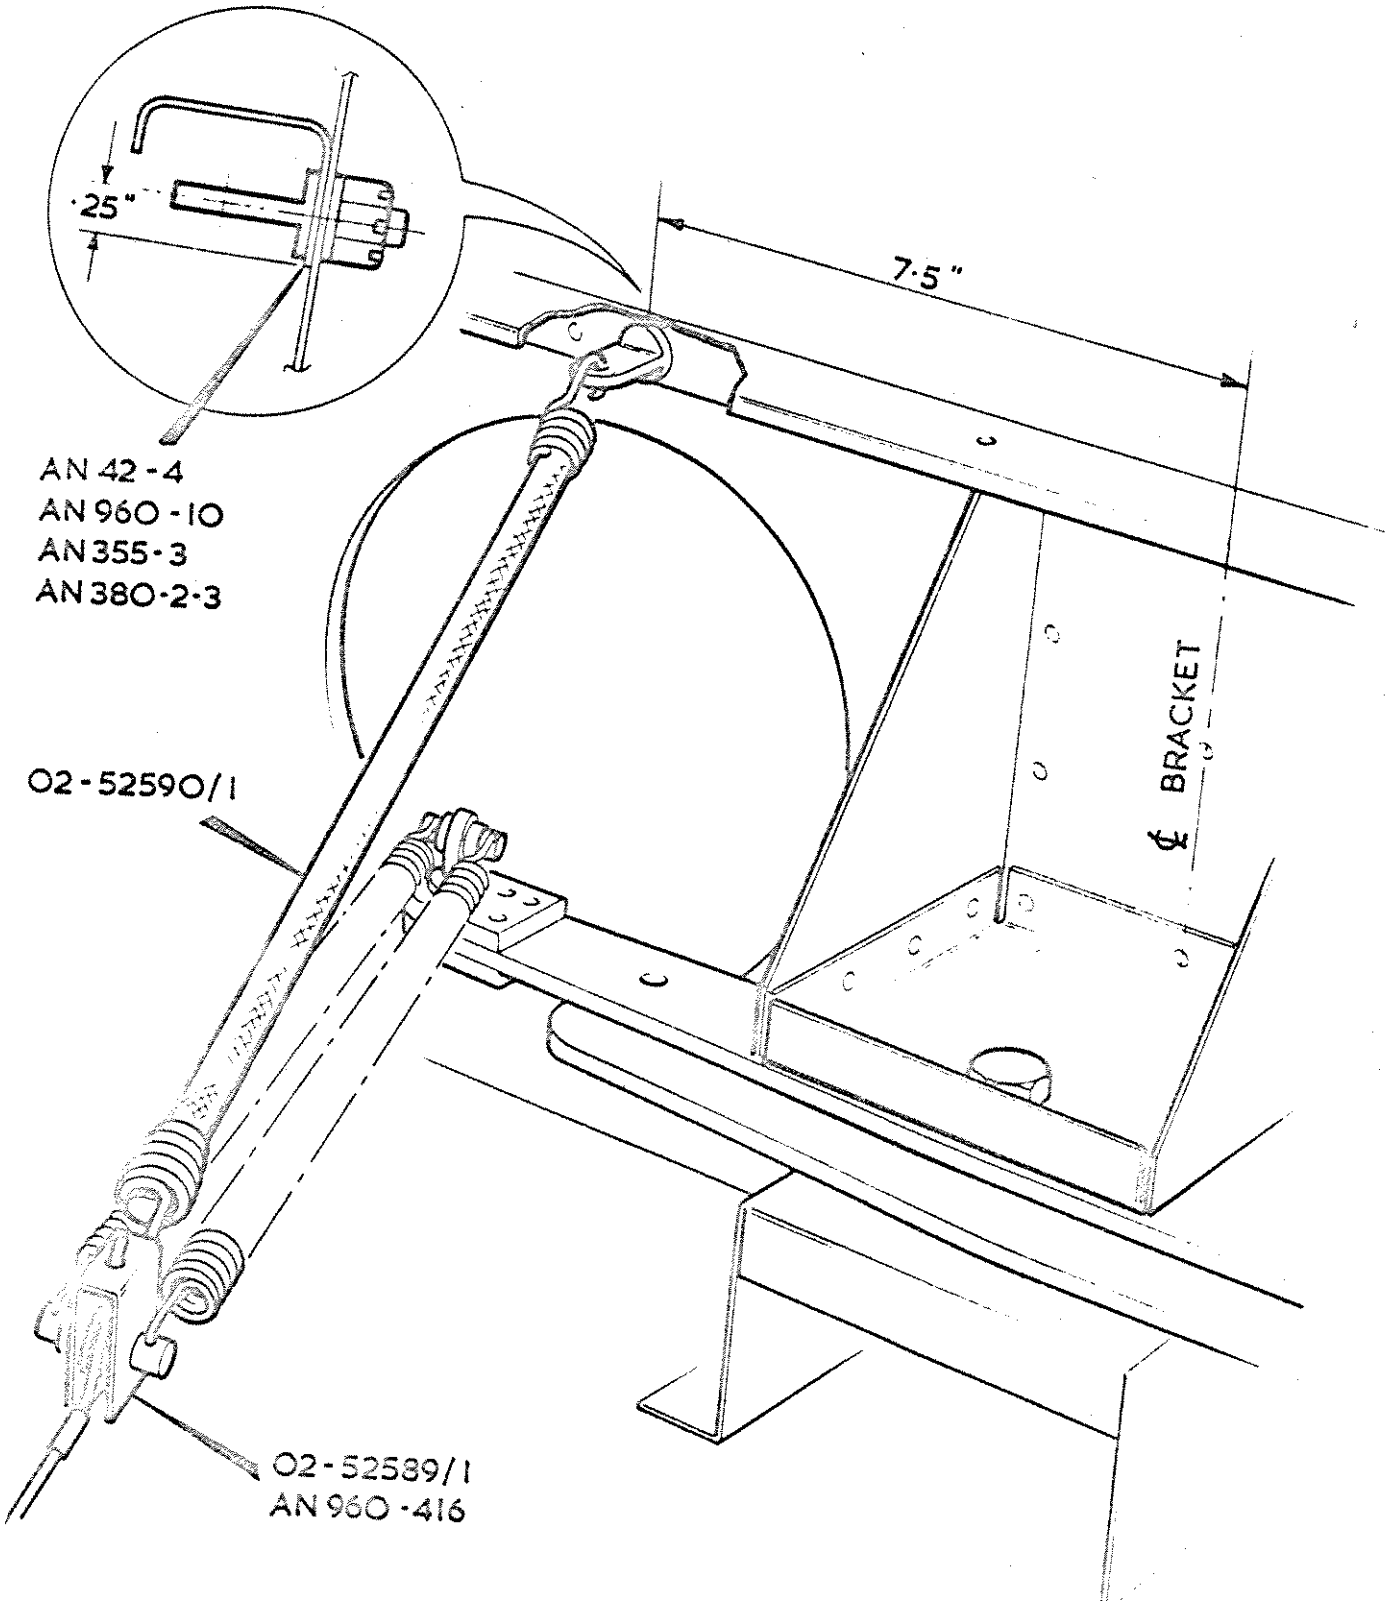
SERVICE BULLETIN No. 61

REASON: The Airtourer 115 trim lever has been heavy to adjust to the full nose up postion. Several cases have been reported of the trim becoming disengaged due to the heavy load and moving to the nose down position.

(2) Drill No. 11 through rear member as shown on page 3 and install eyebolt Part No. AN 42-4.

(3) Disconnect forward end of nose-down spring and install shackle Part No. 02-52589/1 using AN960-416 washers as spacers inside shackle.

(4) Re-connect spring and install auxiliary bungee. Part No. 02-52590/1.
