VICTA AVIATION DIVISION

SERVICE BULLETIN No. 4

SUBJECT Rudder pedals bearing blocks. Mod. No. B4.

EQUIPMENT AFFECTED Airtourer 100.

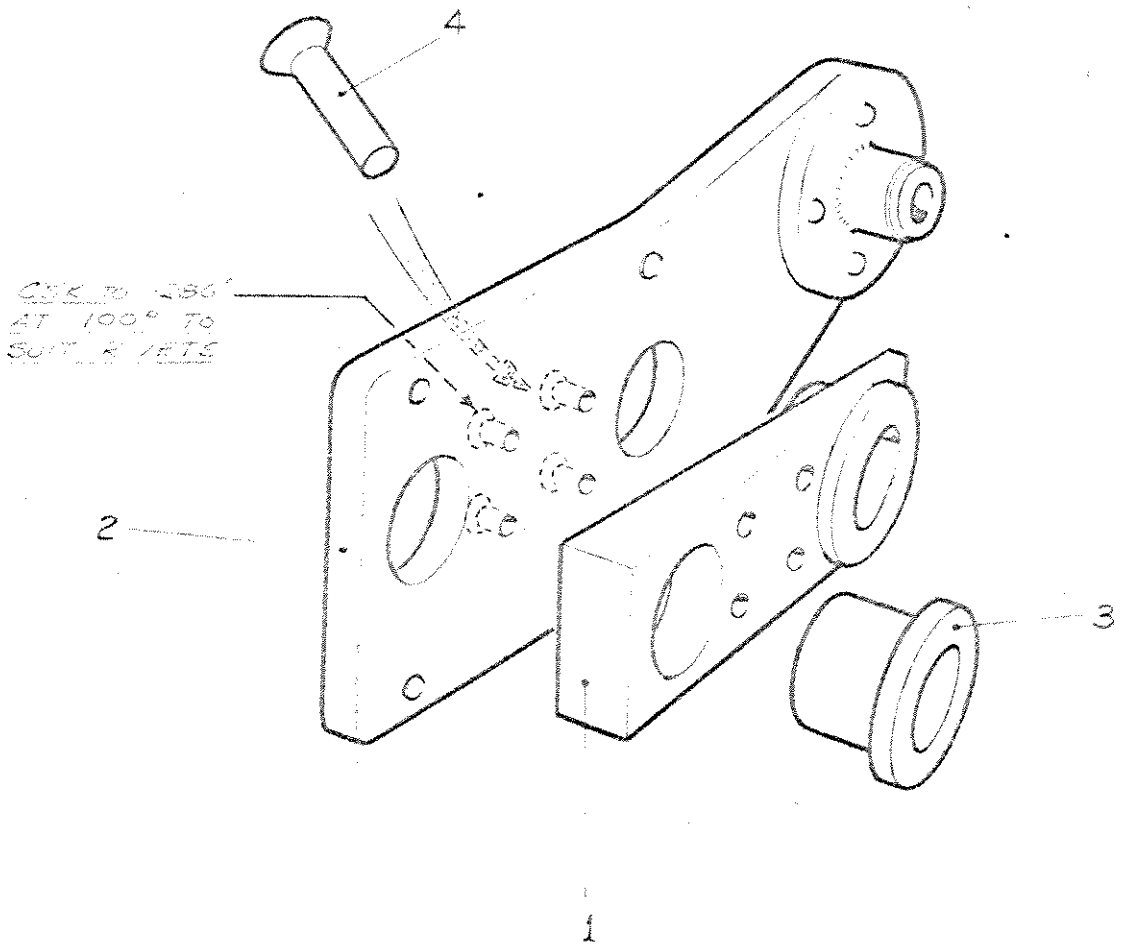
Fig. 1 Bearing Block

REASON Failure of the rivets in the structure of the bearing blocks has occurred due to excess load being applied in a downward direction on the rudder pedals, thus allowing the rear rudder pedals torque tube to pivot on the forward torque tube bearing.

DETAILS Rectification of the above failure can be achieved by replacing the existing rivets with larger diameter rivets and the existing rear bearing with a longer bearing. Refer to details listed below:

(g) Remove the four self locking nuts and washers securing each bearing block to the inner sides of the fuselage, discard the nuts and withdraw the clevis bolts from the outer sides of the fuselage, thereby freeing the rudder pedal assembly from the fuselage structure.
NOTE: It is only necessary to partially withdraw the clevis bolts. However, if they are fully withdrawn care must be taken to ensure that the tubular spacers between the channel structure remain in position.
